# Site HO24

## Heritage Impact Assessment

Client: Castle Point Borough Council  
Project Number: F1525

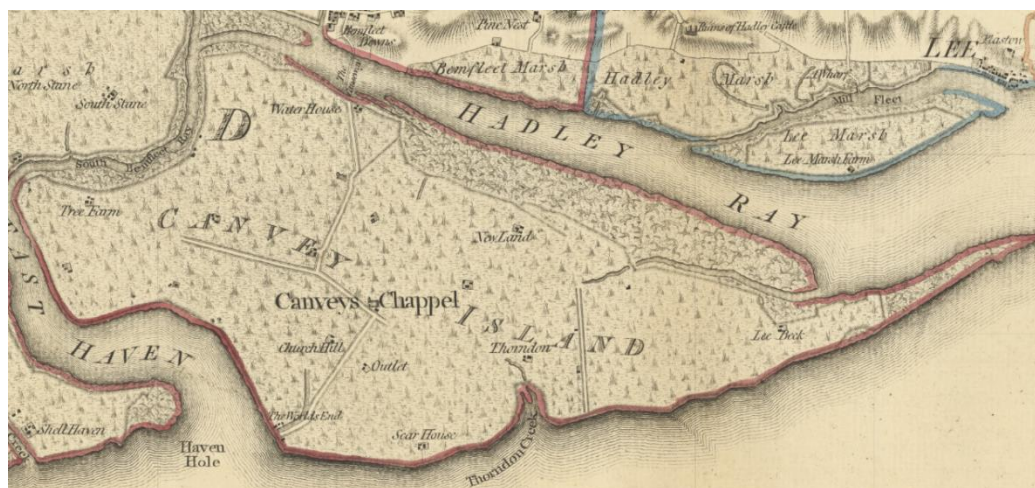
**Figure 3: Chapman and Andre Extract (1777)**

- 3.23. The Chapman and Andre map (**Figure 3**) shows the whole of Canvey Island as rough marshland with scattered farmsteads and a chapel, surrounded by an earthwork sea wall. The road that runs down the east side of the allocation area is depicted running on the same line south from the original causeway crossing.

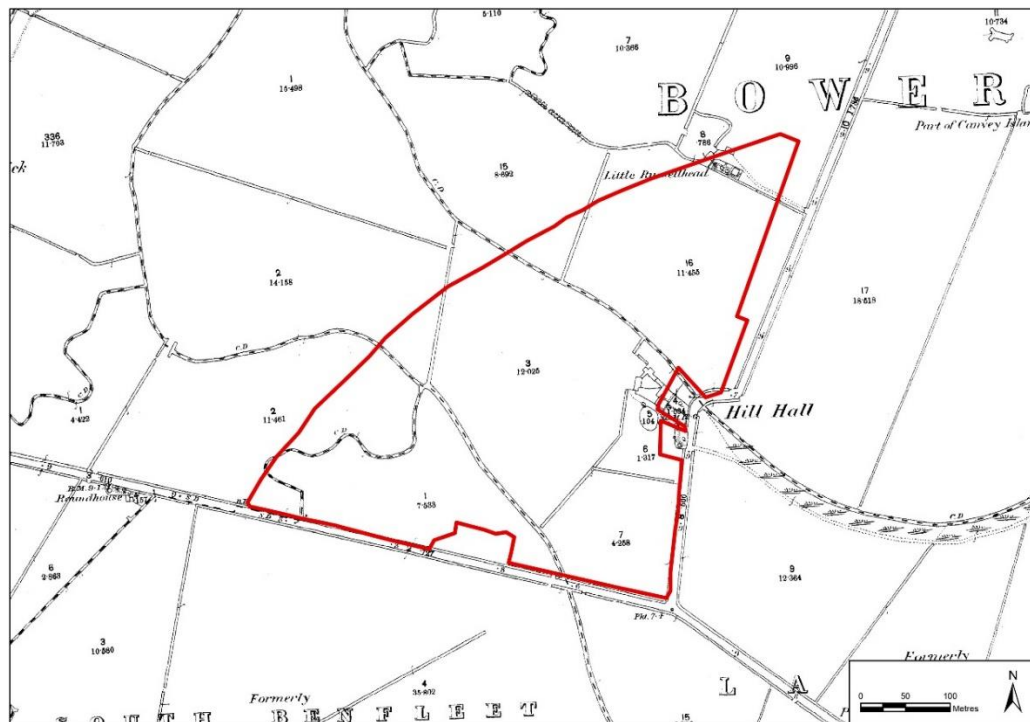
**Figure 4: Extract from the OS 1<sup>st</sup> Edition 25' map (1877)**

3.24. The first edition Ordnance Survey (OS) map (**Figure 4**) shows evidence of reclaimed marshland divided into irregular fields with a single former sinuous boundary surviving in the south west corner. There are two farmsteads, Hill Hall and Little Russellhead within the Site. The southern part of the areas has already been drained as indicated by the straight boundaries.

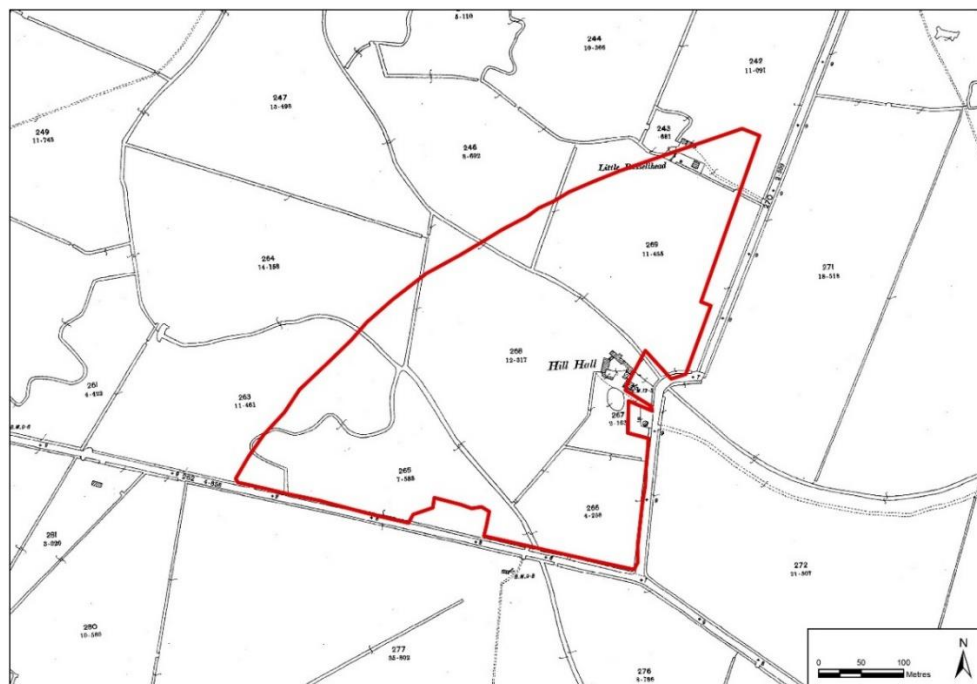
**Figure 5: Extract from the OS 2<sup>nd</sup> edition 25' map (1898)**

3.25. The second edition OS map (**Figure 5**) shows limited change from the first edition. The number of buildings at Little Russellhead had been reduced.

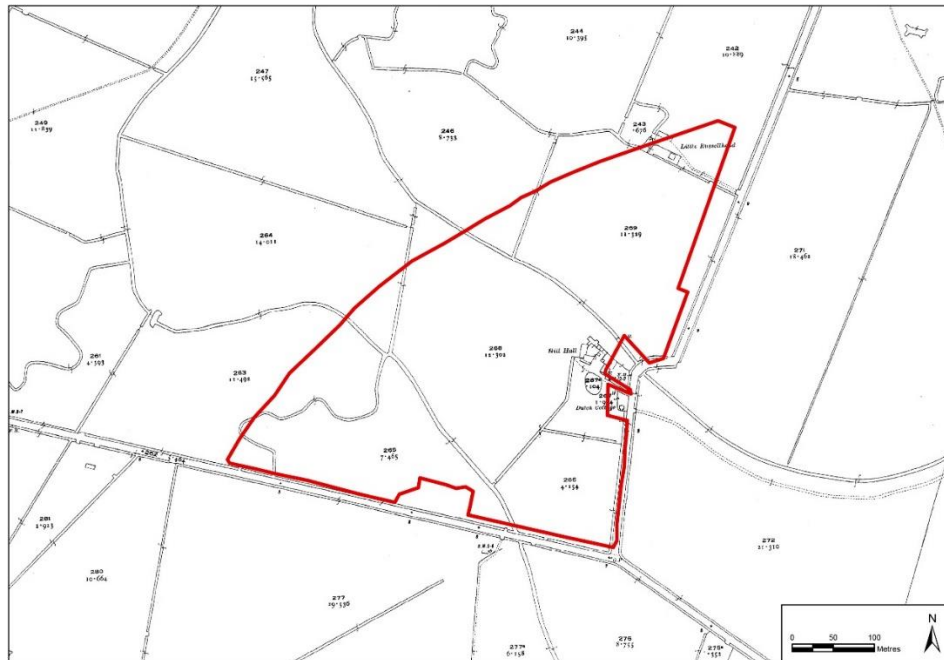
**Figure 6: Extract from the OS 3<sup>rd</sup> edition 25' map (1923)**

3.26. The third edition OS map (**Figure 6**) shows no change in the immediate environs of the Site.

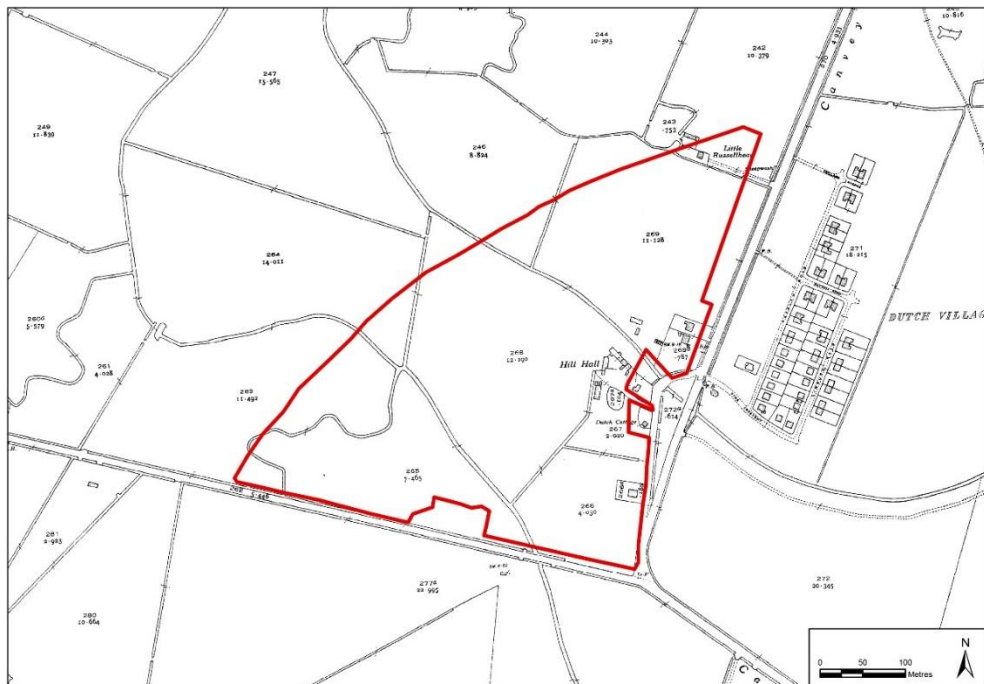
**Figure 7: Extract from the OS 4<sup>th</sup> edition 25' map (c.1938)**

- 3.27. The fourth edition OS map (**Figure 7**) shows the addition of buildings to the east of the Site. The road to the east of the Site had been straightened, and the first houses of the Dutch Village were in place to the east.

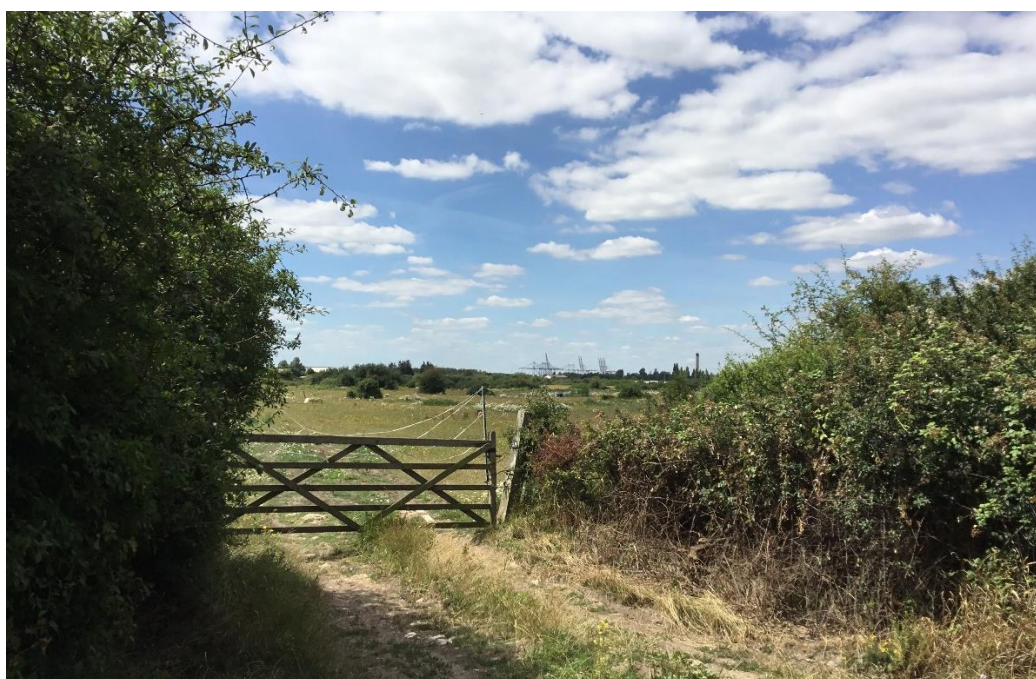
- 4.4. Views of the northern portion of the Site (**Figure 8**), seen from the west side of Canvey Road, show the area to be comprised largely of fields with a number of mature bushes and some wildflowers. A dirt track leads off the west side of Canvey Road, with a wooden gate providing access into this area of land. The northernmost part of the Site largely comprises condensed trees and bushes.

**Figure 8: View south west across the Site from the east side of Canvey Road**

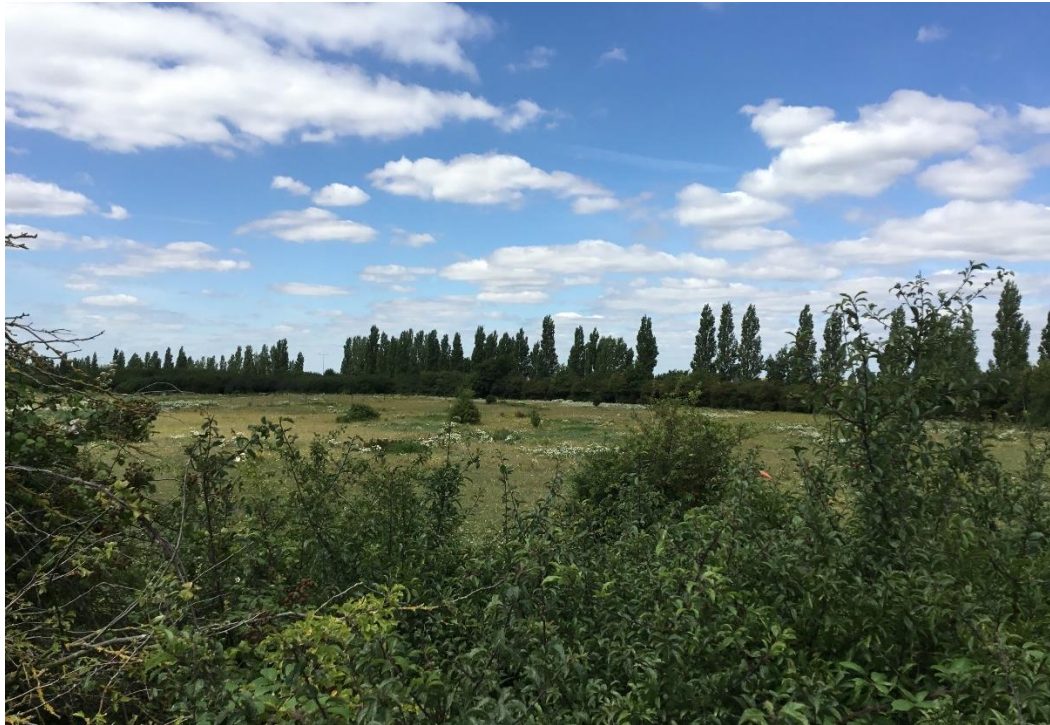
- 4.5. Looking west across the Site from the eastern boundary on Canvey Road, the view is of an open grassed area with the Poplar trees along Roscommon Way, which demarcate the north west boundary of the Site, visible in the background (**Figure 9**).

**Figure 9: View west across the Site from its eastern boundary**

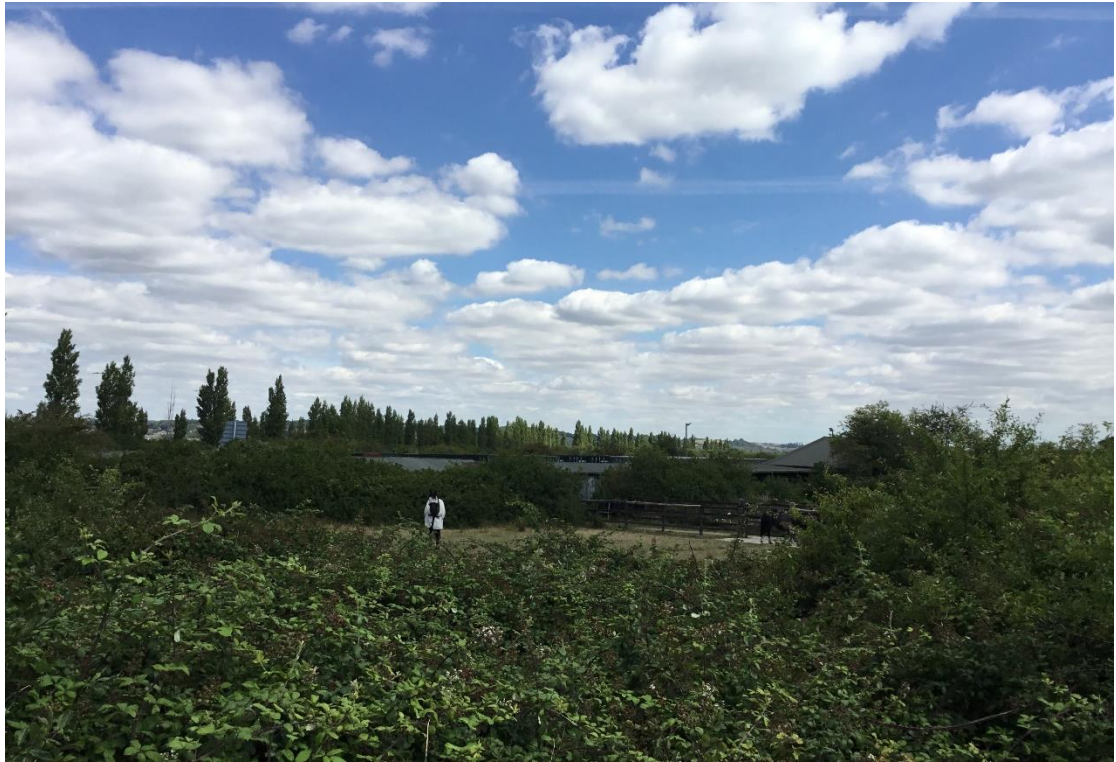
- 4.6. **Figure 10** shows the view across the Site from the junction of Roscommon Way with Northwick Road. This south west portion of the Site incorporates a small field, in use for grazing, and a group of industrial buildings, the roofs of which can be seen beyond this field.

**Figure 10: View north east across the Site from the junction of Roscommon Way and Northwick Road**

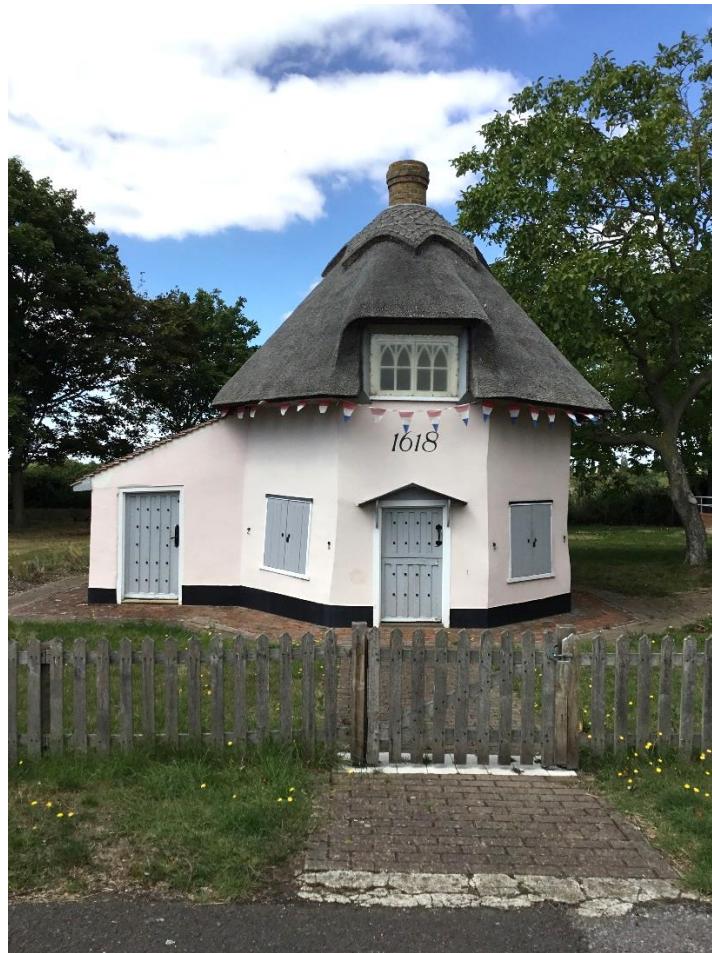
**Figure 11: Grade II Listed Dutch Cottage**

- 4.7. The Grade II Listed Dutch Cottage (**Figure 11**) is located immediately adjacent to the eastern boundary of the Site. The listed building is accessed via a small lane off Northwick Road, which leads to a tarmac car park at the front of the building (**Figure 12**). The heritage asset is set within its own gardens which surround the building on all sides.
- 4.8. To the rear of Dutch Cottage, beyond its gardens and boundary fence, is the open land of the Site (**Figure 13**). The Site forms part of the historic rural context of the listed building and is therefore an important element of its setting.

- 7.7 Development on the Site would impact upon the Grade II Listed Dutch Cottage as a result of the loss of part of its historic rural context and change to the character of the asset's setting, which would cause harm to its significance. This harm would be less than substantial with regard to the NPPF. The level of harm would be dependant upon the detailed masterplan.

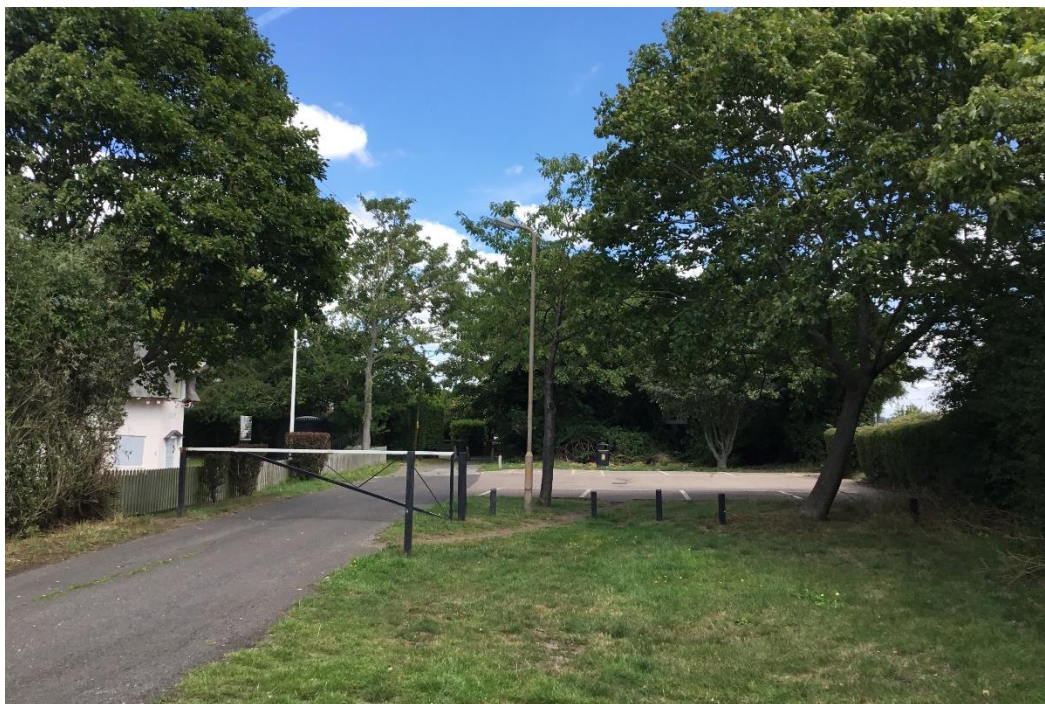
**Figure 12: View towards Dutch Cottage from the south**

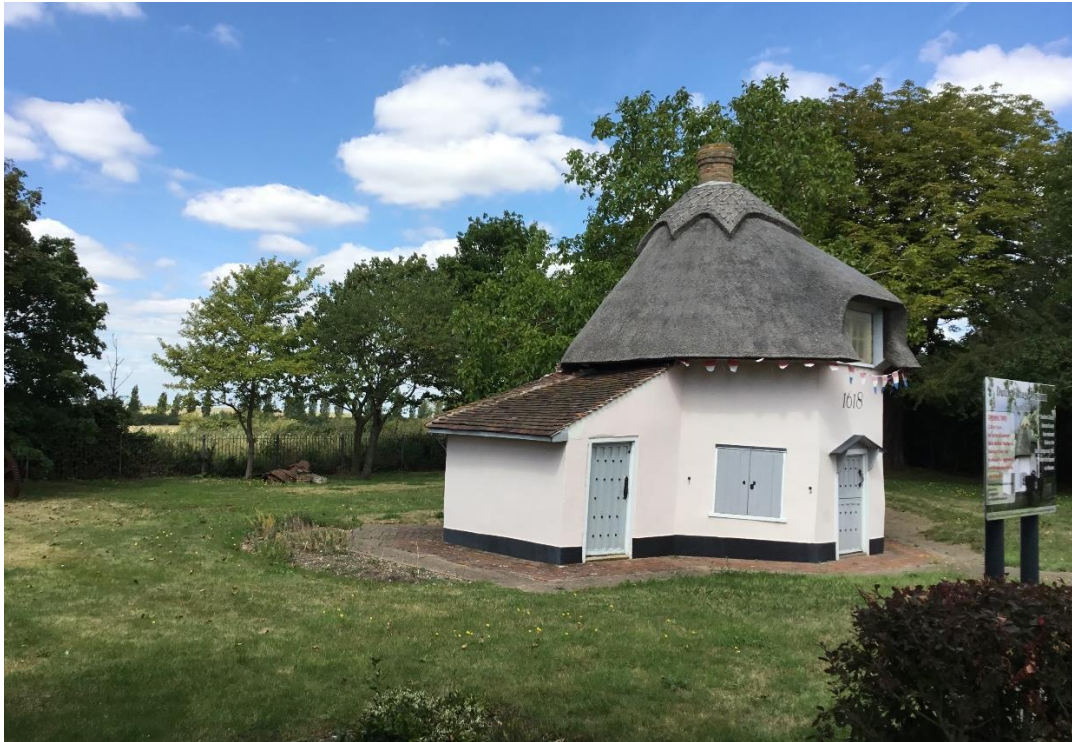
**Figure 13: Dutch Cottage with view of the Site to its rear**

- 6.9. Development on the Site would result in the loss of part of this historic context and an irreversible change to the open and rural character of the asset's setting. Consequently, it is considered that any development on the Site would cause a degree of harm to the significance of Dutch Cottage. With regard to the NPPF, it is considered that this harm would be less than substantial. The level of this harm would be dependent on the details of the masterplan. It is advised that a buffer is incorporated into any future masterplan. This is unlikely to completely mitigate any harm but there is the potential to minimise harm.

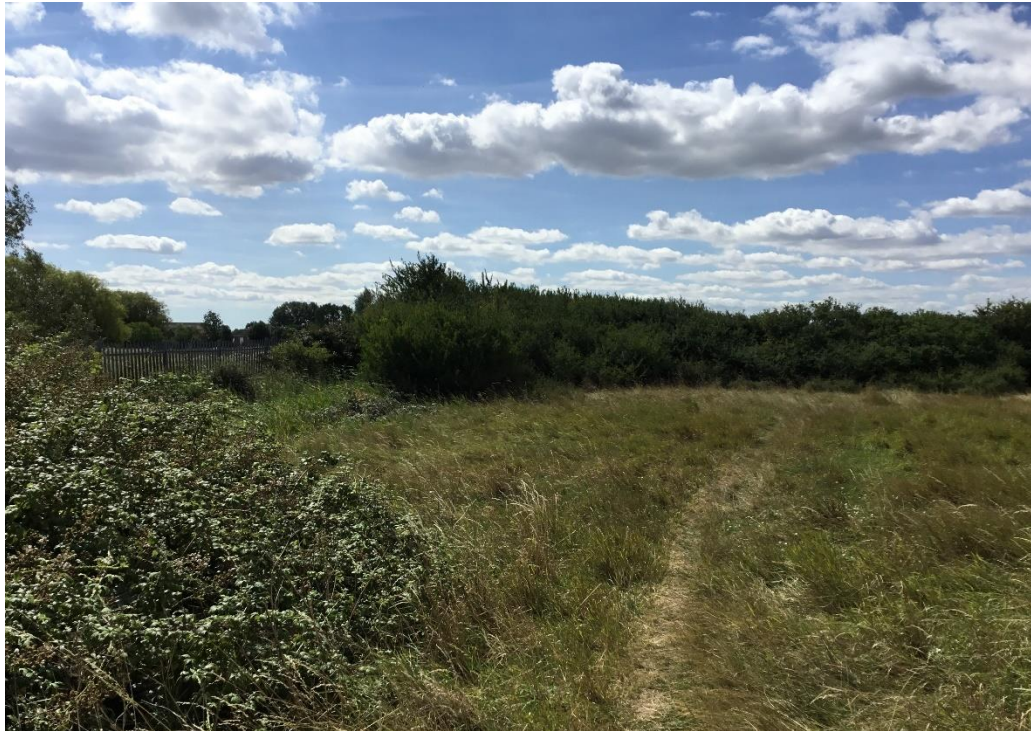
- 4.9. The Scheduled Monument, Roman saltern 260m south east of Great Russell Head Farm (**Figure 14**), is located to the north east of the Site, to the opposite side of Canvey Road. Although the Site forms part of the historic context of the Scheduled Monument, there is no inter-visibility between the two as a result of the interposing vegetation, the busy Canvey Road and the residential development of Dutch Village. As such, there is a sense of detachment between the Site and the heritage asset.

**Figure 14: The remains of the Saltern which survive as a mound approximately 1m higher than the surrounding area**

- 5.14. The principal significance of the heritage asset is drawn from its archaeological interest. The monument is a rare example of a red hill (Saltern) surviving as an earthwork, which is surviving in a partially degraded, although still surviving, open landscape, with view of the historic grazing marsh. The site survives within an area of drained grazing marsh, although earthworks survive both within the designated area and in its surrounding area. The present landscape enhances the appreciation of the asset within its landscape.
