# Site HO23

## Heritage Impact Assessment

**Client:**  
Castle Point Borough  
Council

**Date:**  
September 2020

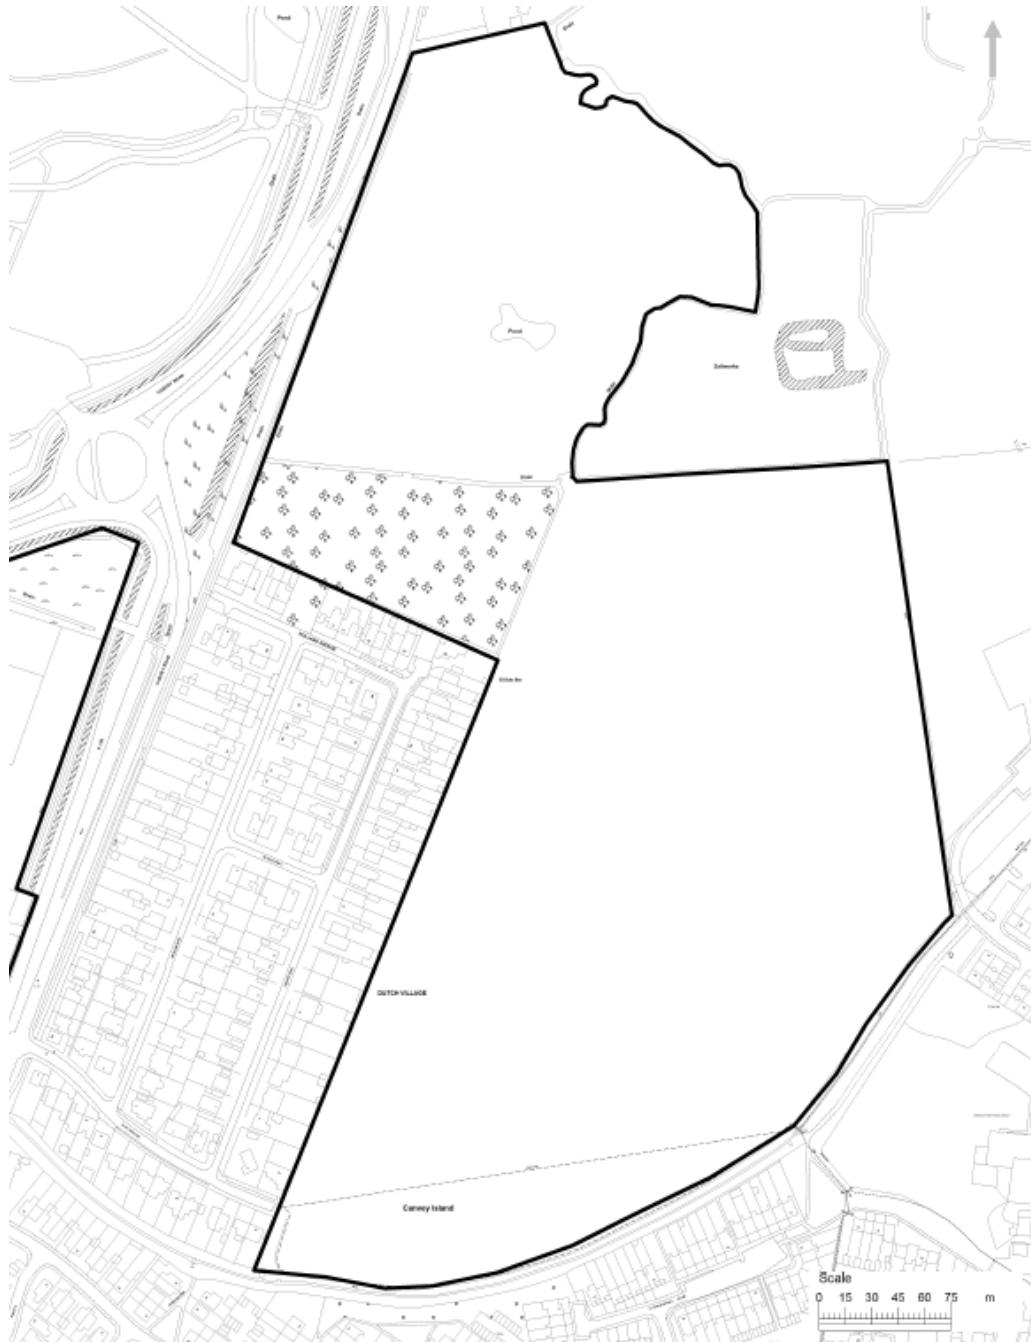
**Figure 1: Location Plan**

- 1.1. This Heritage Impact Assessment has been prepared by Place Services for Castle Point Borough Council. This document provides an assessment of heritage impact for Site HO23 ("the Site") as referred to in the Local Plan. The policy pertaining to Site HO23 is located in **Appendix A**. The location and extent of the Site is shown in **Figure 1**.

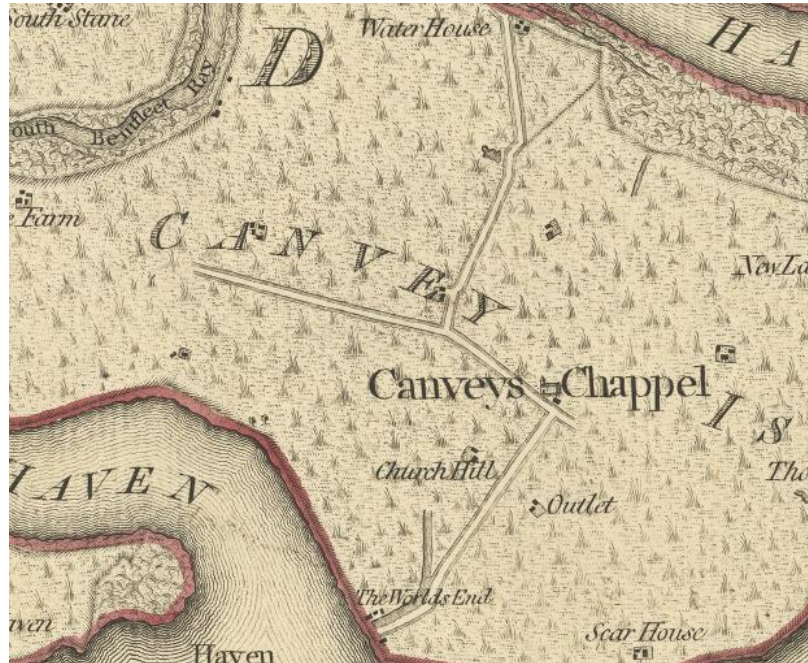
**Figure 3: Chapman and Andre Extract (1777)**

- 3.25. The Chapman and Andre map (**Figure 3**) shows the whole of Canvey Island as rough marshland with scattered farmsteads and a chapel, surrounded by an earthwork sea wall. The road that runs down the west side of the Site is depicted running on the same line south from the original causeway crossing.

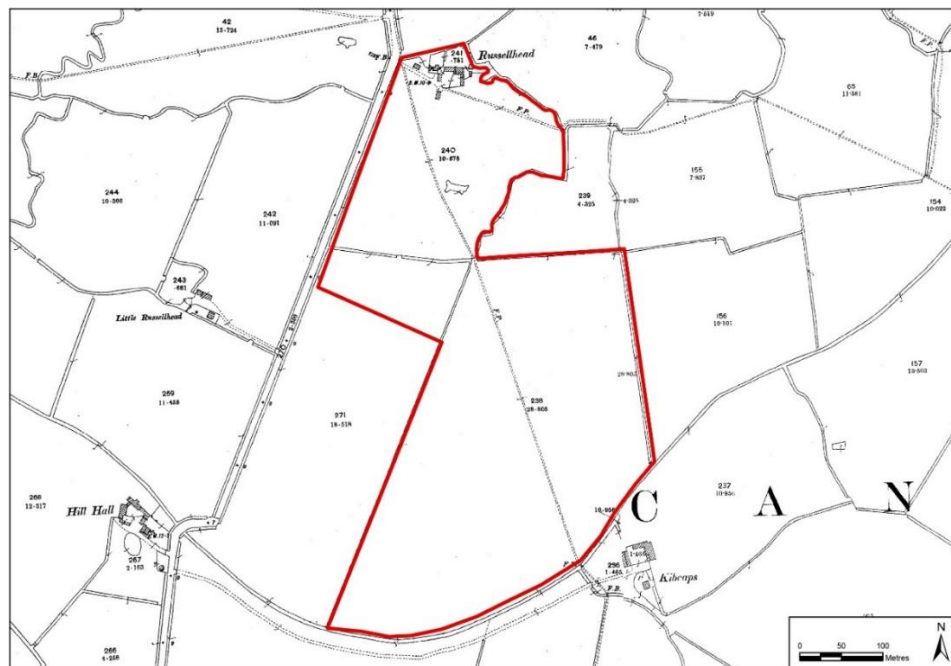
**Figure 5: Extract from the OS 2<sup>nd</sup> edition 25' map (1898)**

3.27. The second edition OS map (**Figure 5**) shows no change since the first edition.

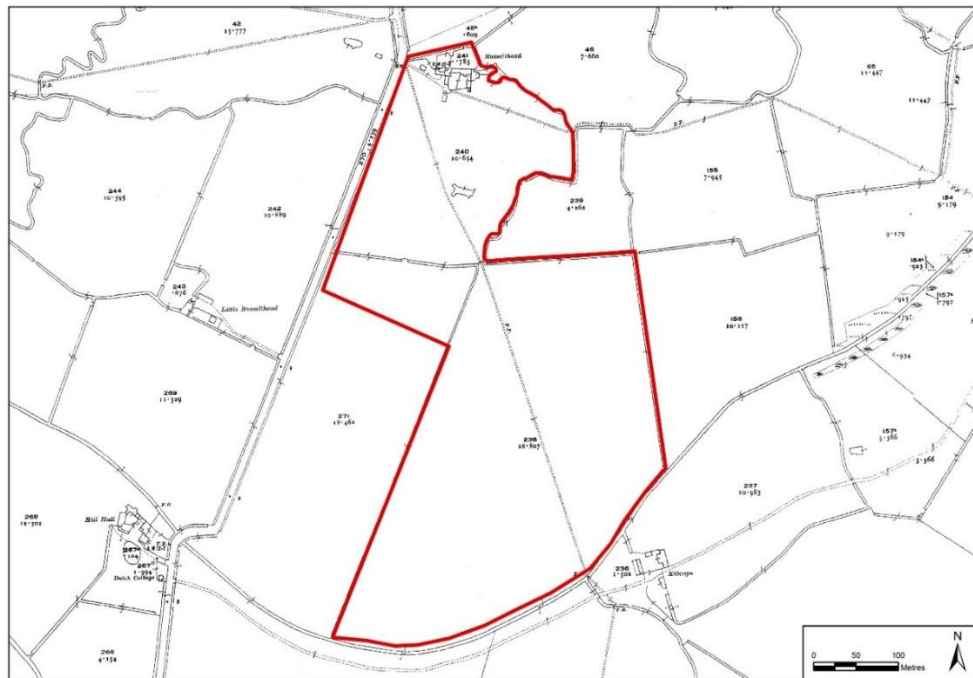
**Figure 6: Extract from the OS 3<sup>rd</sup> edition 25' map (1923)**

- 3.28. The third edition OS map (**Figure 6**) shows no change in the immediate environs of the Site, but housing plots are now shown to the east along new roads. The crossing onto the island to the north is still shown as a causeway.

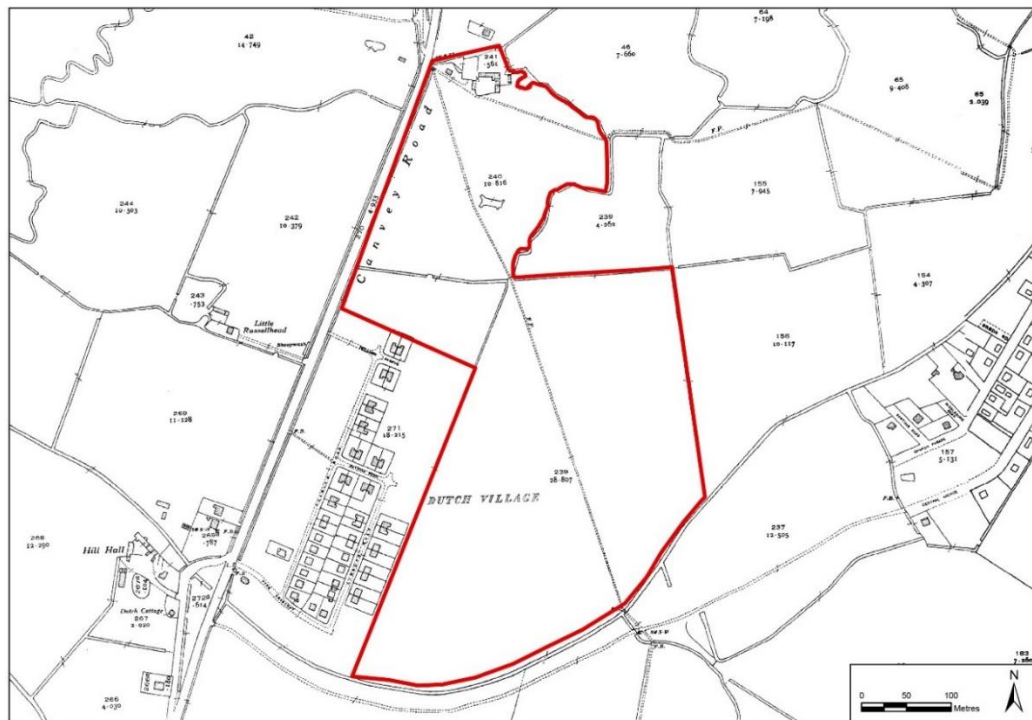
**Figure 7: Extract from the OS 4<sup>th</sup> edition 25' map (c.1938)**

- 3.32. The fourth edition OS map (**Figure 7**) shows no change within the Site, but housing has extended closer from the east, and the first houses of the Dutch Village have been built immediately to the west of the Site. The farm buildings of Russellhead were still shown, though the farmhouse appears to have been demolished. There was now a road bridge in place of the causeway to the north.
- 3.33. The site of Russelhead farm is now totally clear and is open space next to the new property developed immediately north of the Site.

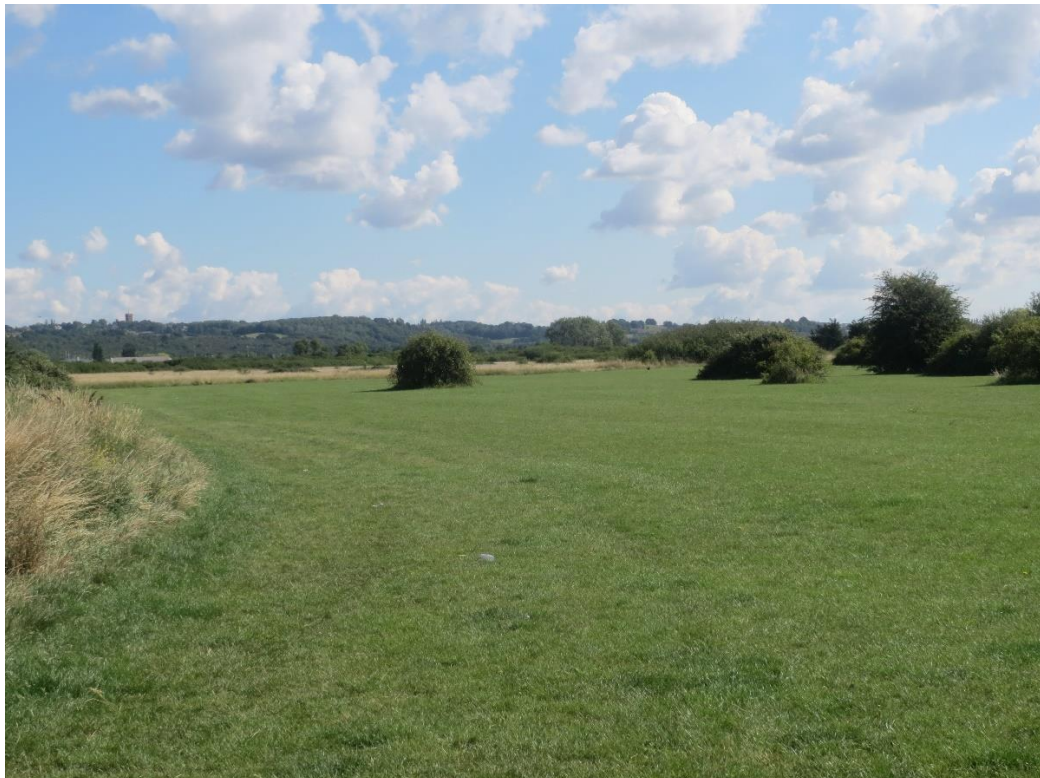
**Figure 8: View looking north from east of Dyke Crescent**

- 4.2. The Site is predominately comprised of open fields, with a vegetated boundary to the north. The topography of the pastoral land is slightly undulating.
- 4.3. The west boundary of the Site is formed by Canvey Road, with the south west and south boundaries predominantly following the line of residential development adjacent to the Site. The eastern boundary largely follows the field boundary abutting the local school playing fields. To the north lie open fields created from the former grazing marsh. Some of these are under crops whilst others are grassed, possibly being grazed.
- 4.4. Entering the Site from the south-western corner shows the southern half of the Site to be open grassland with occasional mature bushes (**Figure 8**).

- 4.5. Visible in the distance, on the higher ground, (**Figures 8 & 9**) is the Grade II Listed Benfleet Water Tower. The height of this brick-built water tower would have historically provided the pressure for the water supply system. Although visible from within the Site, any views of the Site from the water tower would not have formed part of its original design intentions; rather its height was solely a consequence of its function. Considering the distance and proximity to the Site, this heritage asset does not need to be considered further within this assessment. The edges of the field are overgrown and there are small areas of scrub in various locations. Throughout the field there are undulations which are likely to have their origins in its original use as a grazing marsh.

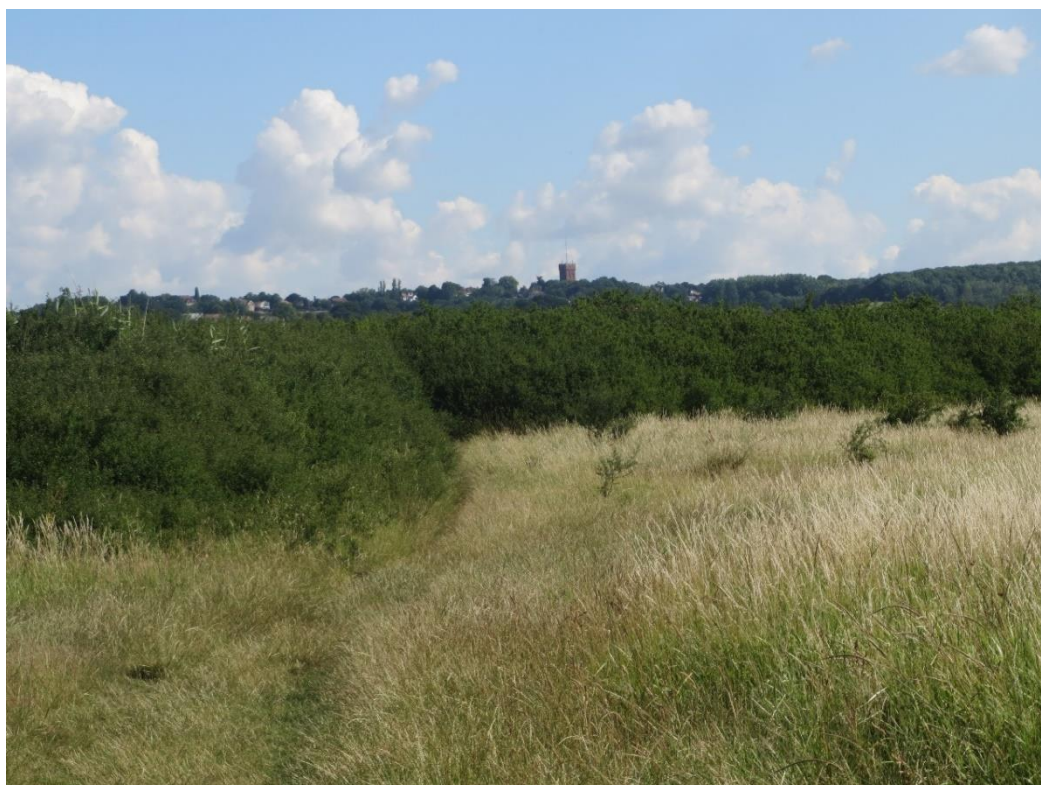
**Figure 9: View looking north at the boundary with the Scheduled Monument**

- 4.6. During the visit the northern half of the field had been uncut and was knee high grass with the northern boundary defined by a deep ditch and wide block of thorn scrub (**Figure 9**). The Scheduled mound relating to the saltern lies to the north of this ditch.

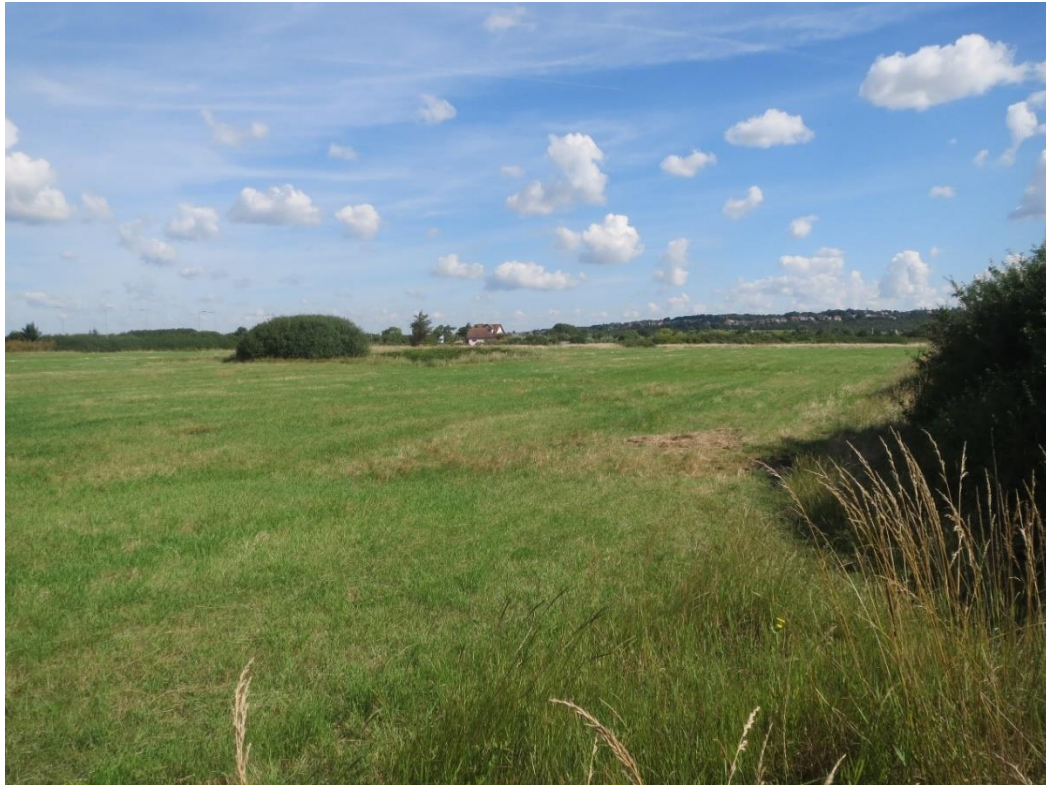
- 4.7. The northern field of the Site comprises rough grass, although it had been cut showing a considerable spread of undulations across the field (**Figure 10**). These features probably relate to earlier channels associated with the grazing marsh, however, considering their position immediately adjacent the Scheduled Monument, they may also be part of the saltern complex.

**Figure 10: Northern part of development showing earthworks across the field.**

- 7.12 Before the principal of development is considered in the northern field it is recommended that a field evaluation by geophysics and trial trenching is undertaken to establish the significance and extent of surviving archaeological deposits.

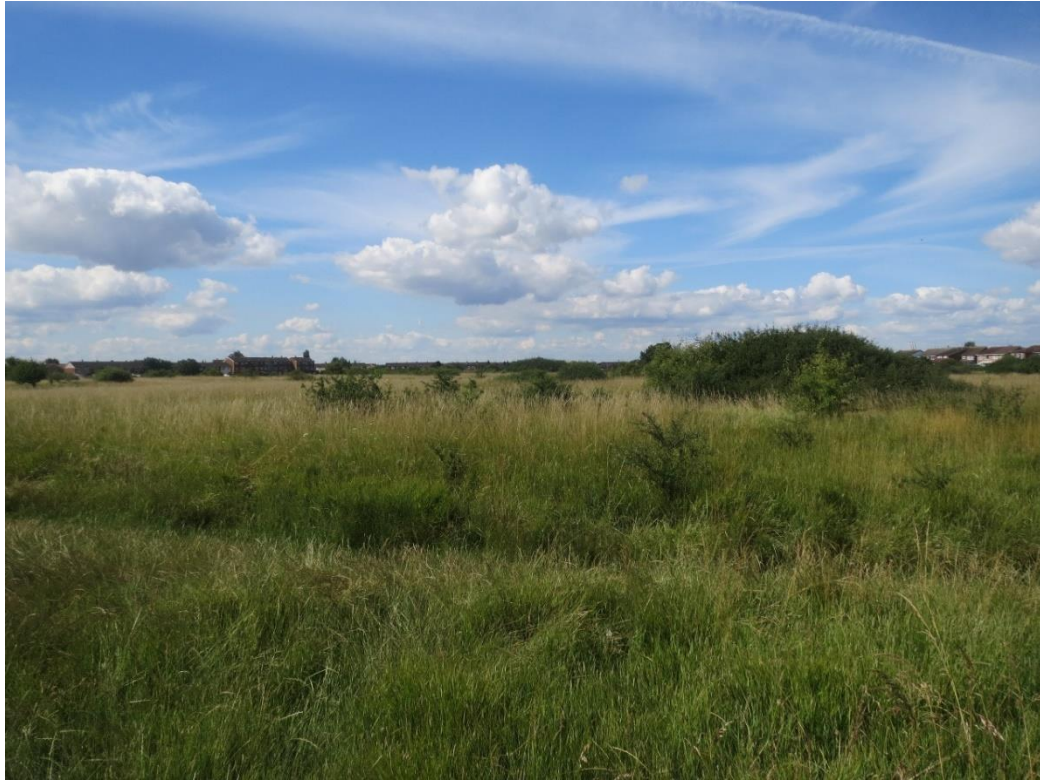
- 4.8. The Scheduled Monument is located immediately to the east of the northern field of the Site and to the immediate north of the southern field of the Site. The boundary to the south is formed by a hedge largely comprising blackthorn, on either side of a ditch.
- 4.9. The Monument is covered with rough grassland, although the mound is visible being approximately 1m in height above the surrounding area (**Figure 11**).

**Figure 11: The remains of the Saltern survives as a mound approximately 1m higher than the surrounding area**

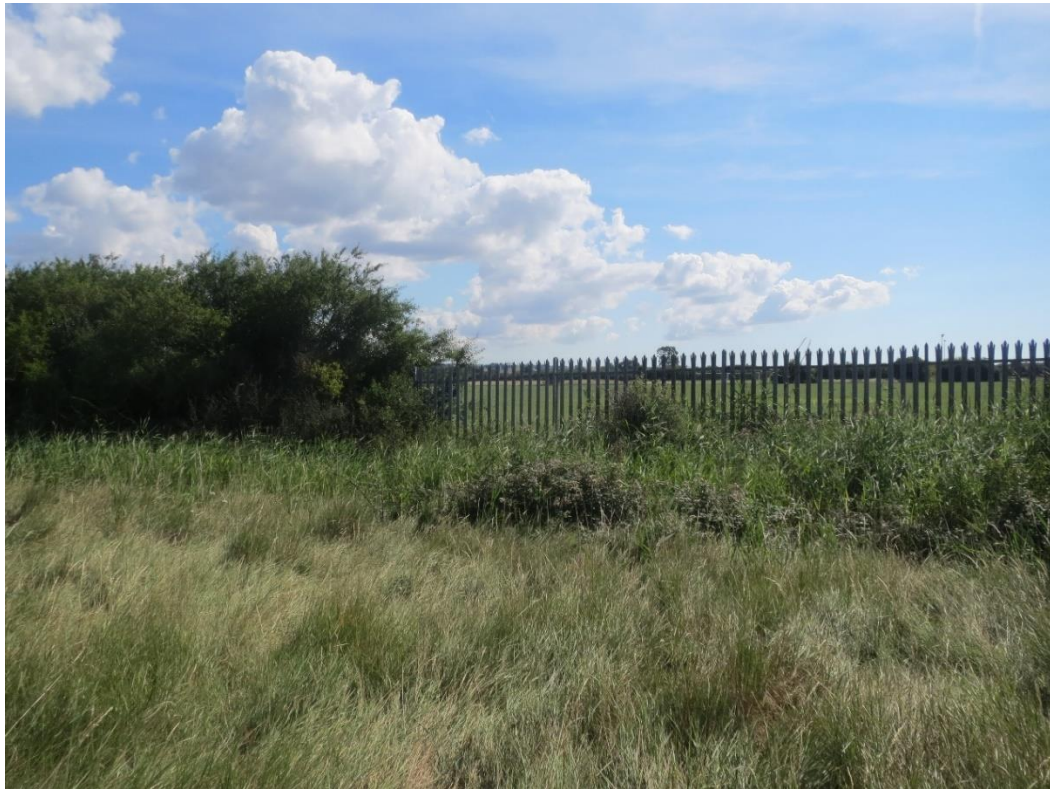
- 4.10. To the east of the Scheduled Monument are school playing fields, which appear to have been levelled during the construction as there is a distinct difference in ground level from the Scheduled Monument (**Figure 12**).

**Figure 12: Height difference was visible between the Scheduled Monument and adjacent school fields**

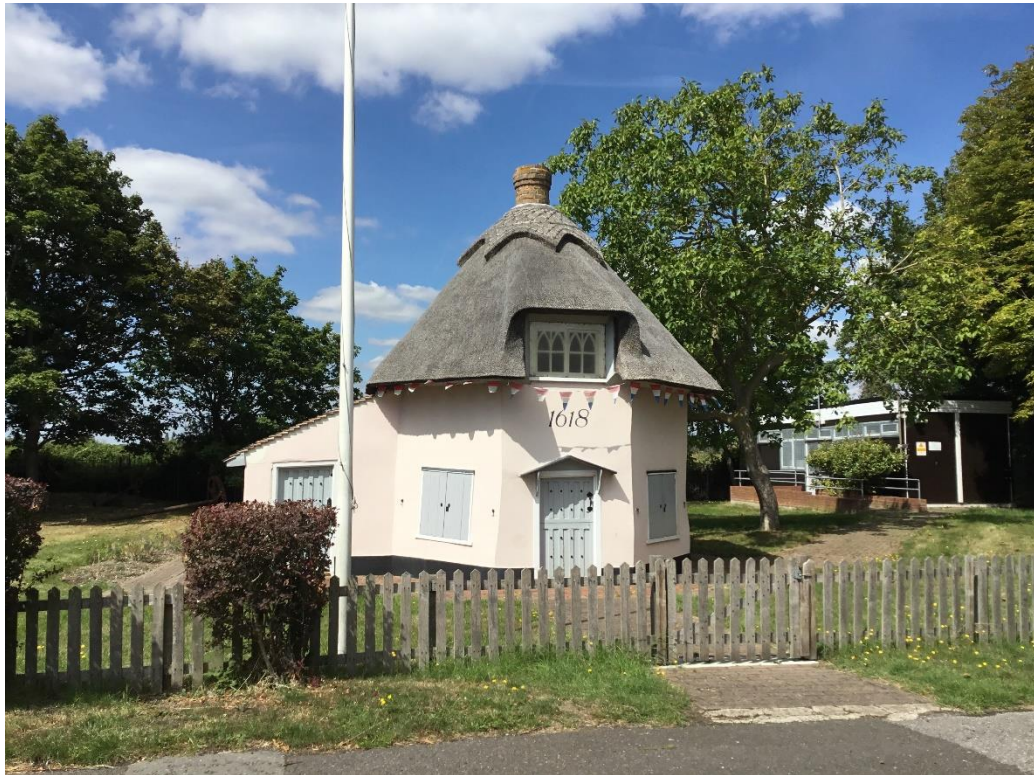
**Figure 13: Grade II Listed Dutch Cottage**

4.11. The Grade II Listed Dutch Cottage (**Figure 13**) is located to the south west of the Site, to the opposite side of Canvey Road. The listed building is set within its domestic gardens and is fronted by a tarmac car park (**Figure 14**). There is no inter-visibility between the listed building and the Site. Although the open land of the Site forms part of the historic context of the heritage asset, there has always been a degree of separation between the listed building and the Site as the principal thoroughfare of Canvey Road has historically existed between them. This detachment is further reinforced by the residential development to the south west of the Site, constructed in the early twentieth century (the Dutch Village).
