South Benfleet

Conservation Area Appraisal and Management Plan

Essex County Council

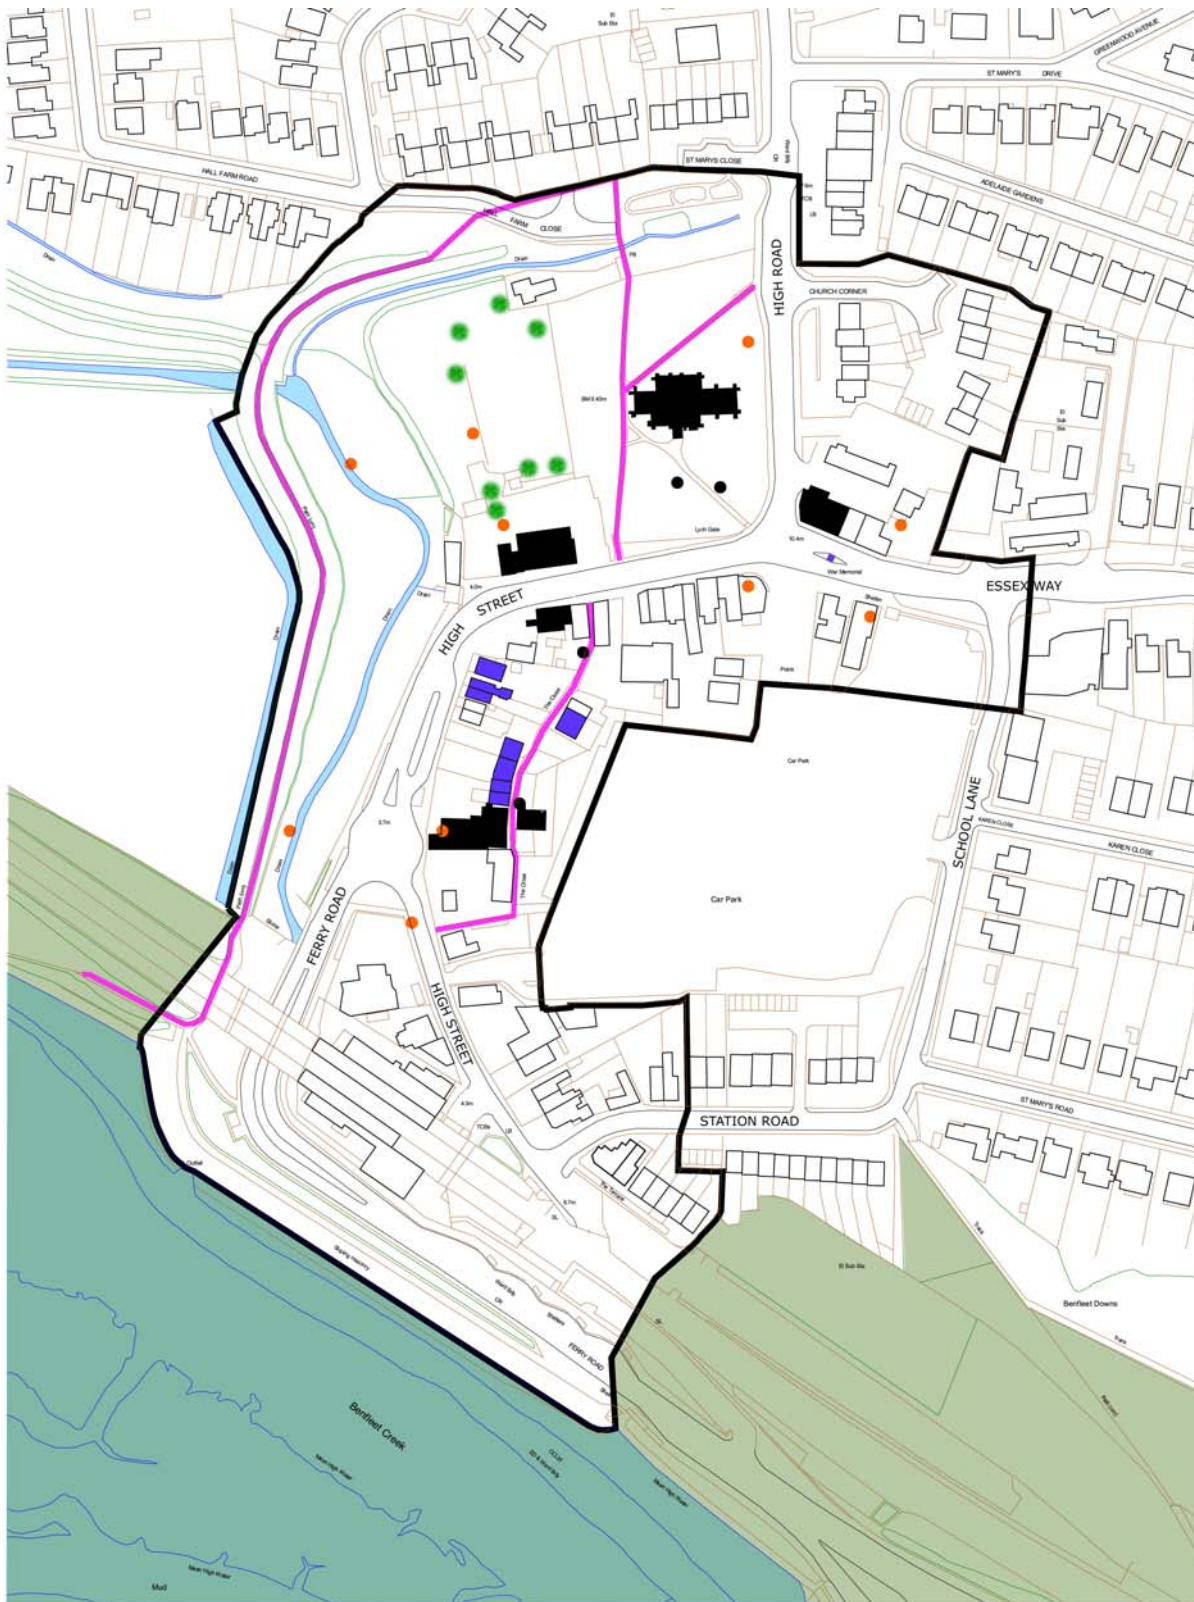
South Benfleet Conservation Area Designation Map

Fig. 1 Designation map showing conservation area boundary, listed buildings, tree preservation orders, locally listed buildings, rights of way and the Green Belt.

- 1.2 The conservation area (Fig.1) covers the historic centre of the village, including St. Mary's church, the High Street, the station and the open land adjacent to the creek side. There are nine entries on the statutory list of listed buildings, including the grade I listed church and grade II* listed Anchor public house; the remainder are grade II listed and include two lamp posts and five grave stones (see Appendix 1). There are no scheduled ancient monuments, but the conservation area is of considerable archaeological importance because of the battle of Benfleet in 894 AD. To the south of the conservation area, the Benfleet Creek is Green Belt, whilst to the east is the Hadleigh Marshes Special Landscape Area and Hadleigh Castle Country Park.

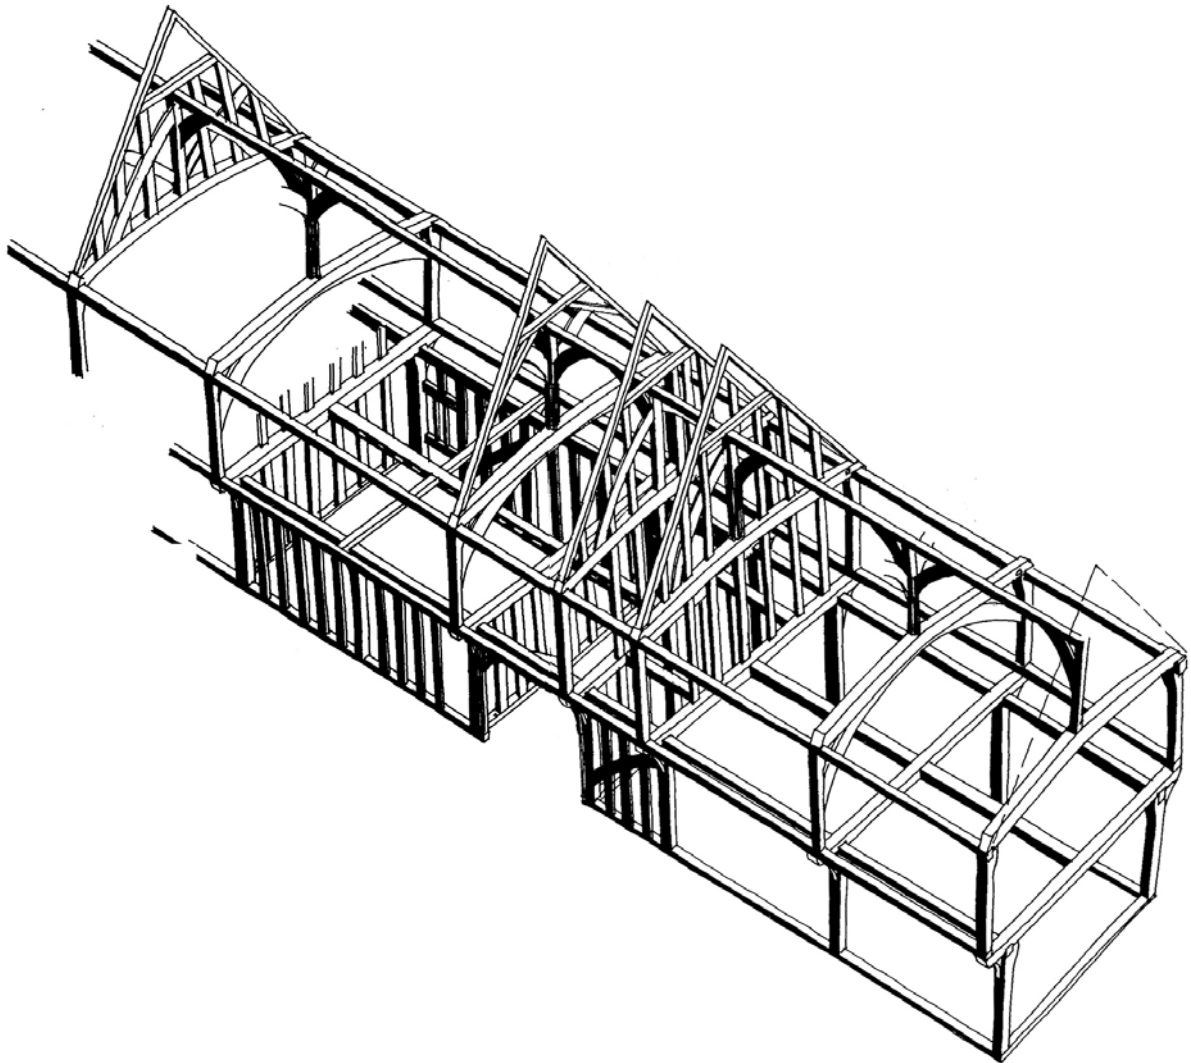
Fig. 2 The timber frame of the Anchor (D.F. Stenning).

dating from the 14th century (*Fig. 2*). It is an unusual building, not a normal house, possibly a hall for the manorial court or else for a religious guild attached to the church. The only other medieval building in the conservation area is the Hoy and Helmet public house which is 15th- or 16th-century in date.

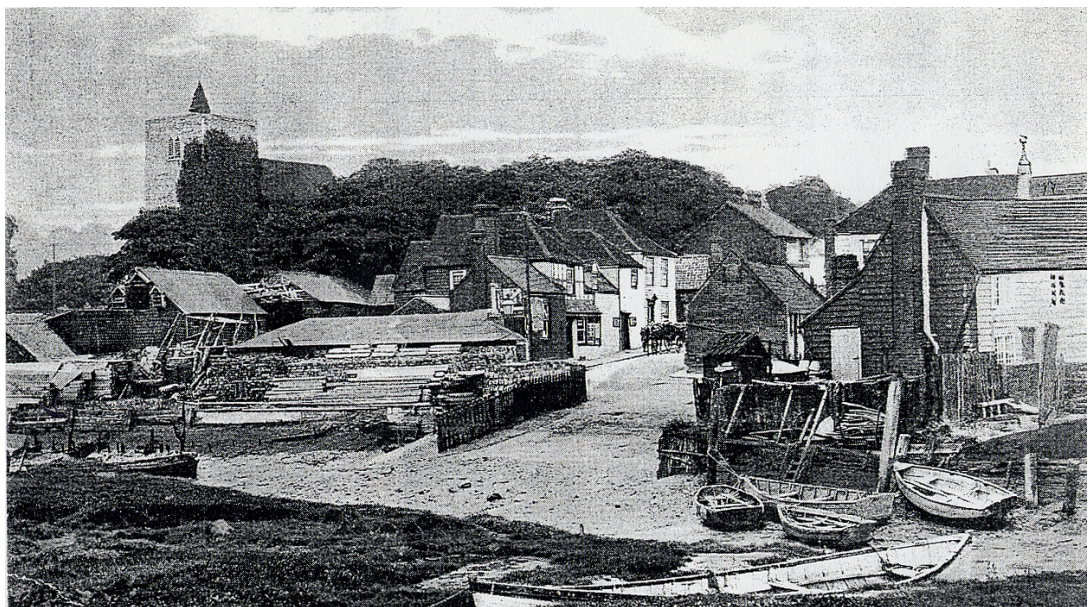
Fig. 6 This old photograph shows the former relationship between the High Street and the creek, the road originally terminating in a gangway or landing place.

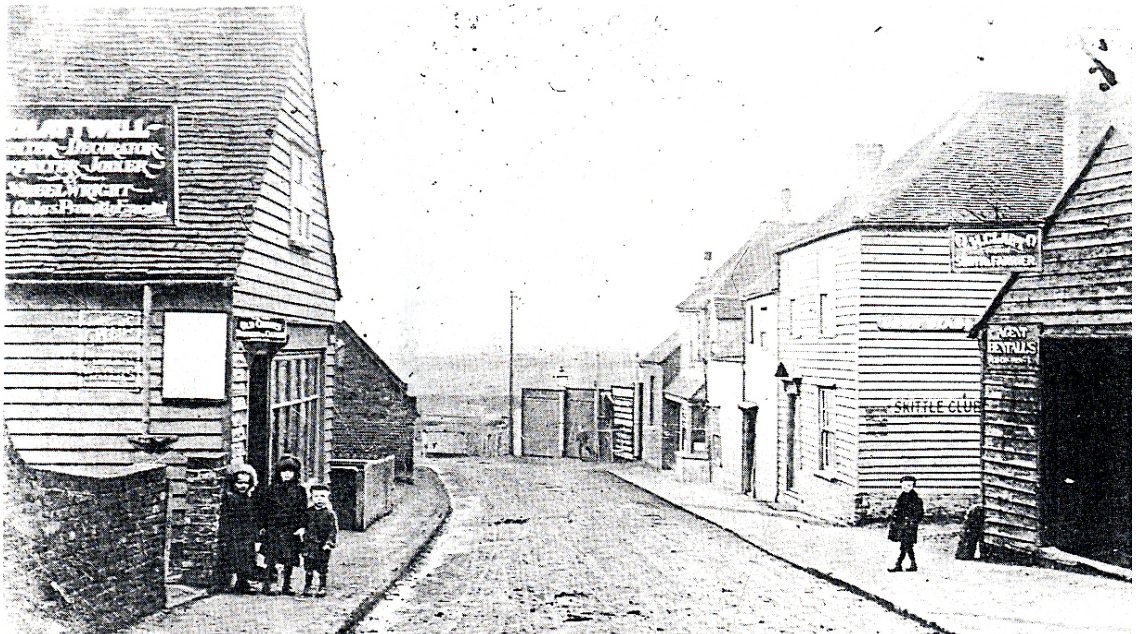
Fig. 7 An old photograph looking west down the High Street. Weatherboard is the predominant building material.

- 5.1 The older buildings are timber-framed. Most timber-framing is now concealed. The Anchor has been clad with brick at the ground floor, and rendered above. The Hoy and Helmet, and Dickens restaurant, have false timber framing at the first floor. Old photographs (*Fig. 7*) indicate that there were once many weatherboarded houses, but very few of these survive. Weatherboarding was, and still is, a characteristic material of southern Essex, especially the coastal areas. There is little red brick, the 18th-century façade of the Half Crown Inn being a notable exception. Most of the 19th-century buildings are of yellow London stock brick. These bricks were probably made locally as there were brickworks at Benfleet in the 19th century. The later 19th-century housing in the village comprised semi-detached Victorian cottages built of yellow stock brick with slate roofs and sash windows (*Fig. 8*). Most of these brick buildings have now been painted, usually white. Combined with replacement windows of various types and concrete tiles, this has led to an unfortunate loss of character. The Close has developed its own distinct late 20th-century aesthetic of white painted brick walls and black joinery (*Fig. 9*).

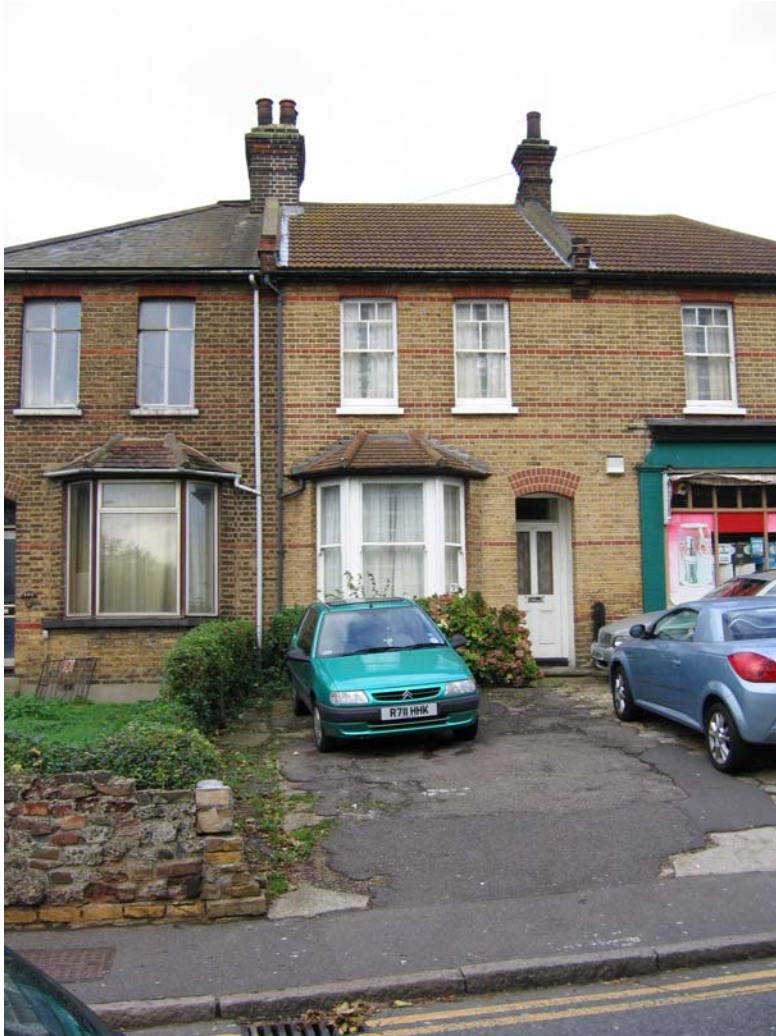
Fig. 8 No. 103 High Street, a well preserved Victorian cottage typical of the late 19th-century development at the southern end of the village in the vicinity of the station. Brickwork and windows are intact but it has lost its slate roof.

- 8.22 There follows a terrace of three Victorian cottages, the first with replacement windows, the middle one (**no. 103**) being one of the few in the village to preserve its original appearance (*Fig. 8*), and the third a shop on the corner where Station Road climbs steeply up the edge of the Downs.⁹

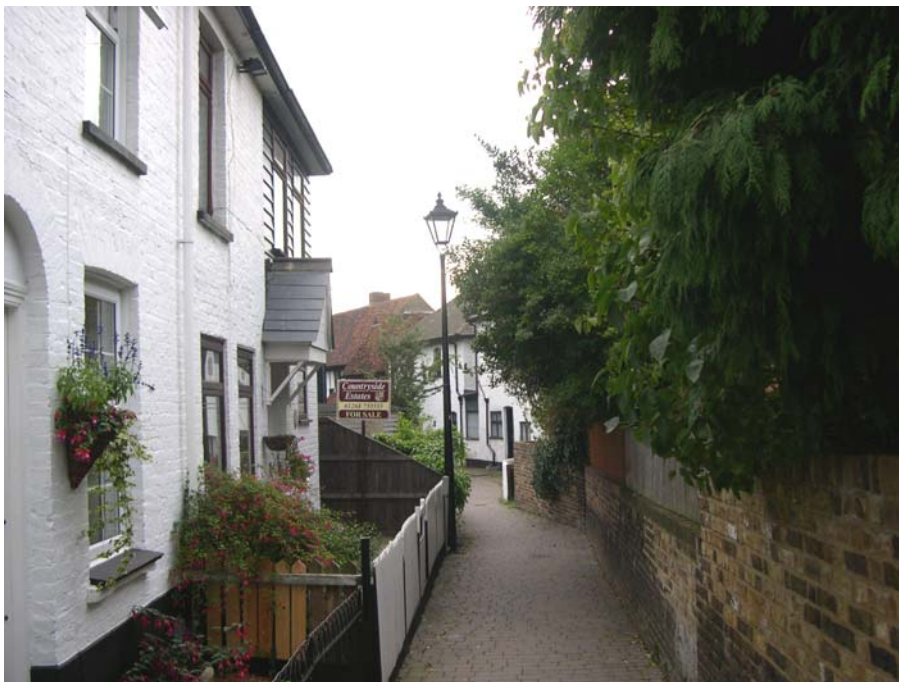
Fig. 9 The Close looking south. White painted walls with black woodwork contribute to the distinctiveness of this alleyway.

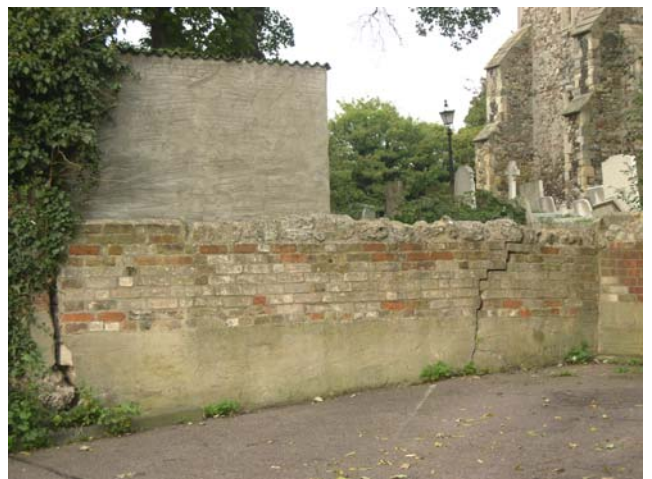
Fig. 14 Breeze block structure and decrepit boundary wall at the edge of the churchyard, seen from the Hoy and Helmet car park.

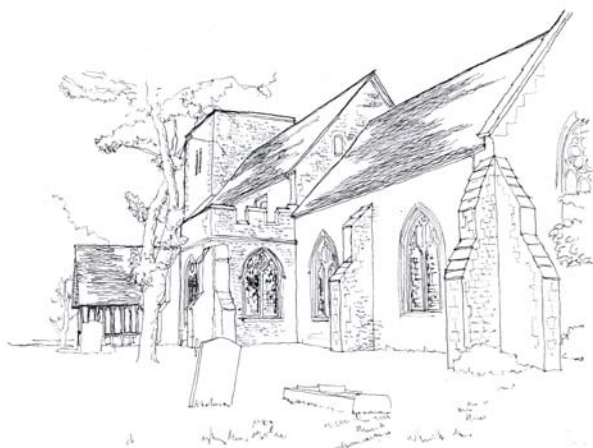
Fig. 15 St. Mary's church.

- 8.3 The **church** is a large, imposing but rather sombre building constructed mainly of Kentish Rag with levelling courses of brick and tile (*Fig. 15*). It dates from the 12th century, but is largely Perpendicular or 15th-century in appearance. Its outstanding external feature is the 15th-century south porch, a richly decorated and carved timber-framed structure with a hammerbeam roof (*Fig. 16*). It is exceptional by national standards, but the splendour of its carpentry is difficult to appreciate because of its current shabby appearance. Its roof has slipped tiles at the junction with the main church building and needs repair.

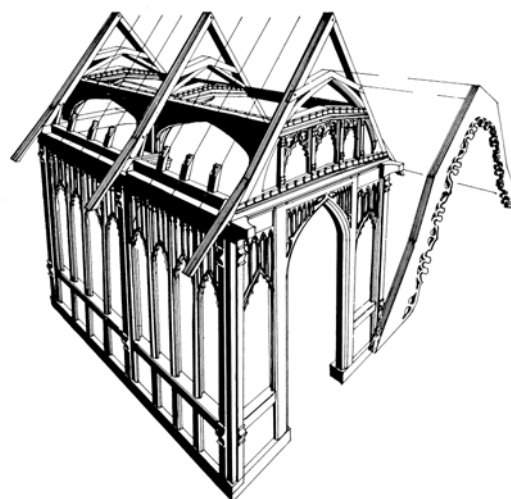
Fig. 16 St. Mary's church, the south porch (C A Hewett)

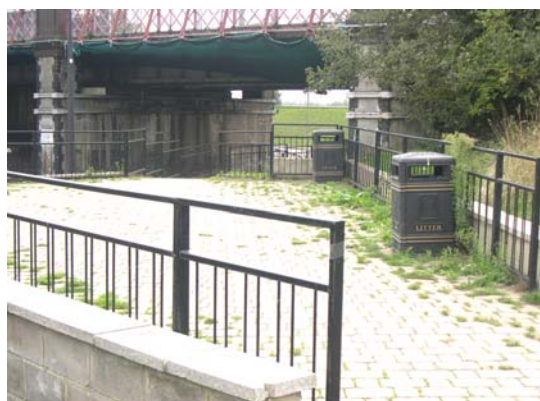
Fig. 20 Amenity area on the footpath between Church Creek and Ferry Road.

- 11.6 The amenity area at the south end of Church Creek (*Fig. 20*) needs better maintenance. The block paving should be weeded, one of the litter bins removed, and a seat re-instated. It would benefit from better railings.

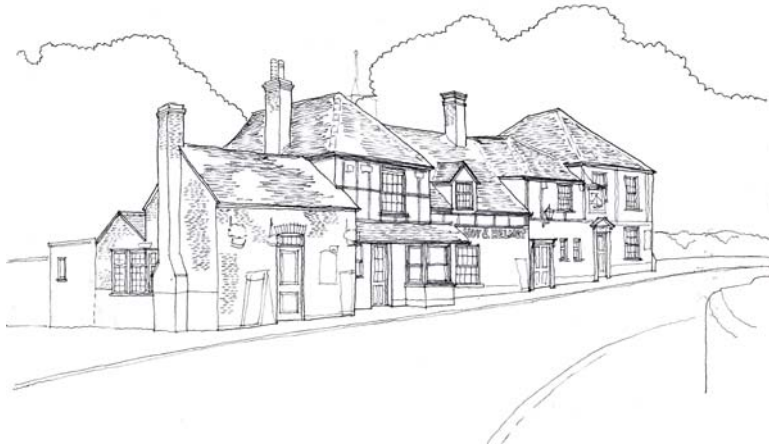
Fig. 22 The Hoy and Helmet.

- 8.10 The High Street slopes down to the creek where it turns to the south. The slope, the bend, and the presence of the Hoy and Helmet and the Half Crown, make for an interesting view. But the total separation of the creek, both physically and visually, from the village is a loss. Originally, the slope opened out into a hard or beach where boats were drawn up, and the High Street effectively terminated here. The pavements in this, the best part of the High Street, are much repaired where service trenches have been cut through them.
- 8.11 Combining elements of differing shape and size, with roofs of varying height and pitch, the **Hoy and Helmet**⁶ is the most picturesque building in the conservation area, and the only one with a recognisably late medieval exterior (*Fig. 22*). The

central part of the building is clearly an H-plan medieval house with a hall flanked by two cross-wings. Similarly, the **Half Crown** on the other side of the road is the only building which is Georgian in appearance, having a red brick façade of the first half of the 19th century.

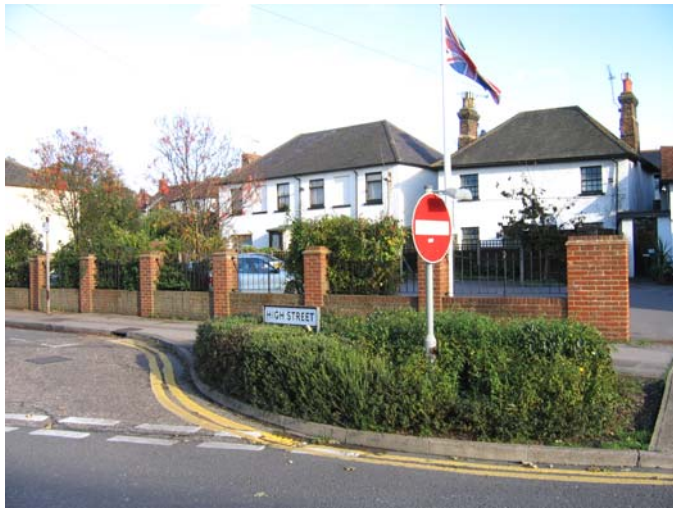
Fig. 26 Nos 55-65 High Street are set well back from the frontage, with which they have a poorly defined relationship.

The houses comprise two semi-detached pairs, that to the north (**nos. 53-55**) being double-fronted, those to the south (**no. 65**) being smaller with end-stacks. The difference in size apart, they are of a similar pattern, and all now have their brickwork painted white and the woodwork black. However, they still have slate roofs and the southern pair still has its original windows. The houses are in the ownership of the **Conservative Club** located immediately to the south, a large grade II listed

- 8.13 From this point, the High Street opens out into a waste land of tarmac, lamp standards, street signs, overhead wires and stationary cars (*Fig. 25*). It is divided by two traffic islands, one of which creates a one-way system parking lot in front of nos. 55-65 which are set a long way back from the frontage. This space in front of the houses was originally gardens but is now car parking for them and the Conservative Club immediately to the south. The car park is bounded by a brick wall with railings, but nevertheless this area appears as a gap in the High Street frontage, with which the houses have a poorly defined relationship (*Fig. 26*). Instead they belong to the Close, onto which they back.

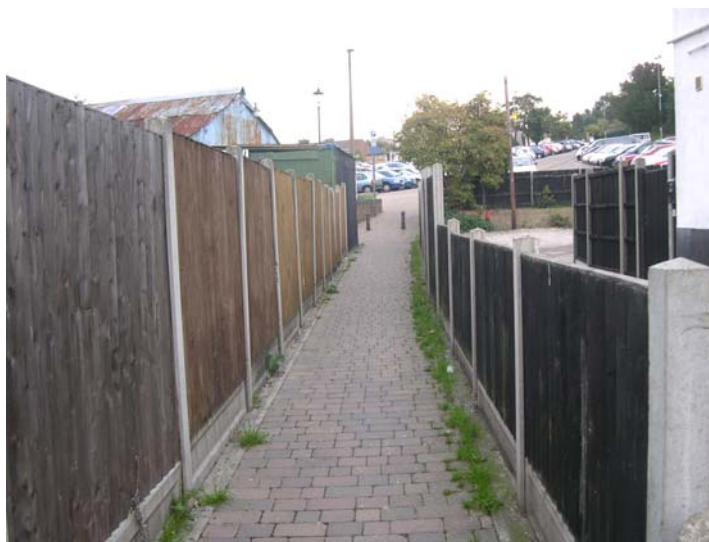
Fig. 28 Footpath through to the Close from the High Street.

- 8.19 A newly redefined footpath along the side of the forecourt leads to the southern end of the Close. Although paved in tegula, it is flanked with close boarded fencing with ugly concrete posts and gravel boards (*Fig. 28*).

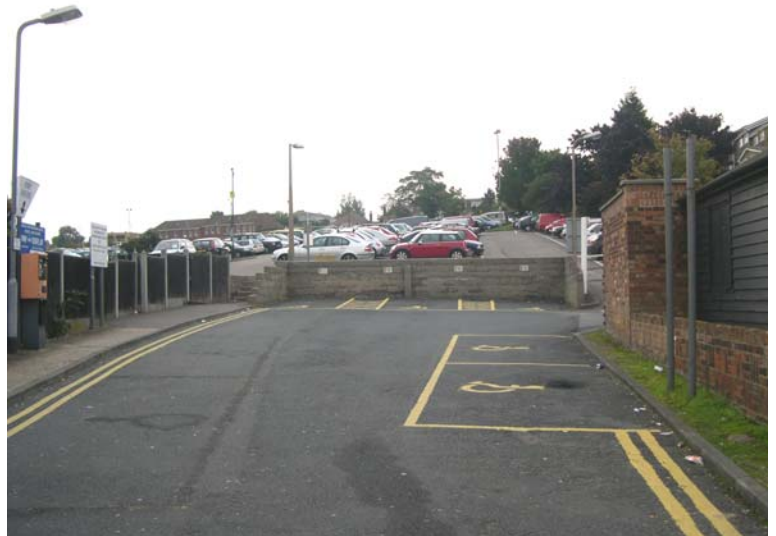
Fig. 29 Disabled parking area on High Street with view through to the main station car park.

- 8.20 The Victorian cottages (**no. 81**) have been rendered, white painted, and refenestrated. They are currently used by a taxi business. The **disabled car park** area is an unfortunate gap in the frontage with a bleak view into the station car park. It is marked out with an abundance of yellow lines and surrounded by a mixture of boundary treatments, including more concrete posts (*Fig. 29*).

- 11.11 The disabled car parking area is partially bounded by a concrete wall and close boarded fencing (*Fig. 29*) which could be replaced to advantage in brick; a higher wall would help to screen the station car park beyond. The parking lots are indicated with yellow lines for which more sympathetic marking out could be substituted. The close boarded fencing of the nearby footpath through to the Close could also be replaced with brick walls. At the least, the concrete posts should be replaced with timber and the fences stained consistent colours. The Close could be improved by use of better materials for some of the boundaries adjoining it.

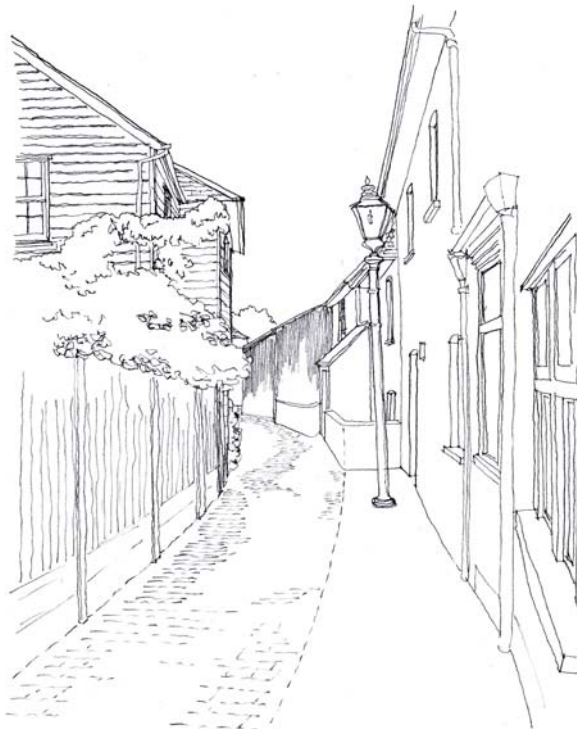
Fig. 31 The Close looking south, no. 7 on the left, the Conservative Club on the right, the corrugated tin shed in the distance.

8.26 The southern end of the Close is fully built up with a tight sense of enclosure between the black-painted tin shed and the white painted buildings facing on to the High Street and the black weatherboarding of no. 7 (*Fig. 31*). None of these buildings individually are of particular merit, but framing the sides of the slightly curving alleyway and unified by the use of black and white paint, they form a successful architectural composition. The old part of the **Conservative Club** presents some timber-framing externally at first floor level, as well as more inside. Its windows on the Close are a mixture of sashes and timber replacements of various types. Originally it was probably a lobby-entry house. One room has 18th-century panelling with remarkable painted scenes, a feature not noted in the list description. Nos. 53-65 have their rear elevations on the Close. The southern pair of cottages (**no. 65**) preserve their original sashes but the brickwork is painted; the northern pair (**nos. 53-55**) are rendered and have replacement timber windows in poor condition. **No. 7**, grade II listed, is a nice double-fronted 18th-century weatherboarded house with sash windows. It has been extended fairly recently on the north side where its garden is enclosed with close-boarded fencing with concrete posts and gravel boards.

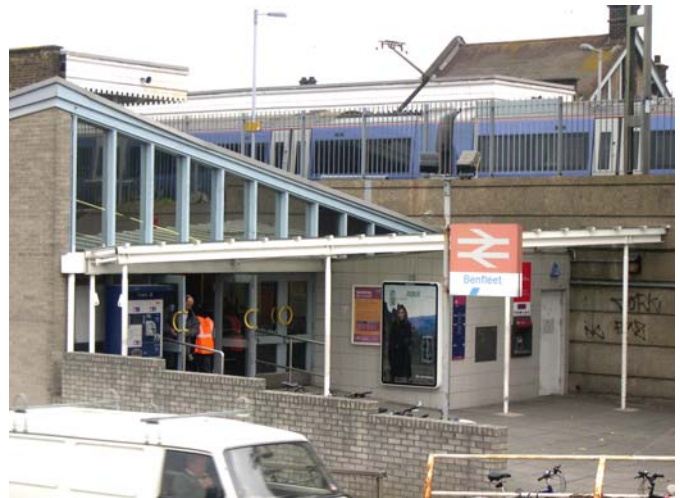
Fig. 32 Benfleet station.

- 8.28 The road from Canvey sweeps in to Benfleet in the shadow of the wooded Downs, but then encounters a stark contrast in the form of the station, an uncompromisingly modern building presenting an angular wall in pale concrete brick to the highway (*Fig. 32*). Just before the station is a landscaped area with informal planting above low brick walls which has been created to enhance the side of the railway embankment and to improve the setting of the lay-by which accommodates three bus stops at this busy transport interchange (*Fig. 33*). The planting looks neglected, and is not enhanced by the utilitarian grey track-side railings above them. In front of the lay-by and station, there are robust curving railings which could look stylish but which are rusting through their white paint. On the other side of the road opposite the station, there is the embankment at the edge of Benfleet Creek.

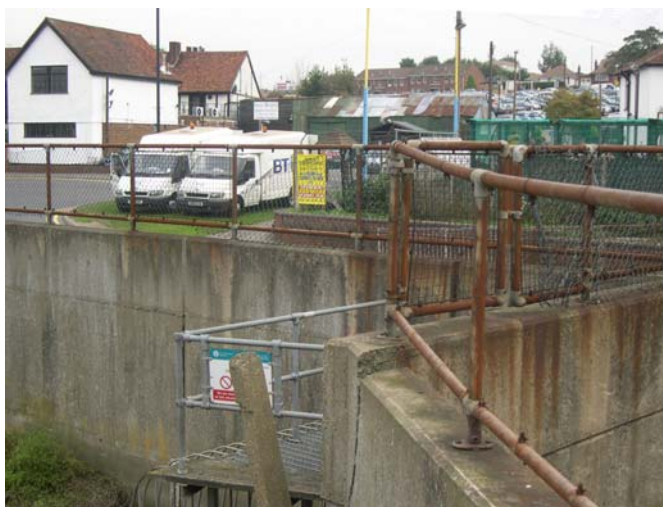
Fig. 35 Ferry Road, concrete revetment around the sluice at the end of the creek

- 8.29 As Ferry Road turns to the north, it drops down below sea level and beneath the railway in a concrete-sided underpass. The bridge is in sorry condition, its metal rusting. Netting has been suspended on the north side to prevent debris injuring pedestrians or damaging cars.¹⁰ Fixed incongruously to the roadside concrete where the road emerges from under the bridge, is a handsome cast iron name plate identifying Ferry Road as being in the conservation area. Beyond the bridge, an ugly concrete revetment with rusting tubular concrete railings at the top of it encloses the sluice controlling the flow of water to and from Church Creek (*Fig. 35*)

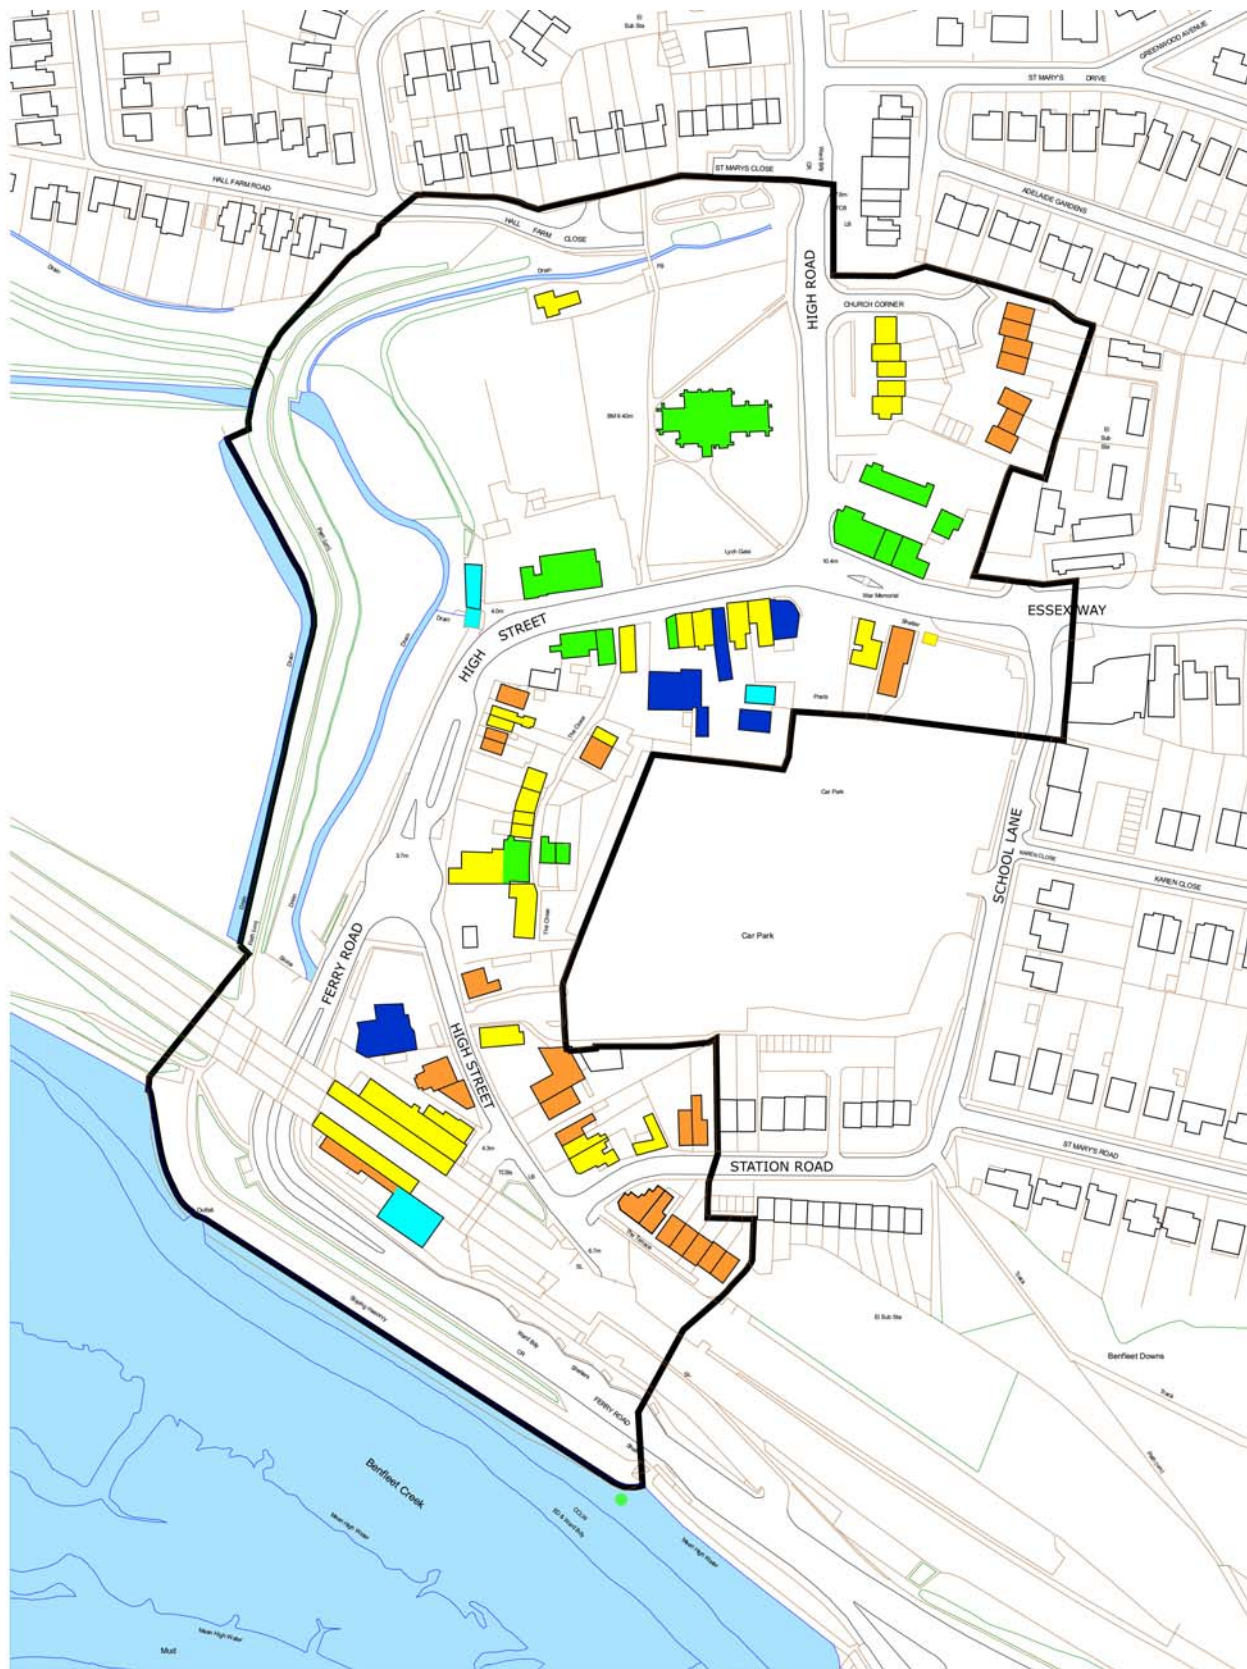
Fig. 36 Map illustrating the contribution of individual buildings to the character of the conservation area.

Map illustrating the individual contribution to character

- 9.2 A map (*Fig. 36*) has been prepared assessing the contribution made by individual buildings to the appearance and character of the conservation area. Although a subjective process, the map can be a helpful guide in the planning process. Buildings have been graded on a scale of five according to the following criteria:

1. Negative, buildings of no architectural quality detrimental to the character of the area, either by reason of mass, design, materials or siting.
 2. Negative, buildings of indifferent design or unsuited to the character of the conservation area.

3. Buildings which have a neutral presence in the conservation area, fitting satisfactorily into it, and buildings which have suffered unsympathetic alteration or improvement.

4. Positive contribution through design, age, materials or detailing.
 5. Positive, listed buildings or landmark buildings.
- 9.3 *Fig. 37* is a map indicating areas of negative townscape within the conservation area or adjoining it, and good and bad views which can be seen within it or from it.

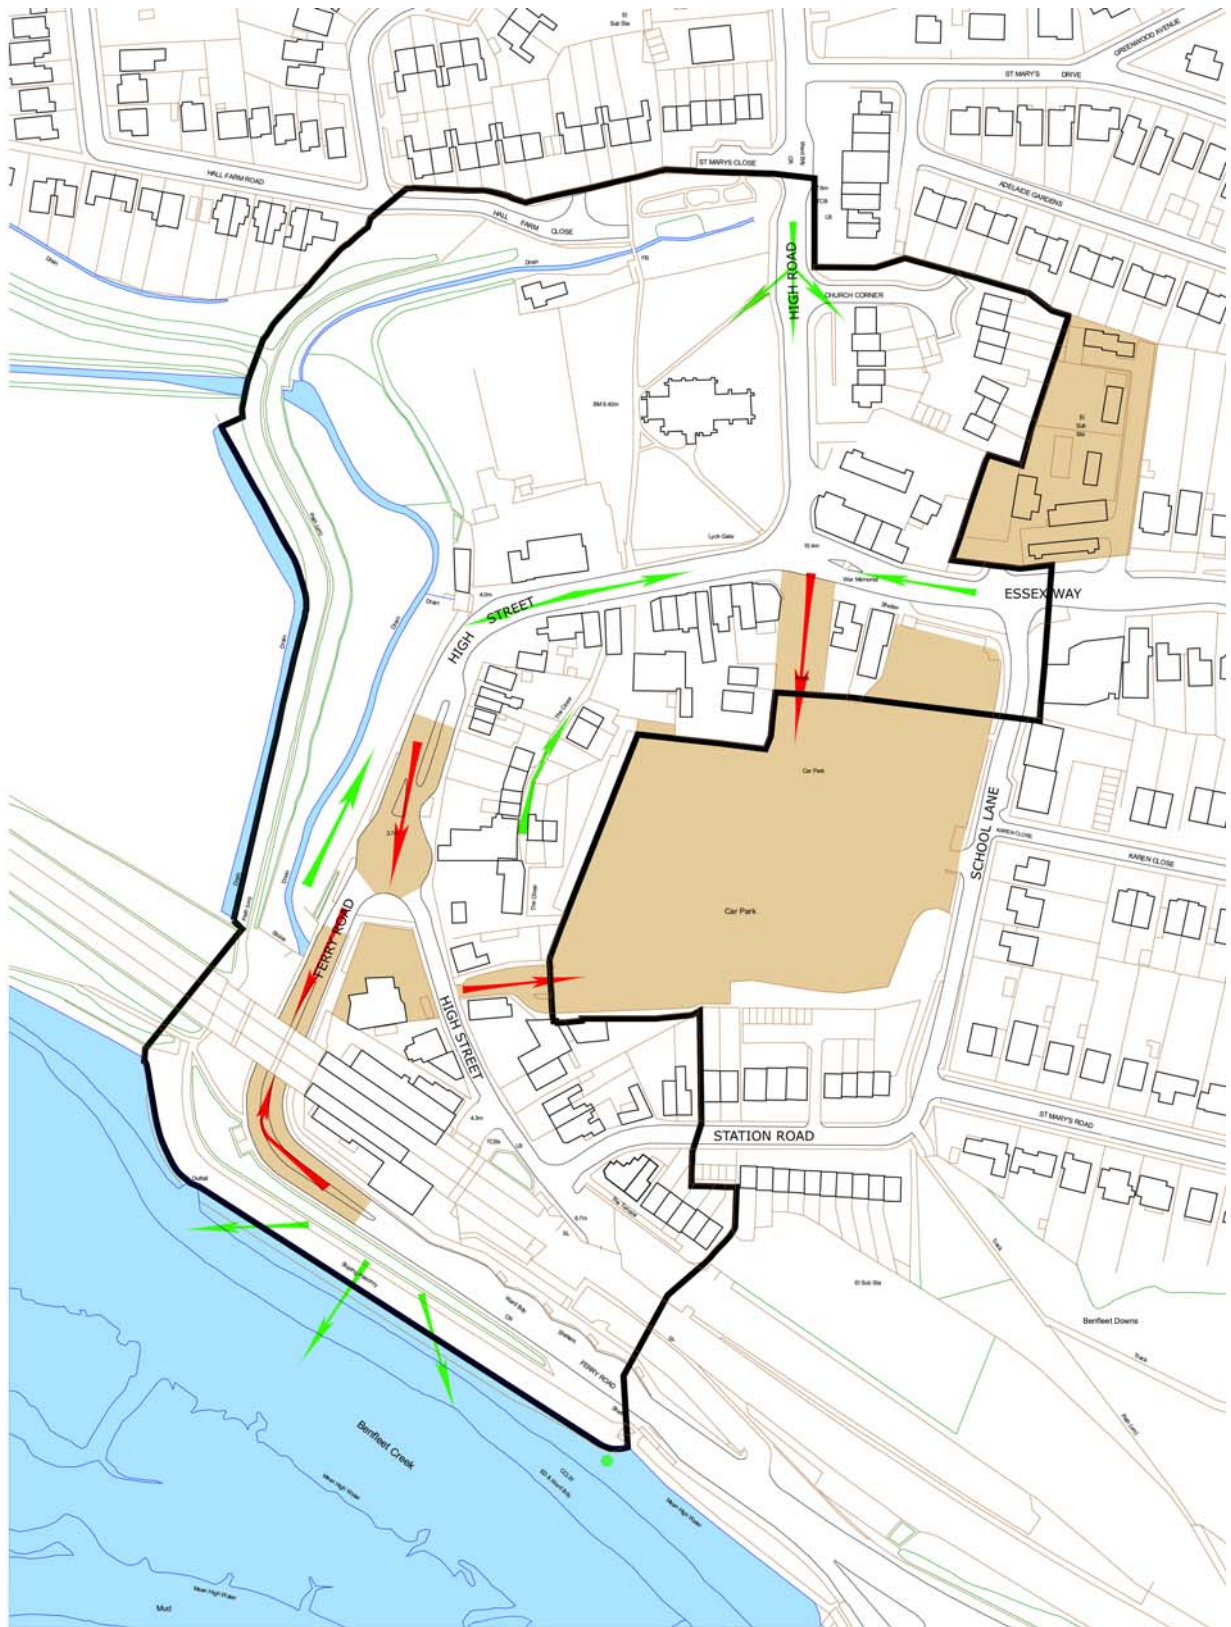
Fig. 37 Negative townscape, and good and bad views.

South Benfleet
Negative townscape, good and bad views

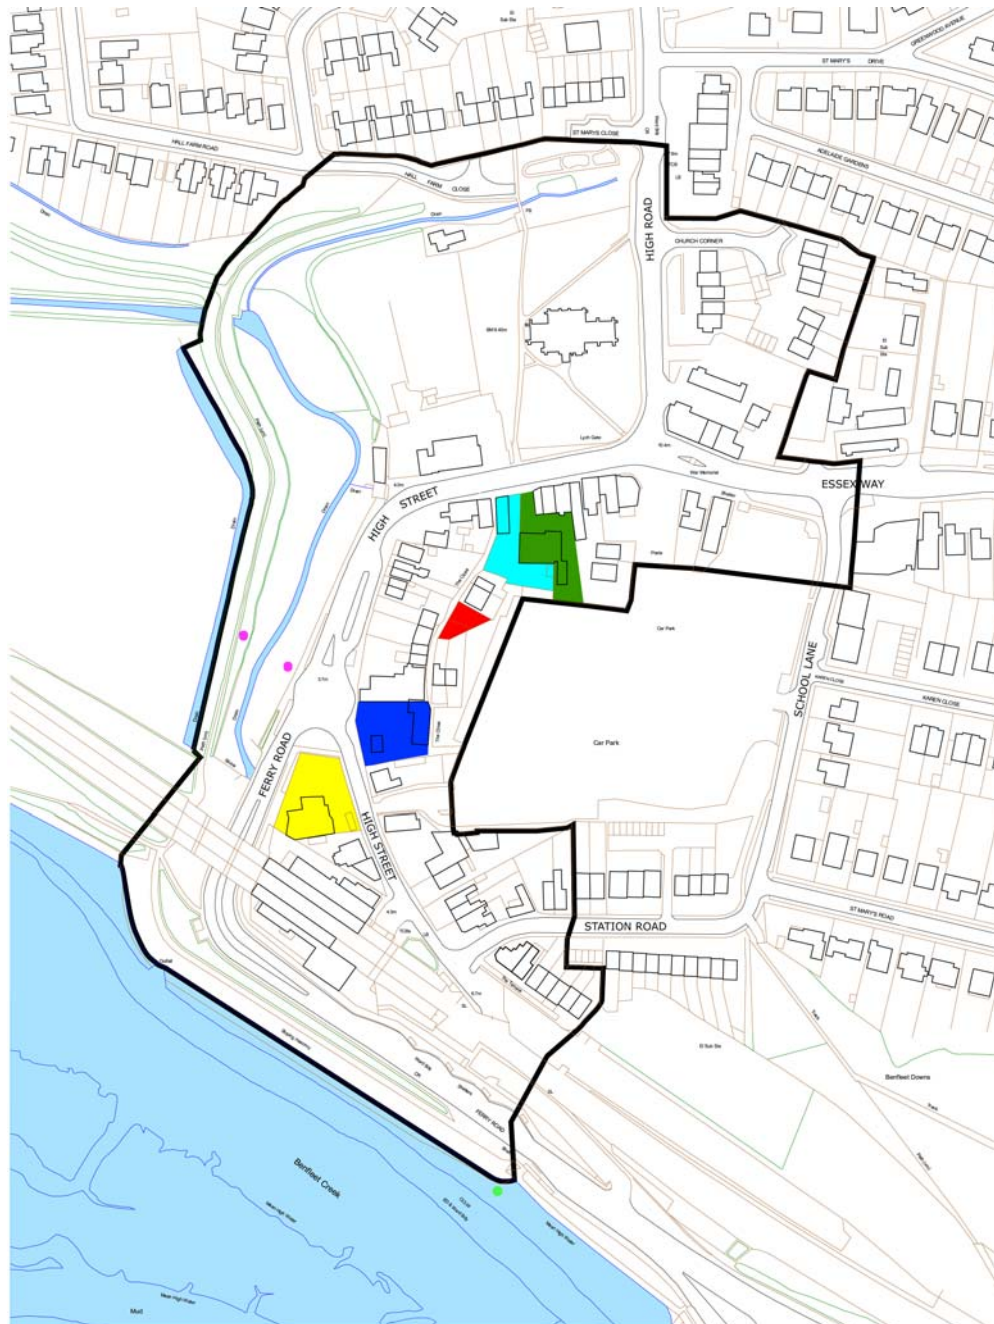
Conservation area sites affected by current (2005) planning permissions or applications

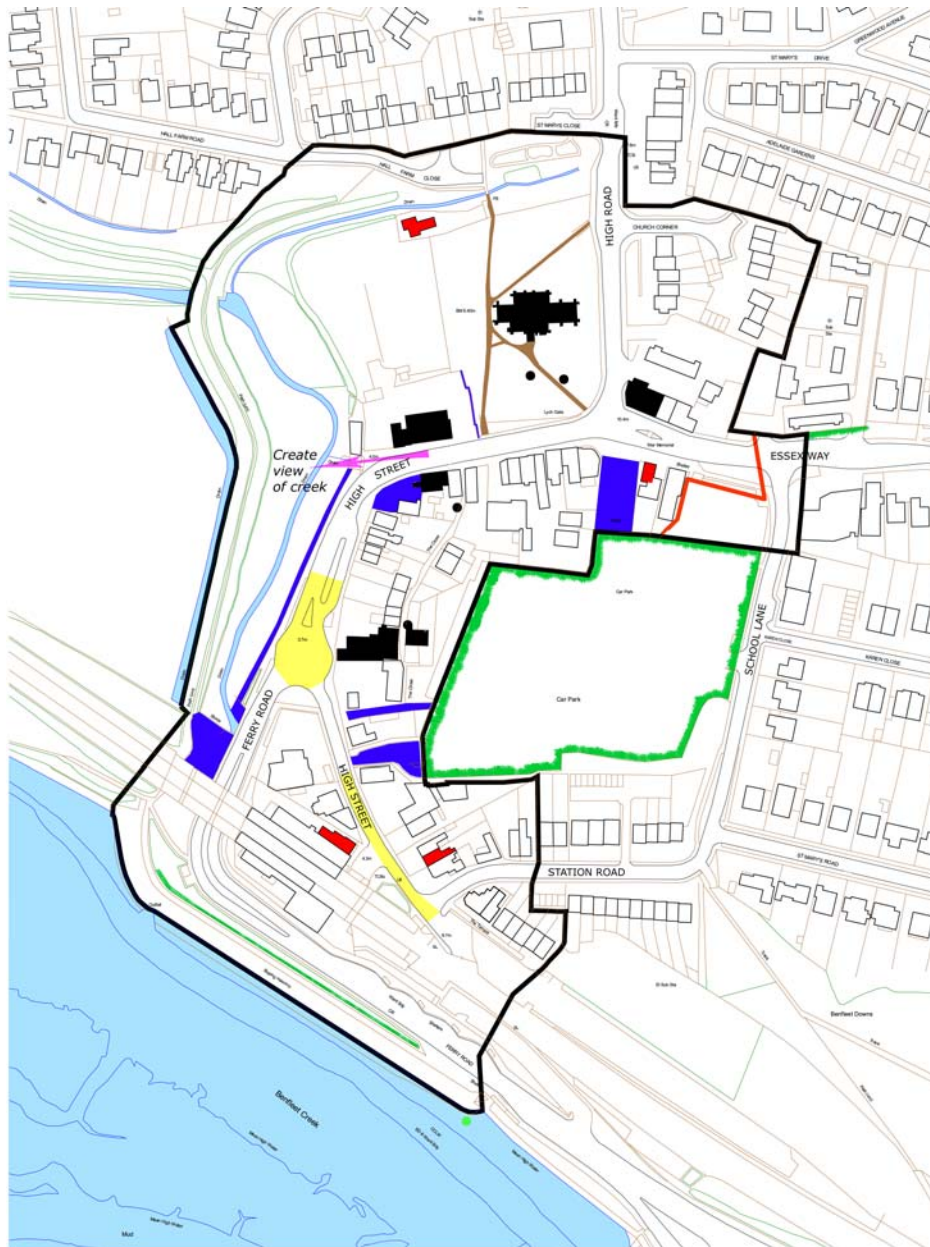
Fig. 39 Recommended areas for enhancement and improvement.

Recommended areas for enhancement and improvement
