# THE CASTLE POINT PLAN

## Local List of Heritage Assets

July 2024

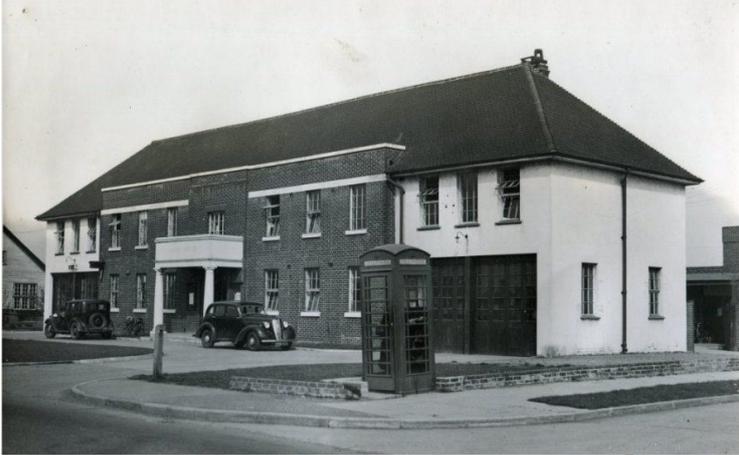
1. Name	Outpatient Centre/ Former Council Office	
2. UID

7. Description (Including Asset Type)		
<p>A purpose-built former council office now Canvey Island Outpatient Centre. The building is a large Neo-classical style building. The principal elevation has seven bay projecting red brick centre with a parapet flanked by three-bay rendered wings. There is a central entrance door with a flat roof canopy supported by columns. The roof is hipped and covered in tiles. The windows are six over six metal casements with flat gauged arched lintels and stone cills.</p>

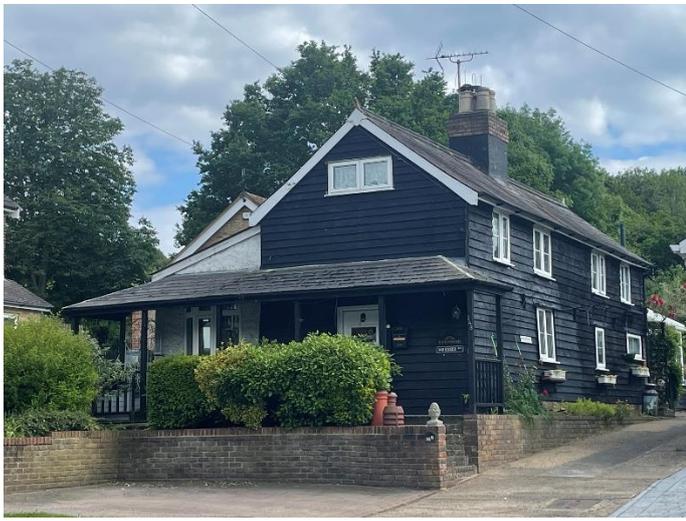
3. Address	148 Essex Way South Benfleet	
4. Postcode	SS7 1IN	
5. Grid Ref	578417 186116	
6a. Conservation Area	No	
6b. If yes, which CA		
7. Description (Including Asset Type)		
<p>A two-storey cottage set perpendicular to the road. The elevations are black weatherboarded, and the roof is covered in slate with a central chimney that is constructed of yellow stock bricks. Windows are small casements that are uPVC. There is a nineteenth century single storey lean-to the east elevation. The front porch canopy is a modern addition.</p>

8. Age	Pre-1840
Exact date (if known):	
9. Authenticity	A single significant phase with significant alterations and/or extensions
10. Architectural and Artistic Interest	
<p>The cottage is present on the late nineteenth century Ordnance Survey map; it is at least nineteenth century in derivation but may have been constructed as early as 1730. The Chapman and Andre map is the earliest map of this area (1777) which depicts a cottage in the same location also set perpendicular to the road.</p> <p>Externally, the cottage has been heavily altered including uPVC windows, replacement doors, fascias, render to the nineteenth century lean to and chimney, and construction of a front canopy. However, the property remains unique within the streetscene. The scale, form, orientation attest to its earlier construction date and is an example of the area's earlier, rural development.</p> <p>Interior has not been inspected.</p>

15. Overall Condition	Good
Notes:	
16. Recommended for inclusion	Yes
17. Date of assessment	14/05/24

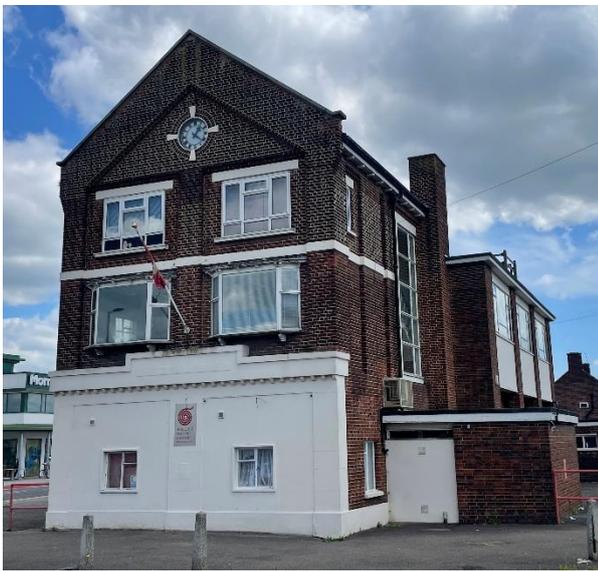
3. Address	High Street Hadleigh	
4. Postcode	SS7 2PA	
5. Grid Ref	580780 187129	
6a. Conservation Area	No	
6b. If yes, which CA

15. Overall Condition      Good

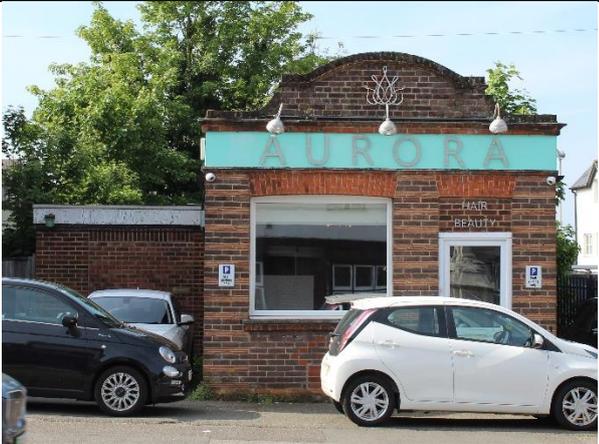
3. Address	8 Essex Way	
4. Postcode	SS7 1LT	
5. Grid Ref	577884 186078	
6a. Conservation Area	Yes	
6b. If yes, which CA	South Benfleet	
7. Description (Including Asset Type)		
<p>A single storey red/ brown brick building laid in stretcher bond. The front elevation has a Dutch gable and alternating brick and creasing tile detail. To the rear/side is a later single storey flat roof extension also in red/ brown brick.</p>

8. Age	1914-1947	
Exact date (if known):		
9. Authenticity	A single significant phase with some alterations and/or extensions	
10. Architectural and Artistic Interest		
<p>Some of the original detailing has been affected by modern alterations, such as blocked up windows, replacement uPVC windows and doors as well as the modern signage. However, the building is an attractive and architecturally distinctive building. The Dutch gable, brick and creasing tile detail is indicative of its early-mid twentieth century derivation. The Ordnance Survey Map published in 1947 denotes the abbreviation Bk within the building plot which indicates that it was formerly used as a Bank.</p>

15. Overall Condition	Good	
Notes:		
16. Recommended for inclusion	Yes	
17. Date of assessment	13/05/24

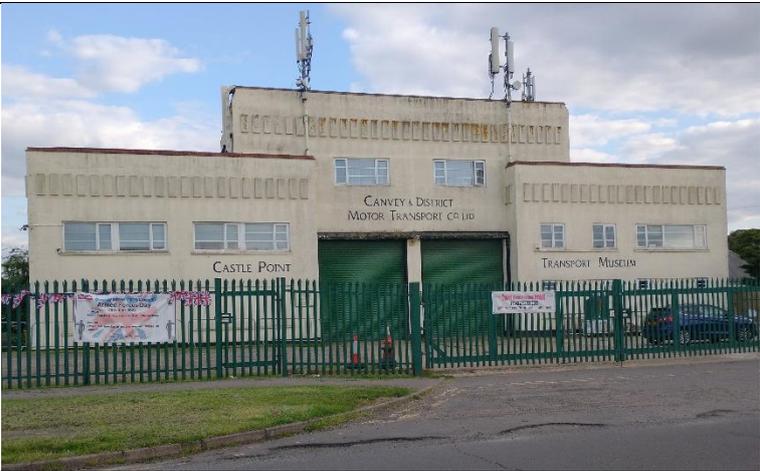
7. Description (Including Asset Type)		
<p>A substantial building, constructed in a Modernist style with a flat roof and simple rectangular motifs above the upper floor windows. The building has a symmetrical composition and is formed of a three sections; a central, taller section that has large garage doors and two windows to the upper floor; and two wing elements that project forward and are two-storeys in height and two bays wide.</p>

8. Age	1914-1947	
Exact date (if known):	1934	
9. Authenticity	A single significant phase and which is largely intact	
10. Architectural and Artistic Interest		
<p>The building was constructed in 1934 for the Canvey District Motor Transport Co. Ltd as a purpose-built bus depot. It is constructed in a distinct Modernist style that relates to local and national styles of the period. The original Crittall style windows have been replaced with uPVC windows, and whilst of a similar design they detract somewhat from the original architectural interest of the building. However, other than the window alterations, the building appears largely unaltered and makes a positive contribution to local character and distinctiveness.</p>

15. Overall Condition	Good	
Notes:		
16. Recommended for inclusion	Yes

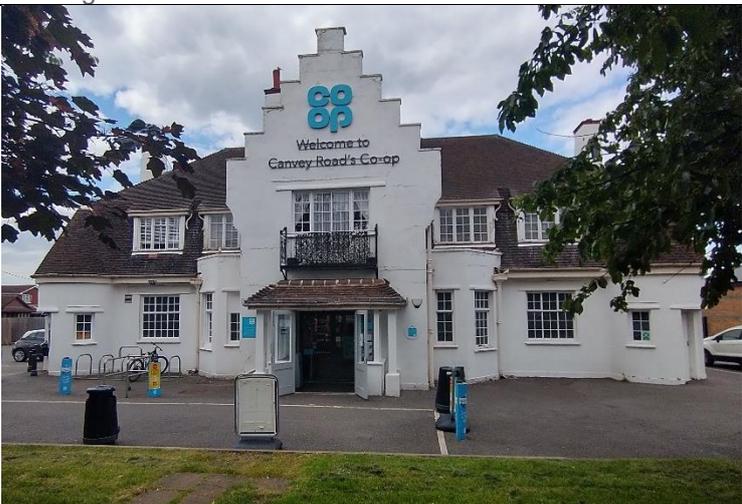
7. Description (Including Asset Type)		
<p>A large, detached building, that is two-storeys high with a hipped roof and dormers set into the eaves. The building is symmetrical in its design with central stepped, Dutch gable flanked by single-storey parapet infills at ground floor. The corners have single storey turreted entrances. The elevations are rendered, and the roof is covered in clay tiles with prominent chimneys.</p>

14. Archaeological Interest	
Some archaeological interest as a primary source of inter-war building techniques, architectural styles and materials.	
15. Overall Condition	Good
Notes:

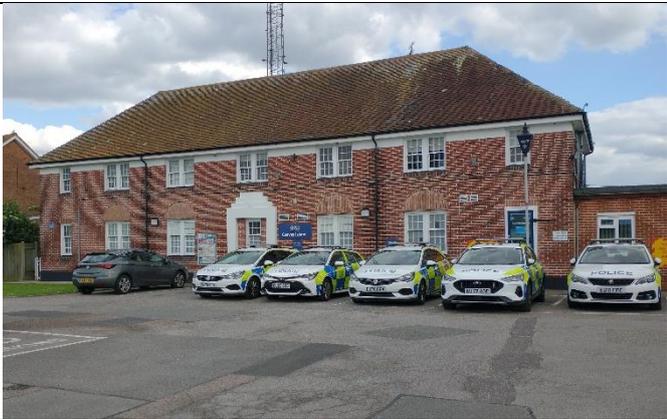
7. Description (Including Asset Type)		
A detached building constructed from red/ brown brick with a hipped roof covered in clay tiles. The building has a central entrance (now blocked up) with a stepped rendered surround. The building is seven bays wide with sliding sash windows.

15. Overall Condition	Good	
Notes:		
16. Recommended for inclusion	Yes	
17. Date of assessment	13/05/24

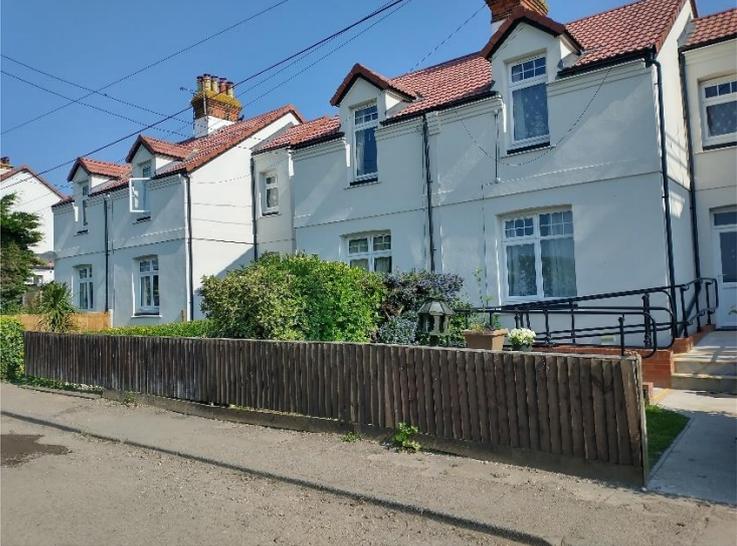
7. Description (Including Asset Type)		
<p>A row of ten semi-detached residential dwellings that were constructed in the late nineteenth century. The dwellings are two-storeys in height with a simple gabled roof forms with a central chimney. There are gabled dormers set into the eaves. Each dwelling has a side projection that is one light wide and set back from the principle building line. The elevations are rendered. Replacement roof covering and windows.</p> <p>The bungalow and the four semi-detached dwellings with red tiled roofs are later additions.</p>

15. Overall Condition      Good

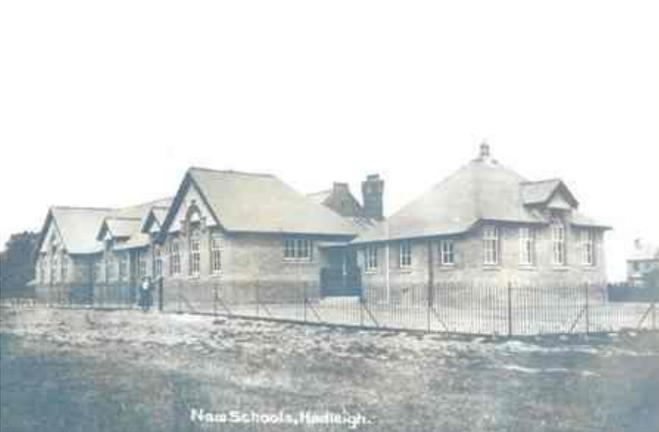
3. Address	Church Road, Hadleigh, Benfleet	
4. Postcode	SS7 2DQ	
5. Grid Ref	581267 187044	
6a. Conservation Area	No	
6b. If yes, which CA		
<b>7. Description (Including Asset Type)</b>		
<p>Hadleigh Junior School is constructed from red brick laid in a Flemish bond. The school building is predominantly single storey with some one and a half and two-storey elements. The roof form is hipped with front gabled projections and covered in clay tiles. With each gable projection is a set of tripartite windows.</p>

15. Overall Condition	Good

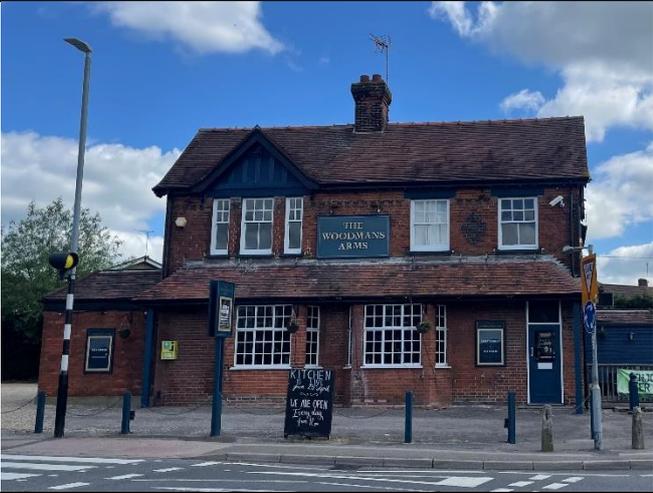
3. Address	Rayleigh Road Benfleet	
4. Postcode	SS7 3TA	
5. Grid Ref	579959 188848	
6a. Conservation Area	No	
6b. If yes, which CA		
7. Description (Including Asset Type)		
<p>The building is two-storeys in height and constructed in red brick laid in Flemish bond, with yellow stock and black head brick detailing to the first floor. The roof form is gabled with clay tiles and a central corbelled chimney. Exposed rafter feet to the eaves and half timbering effect to the gable ends. The ground floor windows are multi-paned metal casement and the first-floor windows are timber, sliding sashes.</p>

The building is a source of primary evidence for early twentieth century construction techniques, architectural styles and building materials	
15. Overall Condition	Good
Notes:	
16. Recommended for inclusion	Yes
17. Date of assessment	13/05/24

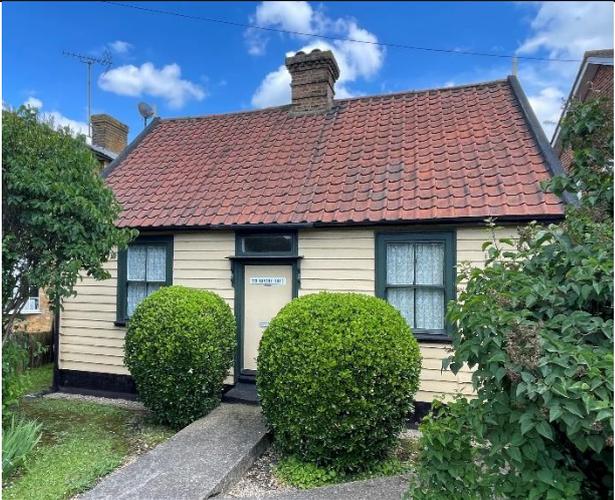
3. Address	73 London Road Hadleigh Benfleet	
4. Postcode	SS7 2QL	
5. Grid Ref	580522 187326	
6a. Conservation Area	No	
6b. If yes, which CA		
7. Description (Including Asset Type)		
<p>A single storey timber framed, weatherboarded cottage, with a gabled roof that is covered in interlocking tiles and decorative barge boards with a finial to the flanks. The central chimney is constructed from brick with dentilled detail. The property has a central entrance that is flanked by two-over-two sash windows.</p>

15. Overall Condition	Good	
Notes:		
16. Recommended for inclusion	Yes	
17. Date of assessment	14/05/24

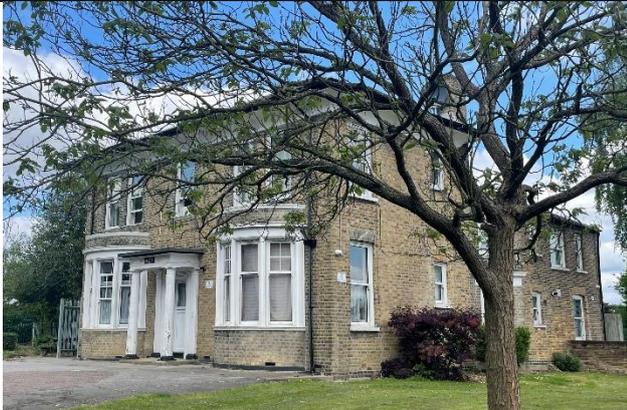
3. Address	107 Rectory Road, Hadleigh, Benfleet		
4. Postcode	SS7 2NA		
5. Grid Ref	581105 187429		
6a. Conservation Area	No		
6b. If yes, which CA			
7. Description (Including Asset Type)			
<p>A two-storey, detached property constructed in the late eighteenth-early nineteenth century. It is built from of yellow stock brick with a hipped roof covered in slates and a prominent chimney stack. The property has a symmetrical composition with a central entrance under a flat roof portico. The entrance is flanked by two bow windows that are four lights wide. Two sash windows above the bays and a single sash window above the entrance. To the rear, the property has two gabled projections.</p>

15. Overall Condition	Good	
Notes:		
16. Recommended for inclusion	Yes	
17. Date of assessment	17/05/24

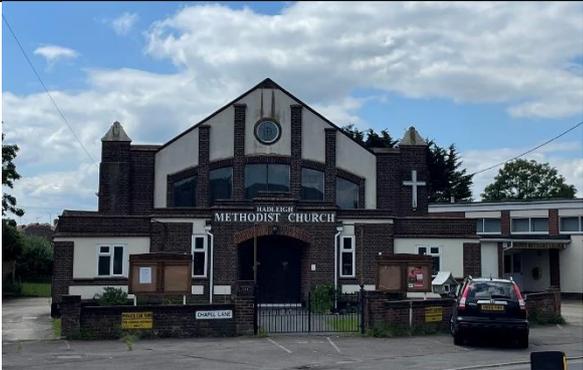
3. Address	Chapel Lane, Hadleigh	
4. Postcode	SS7 2PQ	
5. Grid Ref	580463 187186	
6a. Conservation Area	No	
6b. If yes, which CA		
7. Description (Including Asset Type)		
<p>A 1930s, purpose built chapel constructed of predominantly brown brick with rendered sections, principal section is two-storeys with decorative leaded lights with a single storey front projection that has a central entrance and stepped pediment and church yard to the front. Later flat roof single storey side extensions.</p>

8. Age	1914-1947	
Exact date (if known):		
9. Authenticity	A single significant phase with significant alterations and/or extensions	
10. Architectural and Artistic Interest		
<p>The building is a typical example of 1930s century architecture. Some of the original windows appear to have been replaced and the modern extension do erode its original design. The property makes a positive contribution to local character and distinctiveness.</p>

15. Overall Condition	Good	
Notes:		
16. Recommended for inclusion	Yes	
17. Date of assessment	17/05/24

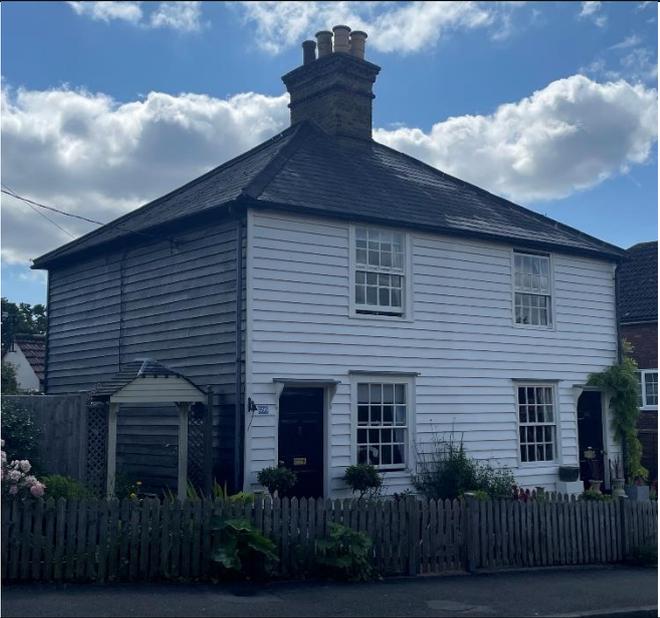
3. Address	399 & 401 Daws Heath Road Benfleet	
4. Postcode	SS7 2UG	
5. Grid Ref	581205 188469	
6a. Conservation Area	No	
6b. If yes, which CA		
7. Description (Including Asset Type)		
<p>A pair of semi-detached timber frame cottages. The roof is hipped, covered in slates with a central chimney that is constructed from yellow brick with red brick and dog-tooth detail. The elevations are painted weatherboarding. The pair are mirrored in appearance and are each one two bays wide with a ground and first floor sash window and an entrance set to the side. The windows are eight over eight sliding sashes.</p>

15. Overall Condition	Good
Notes:

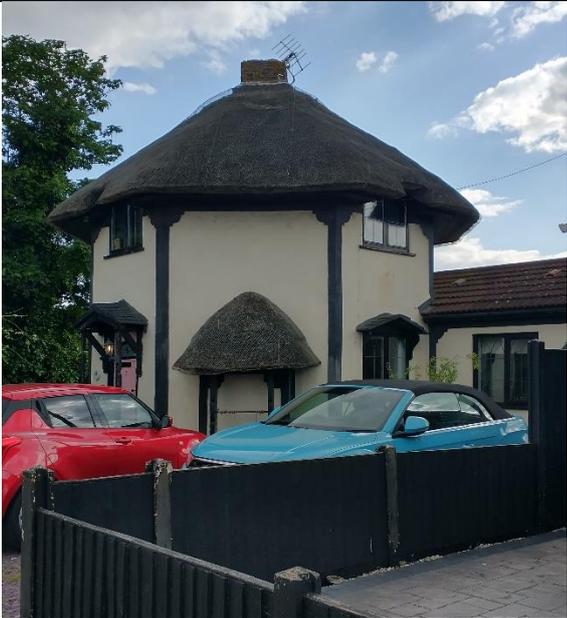
3. Address	2-3 Beechcroft Road, Canvey Island	
4. Postcode	SS8 0HD	
5. Grid Ref		
6a. Conservation Area	No	
6b. If yes, which CA		
7. Description (Including Asset Type)		
<p>The pair of dwellings were constructed between 1933 and 1939 in a 'Dutch cottage' style. They are two storeys in height with an octagonal floor plan. The roof is thatched, terminating in a central chimney stack. The elevations are rendered.</p>

15. Overall Condition	Choose an item.
Notes:	To be confirmed following a site visit.
16. Recommended for inclusion	Yes
17. Date of assessment	17/05/24

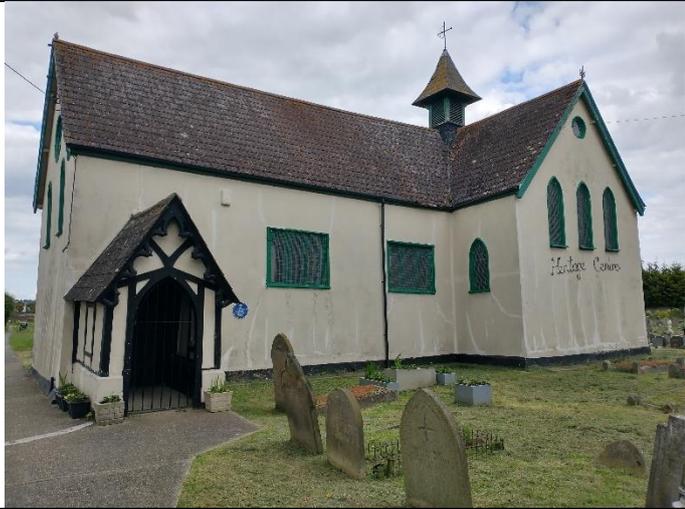
3. Address	22 Canvey Road, Canvey Island	
4. Postcode	SS8 0LW	
5. Grid Ref	577893 183325	
6a. Conservation Area	No	
6b. If yes, which CA		
7. Description (Including Asset Type)		
<p>The church was constructed in the mid to late nineteenth century. Set on an east-west axis with a cruciform shaped floorplan with a gabled roof form. There is a small timber framed porch to the south elevation. Three pointed arched windows to the south gable with a bullseye window above and two pointed arched windows to the east and west gables with a small rose window above. The churchyard is accessed by a lychgate.</p>

15. Overall Condition		Good
Notes:		
16. Recommended for inclusion		Yes
17. Date of assessment		20/05/24

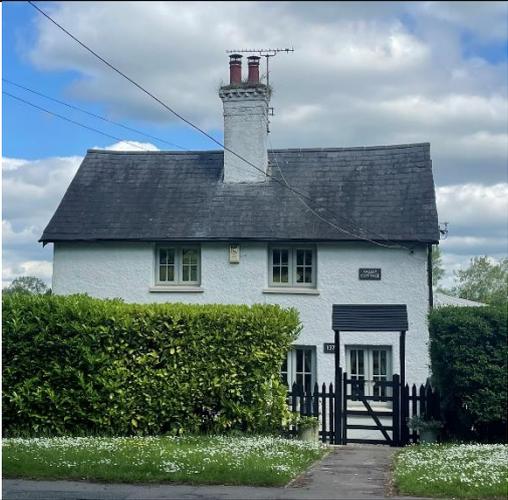
3. Address	137 Daws Heath Road, Benfleet	
4. Postcode	SS7 2TA	
5. Grid Ref	580516 188851	
6a. Conservation Area	No	
6b. If yes, which CA		
7. Description (Including Asset Type)		
<p>The property appears to date from the mid to late nineteenth century. It is set over two-storeys with a simple gable ended roof that is covered in natural slate and has a central chimney with a dogtooth detail. There are decorative barge boards to each gable end. To the rear are two gabled extensions. The elevations are rendered and with uPVC casement windows.</p>

15. Overall Condition	Good	
Notes:		
16. Recommended for inclusion	Yes	
17. Date of assessment	20/05/24

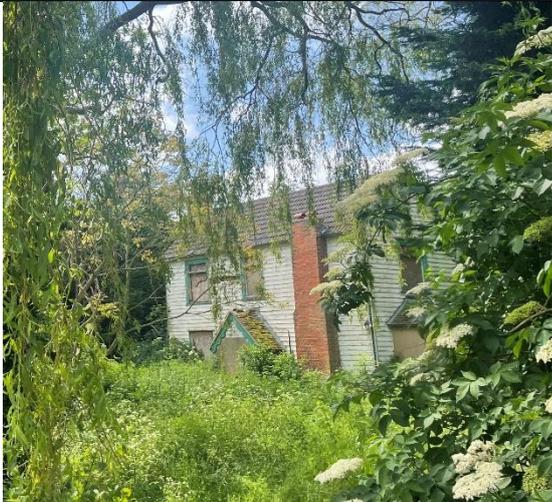
3. Address	Chapel Lane, Hadleigh, Benfleet	
4. Postcode	SS7 2PP	
5. Grid Ref	580113 186858	
6a. Conservation Area	No	
6b. If yes, which CA		
7. Description (Including Asset Type)		
<p>A two-storey detached dwelling with a simple gabled roof covered in concrete tiles. The elevations are weatherboarded and painted white and there are red-brick chimneys to the east and south elevations. At the time of assessment, the property was vacant with boarded windows and doors.</p>

8. Age	Pre-1840
Exact date (if known):	
9. Authenticity	A single significant phase with some alterations and/or extensions
10. Architectural and Artistic Interest	
<p>The property appears to have been extended to the rear, and the original windows and roof covering appear to have been replaced. However, it remains discernible as an early nineteenth century farmhouse, due to the scale, form, location and materials such as the weatherboard and red brick chimneys and contributes positively to the area's historic building stock.</p>

15. Overall Condition	Poor
Notes:

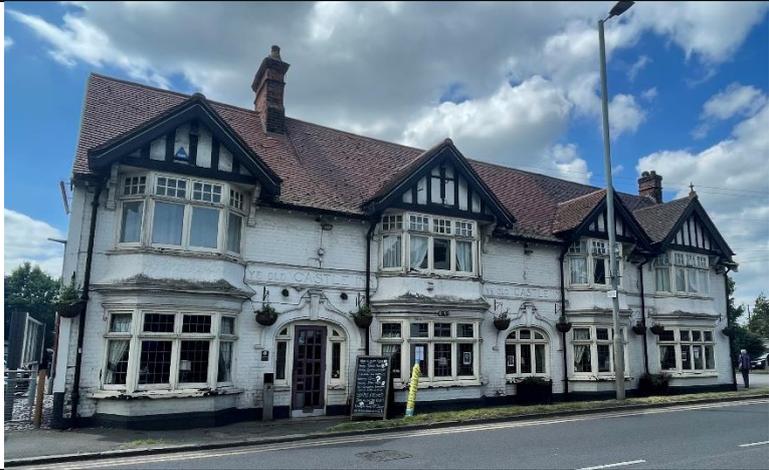
3. Address	High Street, Hadleigh, Benfleet	
4. Postcode	SS7 2PB	
5. Grid Ref	580954 186988	
6a. Conservation Area	No	
6b. If yes, which CA

8. Age	1840-1913
Exact date (if known):	
9. Authenticity	A single significant phase with some alterations and/or extensions
10. Architectural and Artistic Interest	
<p>The property is of a distinctive Edwardian style, features such as the brickwork, bay windows, half timbering and gabled form are typical of early twentieth century vernacular architecture. The property requires some repairs and general maintenance but is an attractive early twentieth century building.</p> <p>The property has been extended to the rear, but the extensions remain subservient, and the original form, scale and appearance of the property remain prominent. The western bay is a later addition and whilst it unbalances the original composition of the property, it relates to the design of the earlier phase. The modern signage detracts from the traditional character of the public house.</p>

15. Overall Condition	Fair
Notes:	
16. Recommended for inclusion	Yes
17. Date of assessment	23/05/24

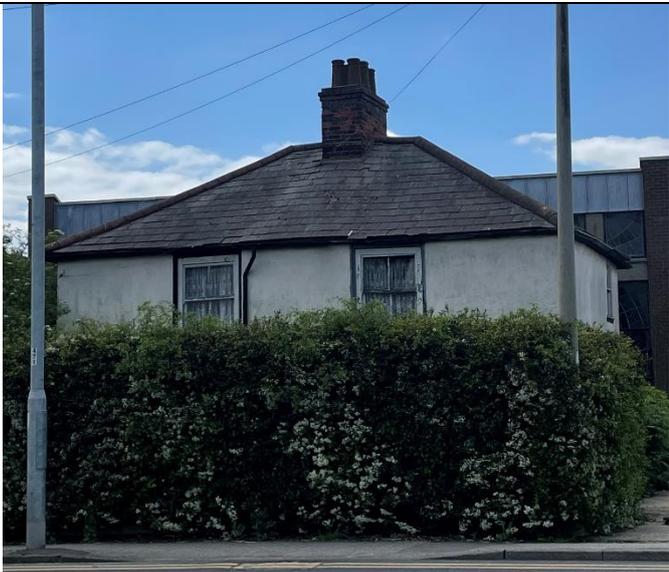
2. UID		
3. Address	High Street, Hadleigh, Benfleet	
4. Postcode	SS7 2PB	
5. Grid Ref	580742 187114	
6a. Conservation Area	No	
6b. If yes, which CA		
7. Description (Including Asset Type)		
<p>A late nineteenth century cottage that is two storeys high and has a hipped roof covered with slate and clay ridge tiles. The roof has a central, red-brick chimney. The elevations are rendered, and the property is two bays wide, the windows to the front are two over two, timber sashes with small casement windows to the side elevations.</p>

8. Age	1840-1913
Exact date (if known):	
9. Authenticity	A single significant phase with some alterations and/or extensions
10. Architectural and Artistic Interest	
<p>The cottage is of a discernible nineteenth century scale, form and appearance. The property is in a poor state of repair and has a modern render to the elevations which has undermined its architectural interest. However, the original scale, form and appearance is still distinctly nineteenth century in character and is representative the local vernacular architecture.</p>

15. Overall Condition	Very Poor
Notes:	
16. Recommended for inclusion	Yes

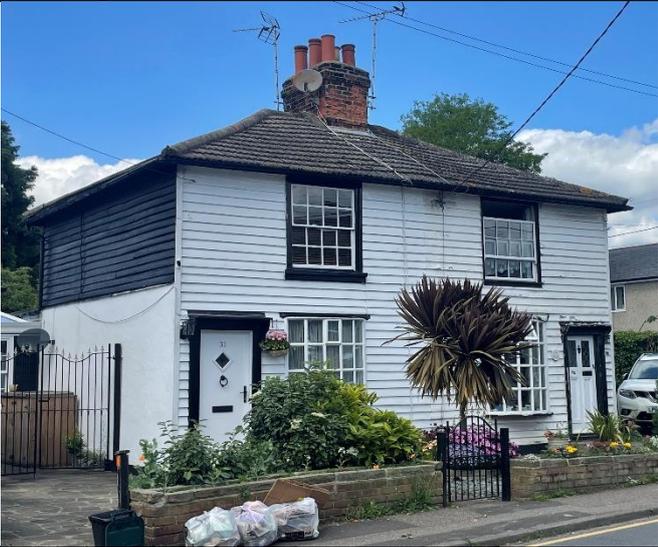
3. Address	31 & 33 Rectory Road, Hadleigh	
4. Postcode		
5. Grid Ref	581056 187138	
6a. Conservation Area	No	
6b. If yes, which CA		
7. Description (Including Asset Type)		
<p>A semi-detached pair of cottages. The pair are two-storeys in height with a hipped roof with a central, red-brick chimney. The roof is covered in concrete tiles and the elevations a predominantly weatherboarded with some render to the ground floor flank elevation. The pair are mirrored in appearance with bow windows at ground floor and eight over eight, timber sash windows to the first floor. There are modern, single storey extensions to the rear.</p>

8. Age	1840-1913	
Exact date (if known):		
9. Authenticity	A single significant phase with some alterations and/or extensions	
10. Architectural and Artistic Interest		
<p>The two-storey scale, hipped form and materials such as the weatherboarding, red brick chimney, sash windows and its symmetrical composition are typical of nineteenth century rural vernacular architecture. The properties have undergone some modern alterations such as replacement roof and doors. They have also been extended to the rear, but due to the low height it remains subservient. Despite the modern alterations the pair have retained a distinguishable nineteenth century character and make a positive contribution to local character and distinctiveness.</p>

15. Overall Condition	Good	
Notes:		
16. Recommended for inclusion	Yes

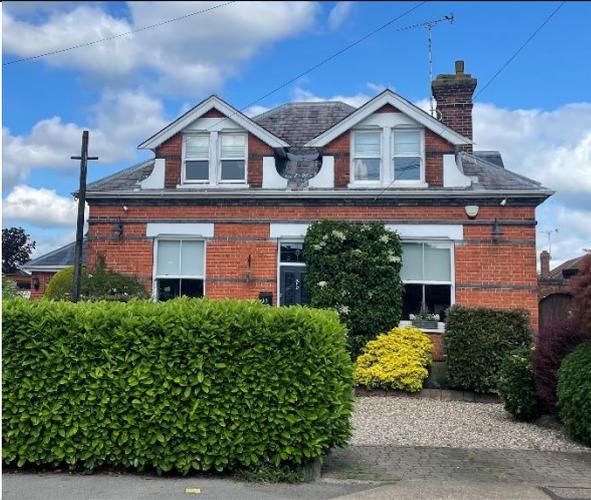
3. Address	15 Common Approach	
4. Postcode	SS7 3LA	
5. Grid Ref	579118 188938	
6a. Conservation Area	No	
6b. If yes, which CA		
7. Description (Including Asset Type)		
<p>The property is a detached, two and a half storey dwelling. The roof form is hipped and covered in slates with large, gabled dormers to the front and a tall, corbelled chimney to the north. It is constructed from red brick laid in a Flemish bond with a string course and dark brick banding running from the cills, lintels and window mid rails. The front elevation has a central entrance that is flanked by two-over-two sash windows.</p>

15. Overall Condition	Good	
Notes:		
16. Recommended for inclusion	Yes	
17. Date of assessment	29/05/24

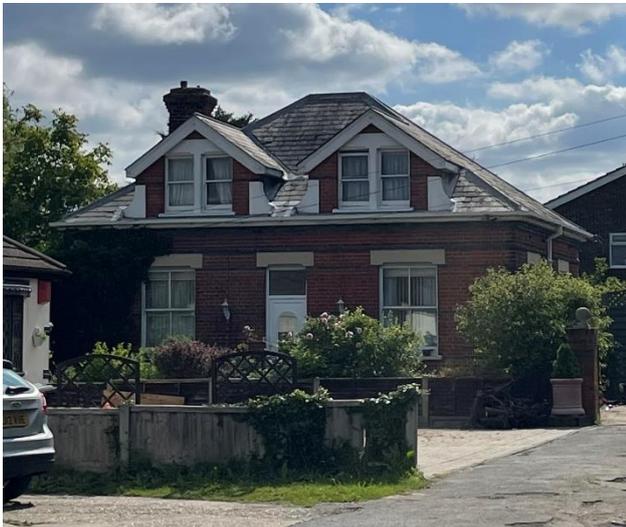
2. UID		
3. Address	17 Chancel Close	
4. Postcode	SS7 4ET	
5. Grid Ref	577323 188727	
6a. Conservation Area	No	
6b. If yes, which CA		
7. Description (Including Asset Type)		
<p>The property is a detached, two and a half storey dwelling. The roof form is hipped and covered in slated with large, gabled dormers to the front and a tall, corbelled chimney to the north. It is constructed from red brick laid in a Flemish bond with a string course and dark brick banding. The front elevation has a central entrance that is flanked by two-over-two sash windows.</p>

15. Overall Condition	Good
Notes:	
16. Recommended for inclusion	Yes
17. Date of assessment	29/05/24

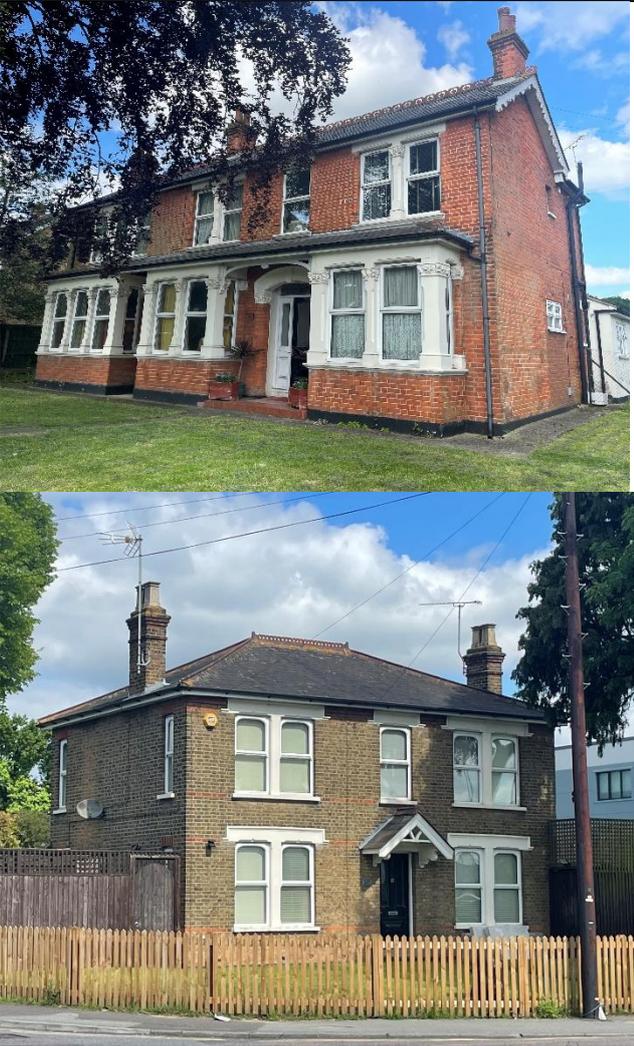
3. Address	523 & 529 Rayleigh Road	
4. Postcode	SS7 3TN	
5. Grid Ref	580028 189413	
6a. Conservation Area	No	
6b. If yes, which CA

15. Overall Condition	Good	
Notes:		
16. Recommended for inclusion	Yes	
17. Date of assessment	29/05/24

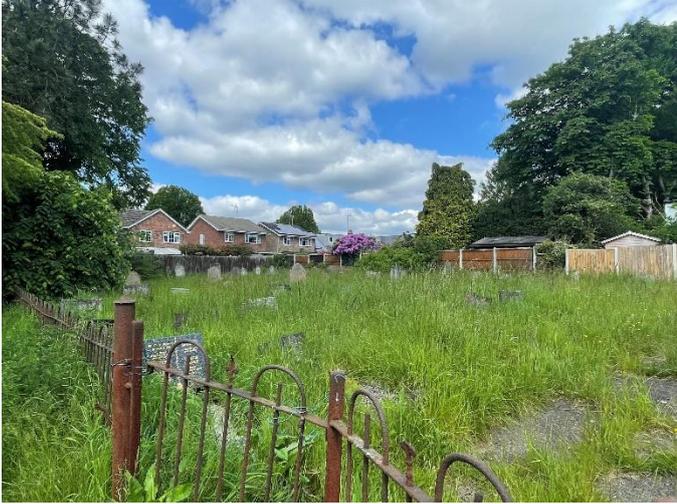
3. Address	352 Daws Heath Road, Benfleet	
4. Postcode	SS7 2UA.	
5. Grid Ref		
6a. Conservation Area	No	
6b. If yes, which CA		
<b>7. Description (Including Asset Type)</b>		
Graveyard of the Daws Heath Evangelical Church (formerly Peculiar People) located to west (rear) of the chapel. The graveyard is roughly rectangular in plan and bound by hoop top metal railings. The yard can be accessed via the public footpath that runs along the south boundary.

15. Overall Condition Fair

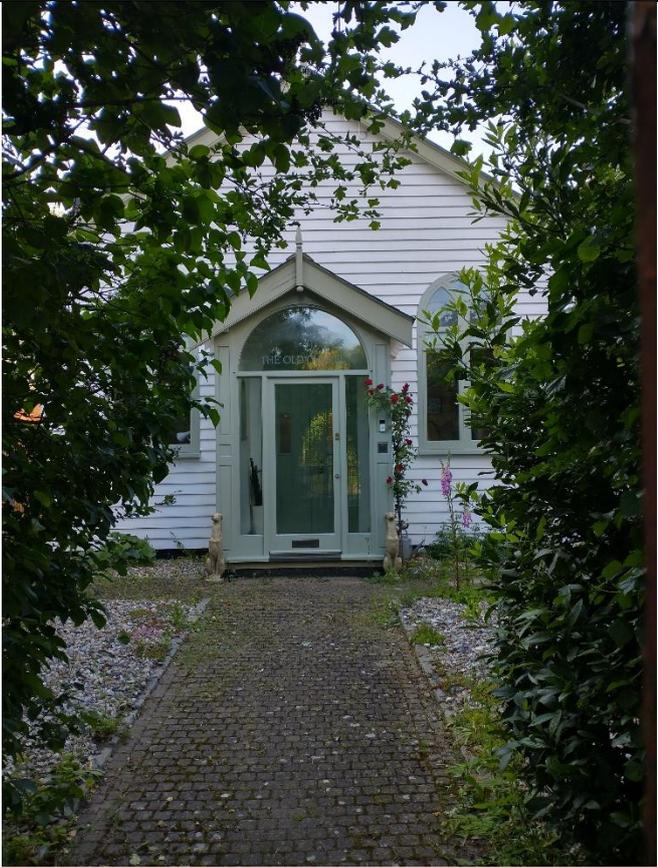
2. UID		
3. Address	185 Daws Heath Road, Benfleet	
4. Postcode	SS7 2TF	
5. Grid Ref		
6a. Conservation Area	No	
6b. If yes, which CA		
7. Description (Including Asset Type)		
<p>A single storey, former chapel, now in residential use. The Old Chapel has a simple gabled roof form that is covered in slates and a small dormer to each roof slope. The elevations are weatherboarded and painted white. The front elevation has a central entrance and porch flanked by two, full height arched windows. To the rear, is a large two-storey extension set perpendicular to the original building constructed in matching materials.</p>

8. Age	1840-1913
Exact date (if known):	
9. Authenticity	A single significant phase with significant alterations and/or extensions
10. Architectural and Artistic Interest	
<p>The property is now in residential use but is still legible as a former nineteenth century chapel. The original materials have been replaced with modern equivalents (uPVC weatherboarding and windows) which has undermined its original architectural interest. The two-storey extension to the rear is large, but the original plan form of the Chapel is still appreciable.</p>	
11. Historic Interest (Including Social and Communal Interest)	
<p>The Peculiar People now known as the Union of Evangelical Church is a Christian movement founded in 1838 in Rochford by James Banyard. The sect was largely confined to Essex. The Old Chapel is a physical testament of the area's social history.</p>	
12. Group Value

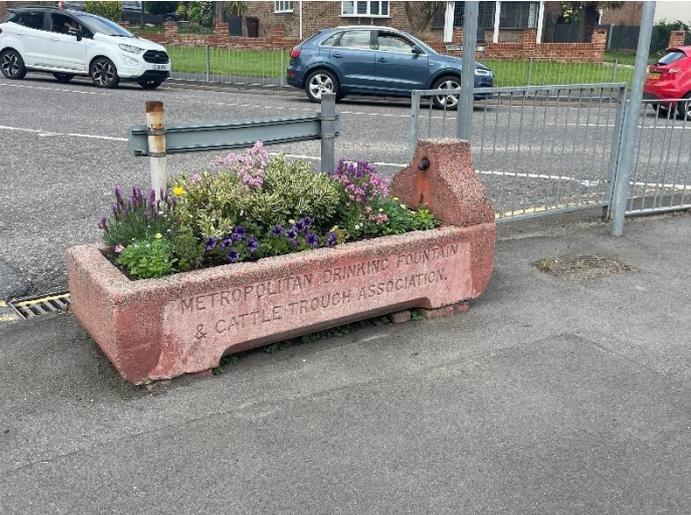
2. UID		
3. Address	Jotmans Lane/Benfleet Park Road (Cemetery Corner), South Benfleet	
4. Postcode	SS7 5DN	
5. Grid Ref	576953 187118	
6a. Conservation Area	No	
6b. If yes, which CA		
7. Description (Including Asset Type)		
<p>A red granite water trough dating from the early twentieth century commemorating the coronation of King George V, installed by the Parish Council. Now planted with flowers. Inscription to the front reads 'Metropolitan Drinking Fountain &amp; Cattle Trough Association' and the rear reads 'In commemoration of the coronation of King George V'.</p>

15. Overall Condition	Good
Notes:	
16. Recommended for inclusion	Yes
17. Date of assessment	29/05/24

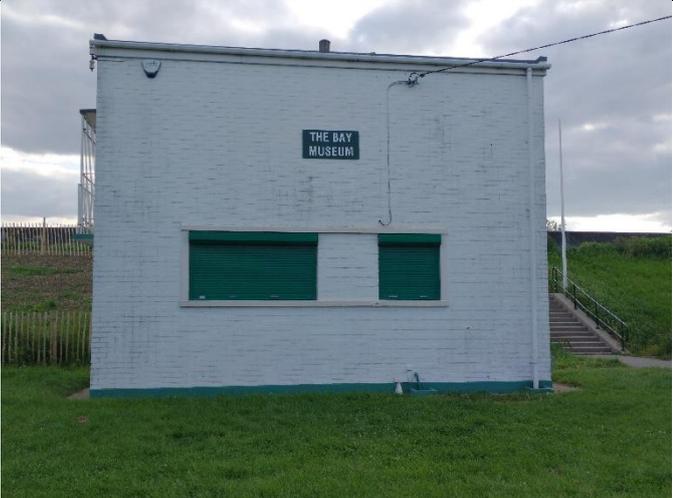
7. Description (Including Asset Type)		
<p>A two-storey building constructed from brick, which is now painted. The building has a flat roof and is covered in felt. There are openings to the ground and first floor and the first floor has a metal veranda. The building is now in use of The Bay Museum and Research Facility.</p>

15. Overall Condition	Good	
Notes:		
16. Recommended for inclusion	Yes	
17. Date of assessment	31/05/24

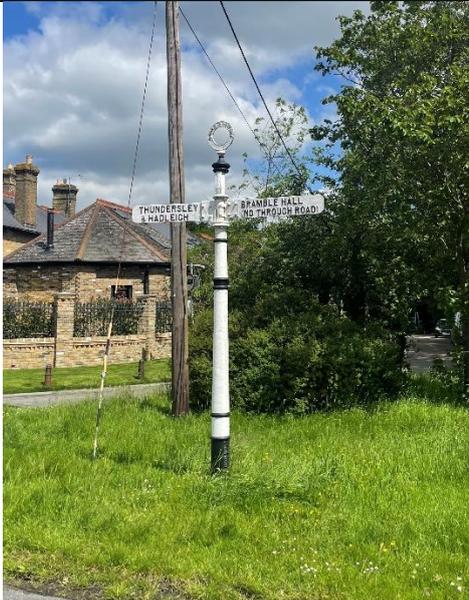
3. Address	Junction of St. Michaels Road and Bramble Road Street sign, Daws Heath	
4. Postcode	SS7 2UW	
5. Grid Ref	581524 188684	
6a. Conservation Area	No	
6b. If yes, which CA		
7. Description (Including Asset Type)	Potentially an early twentieth century fingerpost. A cylindrical post with two fingers with raised lettering and a circular finial.

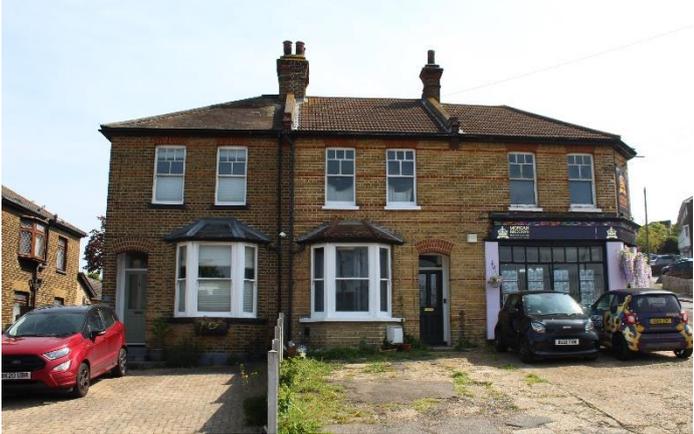
3. Address	101-105 High Street, South Benfleet	
4. Postcode	SS7 5LN	
5. Grid Ref	577786 185916	
6a. Conservation Area	Yes	
6b. If yes, which CA	South Benfleet	
7. Description (Including Asset Type)		
<p>A group of late nineteenth-early twentieth century dwellings and corner shop. The row is constructed from yellow stock brick with red brick banding. There are bay windows to the ground floor of residential properties and timber sash windows to the upper floor.</p>

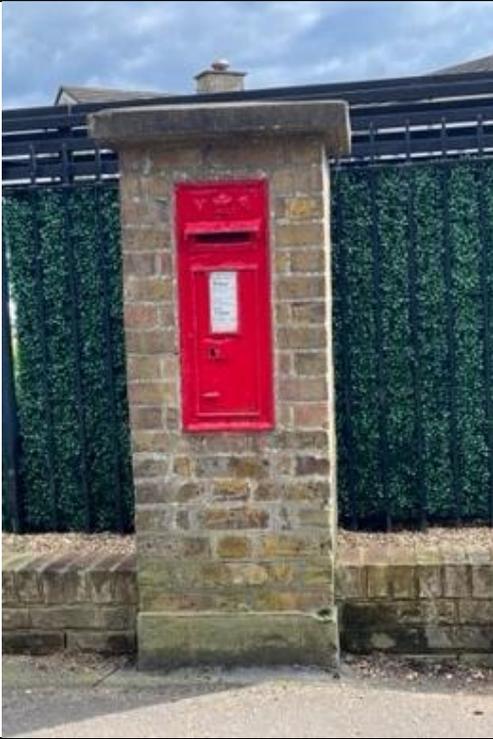
3. Address	Vicarage Hill	
4. Postcode	SS7 1PG	
5. Grid Ref	579007 186692	
6a. Conservation Area	No	
6b. If yes, which CA		
7. Description (Including Asset Type)		
A Victorian Post Box plate set into a brick pier.

8. Age	1840-1913	
Exact date (if known):		
9. Authenticity	A single significant phase and which is largely intact	
10. Architectural and Artistic Interest		
This asset has limited architectural interest. This post box is not present on the late nineteenth century maps and may have been relocated from elsewhere.		
11. Historic Interest (Including Social and Communal Interest)		
N/A		
12. Group Value		
N/A		
13. Landmark Status / Townscape Value		
N/A		
14. Archaeological Interest		
N/A		
15. Overall Condition	Fair	
Notes:		
16. Recommended for inclusion	No	
17. Date of assessment	03/06/24

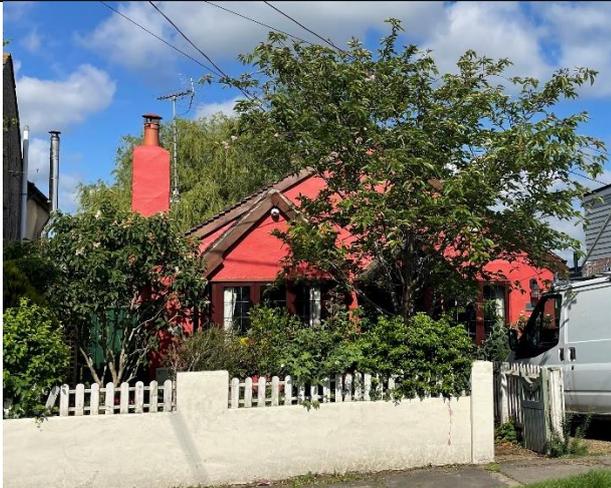
3. Address	99 Manor Road, New Thundersley, Benfleet	
4. Postcode	SS7 4AW	
5. Grid Ref	577498 188891	
6a. Conservation Area	No	
6b. If yes, which CA		
<b>7. Description (Including Asset Type)</b>		
A bungalow dwelling with a gabled roof covered in clay tiles and a tall chimney to the south. The elevations are rendered, and the windows are uPVC.

8. Age	Post 1947	
Exact date (if known):		
9. Authenticity	A single significant phase with some alterations and/or extensions	
<b>10. Architectural and Artistic Interest</b>		
The property appears to have been constructed in the mid-twentieth century. It is of limited architectural interest.		
<b>11. Historic Interest (Including Social and Communal Interest)</b>		
N/A		
<b>12. Group Value</b>		
N/A		
<b>13. Landmark Status / Townscape Value</b>		
N/A		
<b>14. Archaeological Interest</b>		
N/A		
15. Overall Condition	Fair	
Notes:		
16. Recommended for inclusion	No	
17. Date of assessment	03/06/24

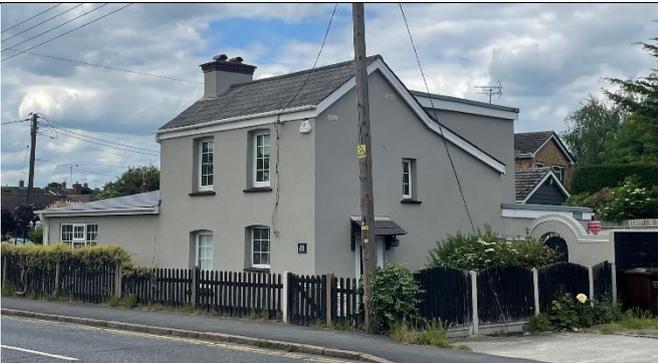
3. Address	362 High Road, South Benfleet	
4. Postcode	SS7 5HP	
5. Grid Ref	577272 187100	
6a. Conservation Area	No	
6b. If yes, which CA		
7. Description (Including Asset Type)		
A nineteenth century cottage that is two-storeys high. The roof is gabled with a catslide to the rear and large box dormers. Large single storey extensions to the side and rear.

8. Age	1840-1913	
Exact date (if known):		
9. Authenticity	A single significant phase with significant alterations and/or extensions	
10. Architectural and Artistic Interest		
The property has been heavily altered and extended over the years which has diminished its architectural interest. The original character and appearance of the property is no longer legible.		
11. Historic Interest (Including Social and Communal Interest)		
N/A		
12. Group Value		
N/A		
13. Landmark Status / Townscape Value		
N/A		
14. Archaeological Interest		
N/A		
15. Overall Condition	Good	
Notes:		
16. Recommended for inclusion	No	
17. Date of assessment	03/06/24

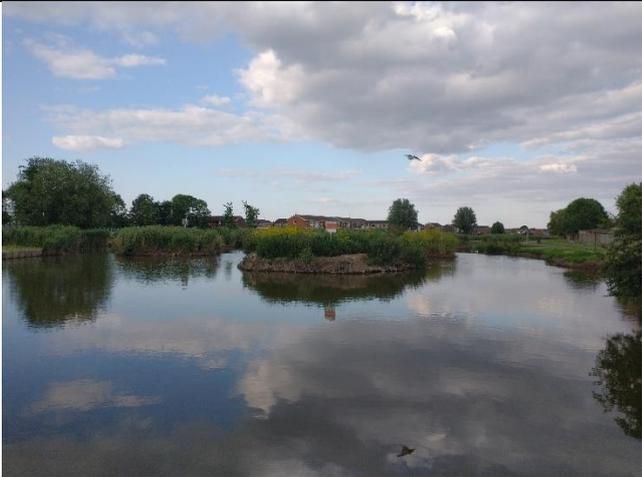
1. Name	Canvey Lake	
2. UID

3. Address	Canvey lake wildlife sanctuary	
4. Postcode		
5. Grid Ref	579673 183983	
6a. Conservation Area	No	
6b. If yes, which CA		
7. Description (Including Asset Type)		
A waterbody that runs on an east-west axis.

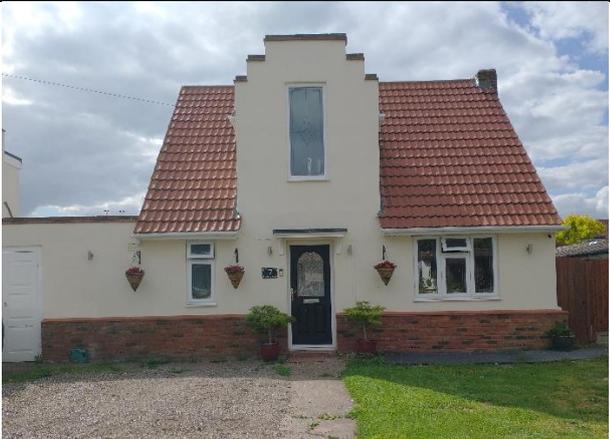
3. Address	The Dutch Village Estate, off Canvey Road, Canvey Island. The Dutch style bungalows in Harlem Road and Limburg Road		
4. Postcode			
5. Grid Ref	577630 183865		
6a. Conservation Area	No		
6b. If yes, which CA			
7. Description (Including Asset Type)			
Two roads comprising of terrace, semi-detached and detached dwellings. The 'Dutch Village' was constructed in the mid-twentieth century along Harlem Road and Limburg Road.

8. Age	Post 1947	
Exact date (if known):		
9. Authenticity	A single significant phase with significant alterations and/or extensions	
10. Architectural and Artistic Interest		
The dwellings are of limited architectural interest. They have been heavily altered over the years and they are not consistent in their character and appearance.		
11. Historic Interest (Including Social and Communal Interest)		
N/A		
12. Group Value		
N/A		
13. Landmark Status / Townscape Value		
N/A		
14. Archaeological Interest		
N/A		
15. Overall Condition	Poor	
Notes:		
16. Recommended for inclusion	No	
17. Date of assessment	03/06/24

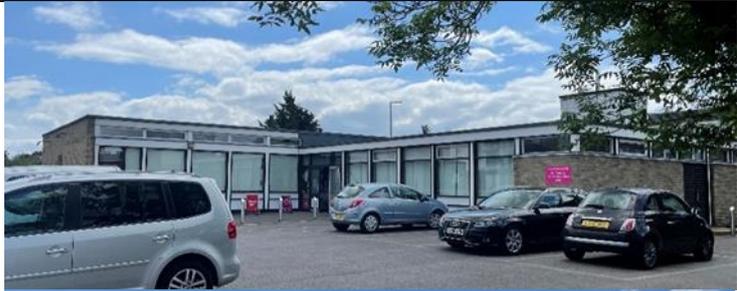
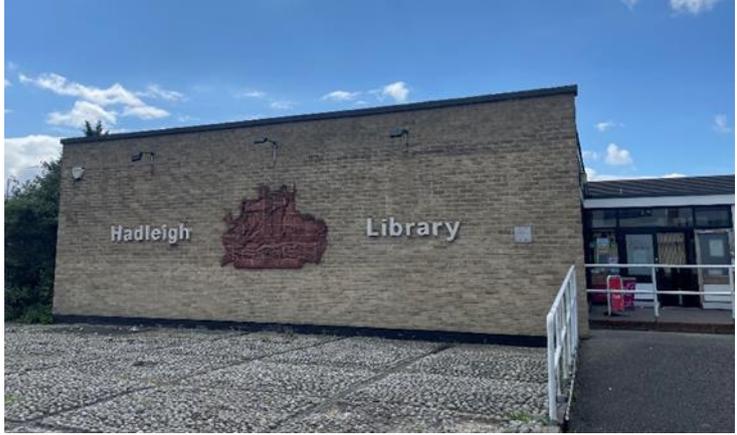
3. Address	180 London Road, Hadleigh	
4. Postcode	SS7 2PD	
5. Grid Ref	580842 187112	
6a. Conservation Area	No	
6b. If yes, which CA

7. Description (Including Asset Type)		
A mid-twentieth century public library. Single storey in height, a steel frame and concrete construction clad in light brick.

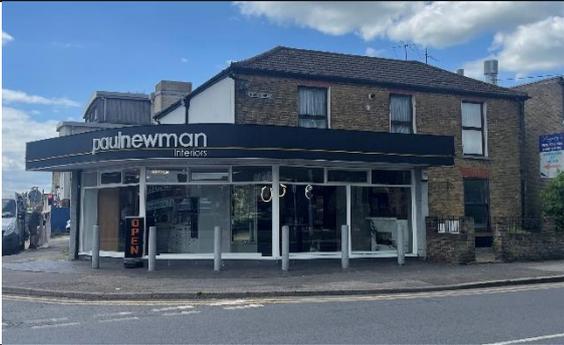
3. Address	136 High Street, Hadleigh	
4. Postcode	SS7 2PB	
5. Grid Ref	581035 186979	
6a. Conservation Area	No	
6b. If yes, which CA		
7. Description (Including Asset Type)		
A two-storey late nineteenth century property with a shop to the ground floor. It is constructed from stock brick with a hipped roof.

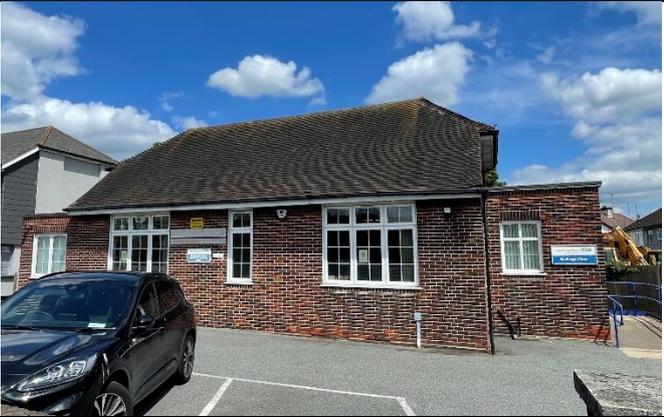
3. Address	49 London Road, Hadleigh	
4. Postcode		
5. Grid Ref	580446 187409	
6a. Conservation Area	No	
6b. If yes, which CA		
7. Description (Including Asset Type)		
A single storey building constructed from red/brown bricks under a hipped roof that is covered in tiles.

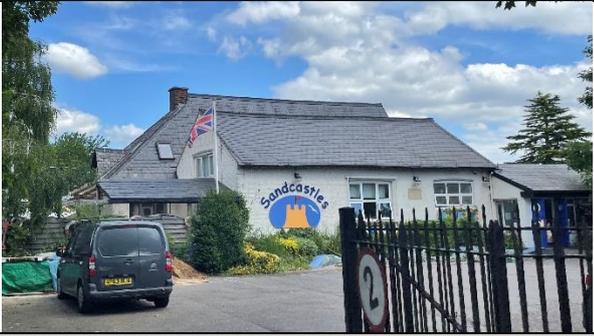
3. Address	81 London Road, Hadleigh	
4. Postcode		
5. Grid Ref	580552 187325	
6a. Conservation Area	No	
6b. If yes, which CA		
7. Description (Including Asset Type)		
<p>The property was constructed in 1855 by architect George Edmund Street. The front section is a simple linear ranger constructed from brick (now painted) and to the rear is a large, steeply pitched building with a slate roof.</p>

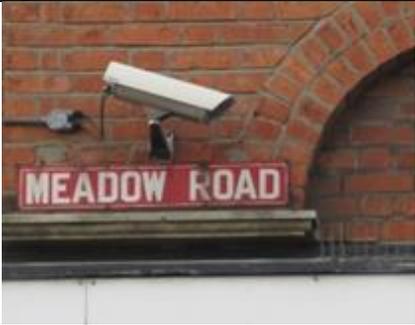
1. Name	Meadow Road Street Sign	
2. UID

3. Address	Meadow Road street name sign, Meadow Road, Hadleigh	
4. Postcode		
5. Grid Ref	581365 186833	
6a. Conservation Area	No	
6b. If yes, which CA		
7. Description (Including Asset Type)		
A metal road sign.

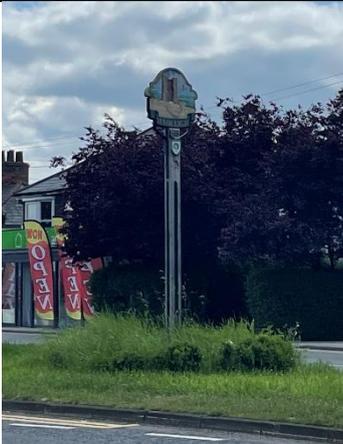
1. Name	Hadleigh Carved Village Sign	
2. UID

3. Address	Hadleigh carved village sign, opposite Salvation Army Temple, London Road, Hadleigh	
4. Postcode		
5. Grid Ref	580712 187155	
6a. Conservation Area	No	
6b. If yes, which CA		
7. Description (Including Asset Type)		
A timber village side with an image of Hadleigh Castle.

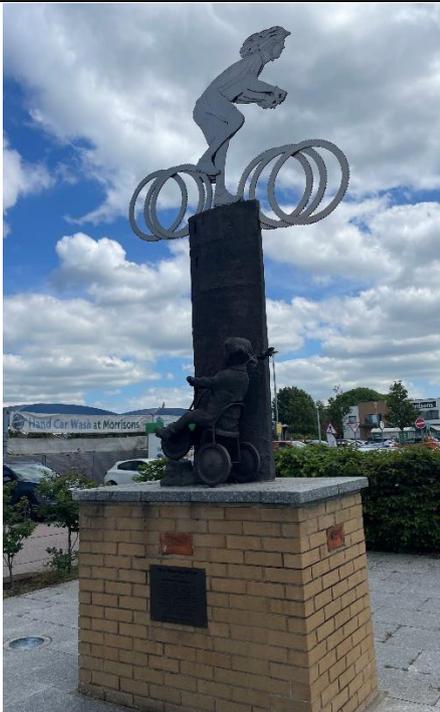
1. Name	Bronze Sculpture		
2. UID

3. Address	Bronze sculpture, London Road (near Morrisons supermarket)		
4. Postcode			
5. Grid Ref	580653 187208		
6a. Conservation Area	No		
6b. If yes, which CA			
7. Description (Including Asset Type)			
<p>A bronze and stainless-steel sculpture sat on a brick plinth; It incorporates Hadleigh Castle, the Salvation Army and James (Cunning) Murrell, together with a celebration of the 2012 Mountain Bike Olympics.</p>

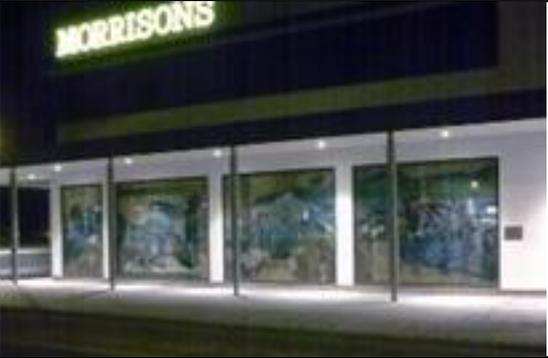
1. Name	Painted Mural	
2. UID

3. Address	Painted murals on wall of Morrison supermarket, Benfleet	
4. Postcode		
5. Grid Ref	580707 187193	
6a. Conservation Area	No	
6b. If yes, which CA		
7. Description (Including Asset Type)		
Four panel painted mural on the side of Morrisons supermarket. The mural depicts images from local history.
