# THE CASTLE POINT PLAN

## Local List of Heritage Assets

July 2024

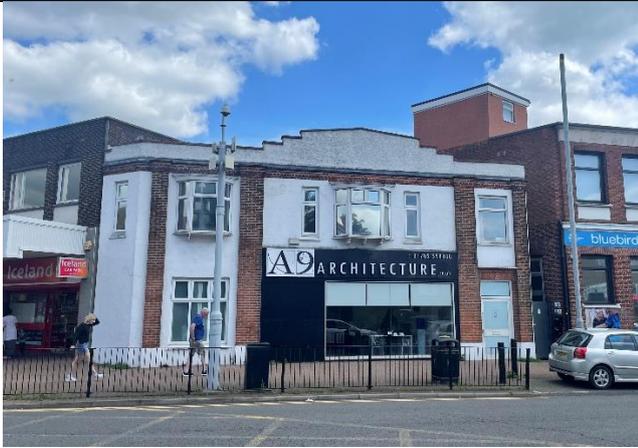
3. Address	Parapet wall at 255 London Road, Hadleigh		
4. Postcode			
5. Grid Ref	581076 187053		
6a. Conservation Area	No		
6b. If yes, which CA			
7. Description (Including Asset Type)			
The parapet wall sits above the first floor, obscuring the roof behind. It is rendered with clay copings.

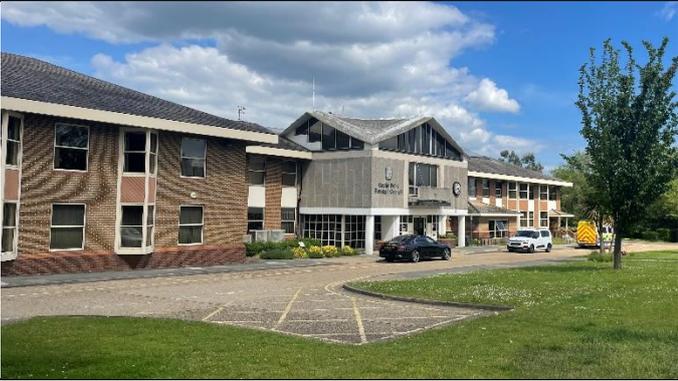
3. Address	Castle Point Council Offices, Kiln Road	
4. Postcode		
5. Grid Ref	579281 187919	
6a. Conservation Area	No	
6b. If yes, which CA		
7. Description (Including Asset Type)	<p>A large mid-late twentieth century, purpose-built council office. The property is two-storeys high. There is a central entrance constructed of concrete panels with a recessed entrance supported on columns and glazing to the gables. The winged elements are constructed of brown brick and have hipped roofs.</p>

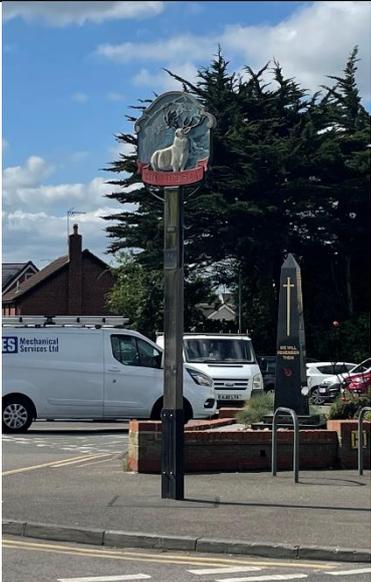
1. Name	Thundersley Carved Village Sign	
2. UID

3. Address	Thundersley carved village sign (on corner of Dark Lane and Hart Road)	
4. Postcode		
5. Grid Ref	578999 188717	
6a. Conservation Area	No	
6b. If yes, which CA		
7. Description (Including Asset Type)		
A timber village sign depicting a stag.

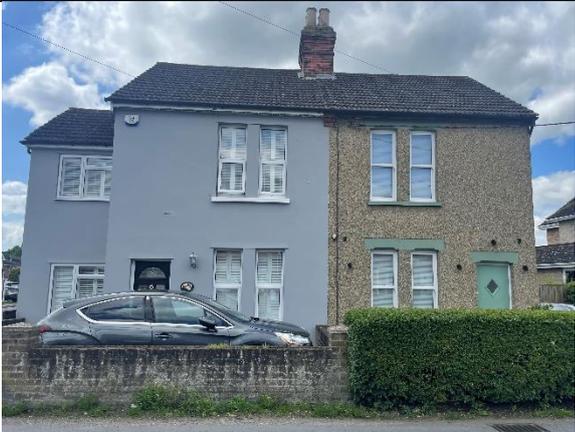
3. Address	304&305 Daws Heath Road	
4. Postcode		
5. Grid Ref	581238 188765	
6a. Conservation Area	No	
6b. If yes, which CA		
7. Description (Including Asset Type)		
<p>A pair of cottages, two-storey in height. The roof form is gabled with a central chimney that is of red brick. The roof is covered in concrete tiles and the elevations are a mix of pebble dash and smooth render.</p>

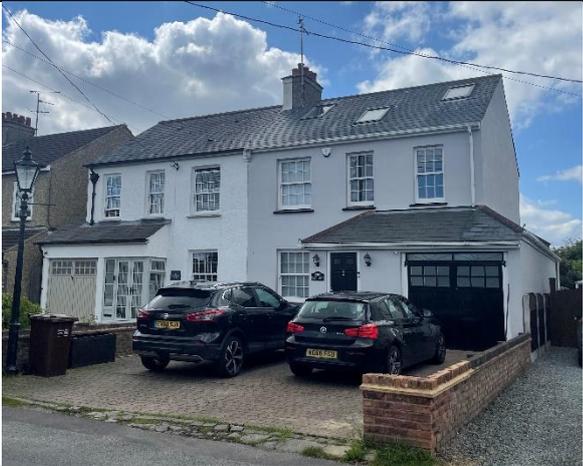
3. Address	320-322 Daws Heath Road	
4. Postcode		
5. Grid Ref	581312 188734	
6a. Conservation Area	No	
6b. If yes, which CA		
7. Description (Including Asset Type)		
<p>A pair of semi-detached residential dwellings. The pair are two-storey in height with a simple gabled roof form and central chimney. The roof is covered in tiles and the elevations are rendered. The windows are uPVC sashes.</p>

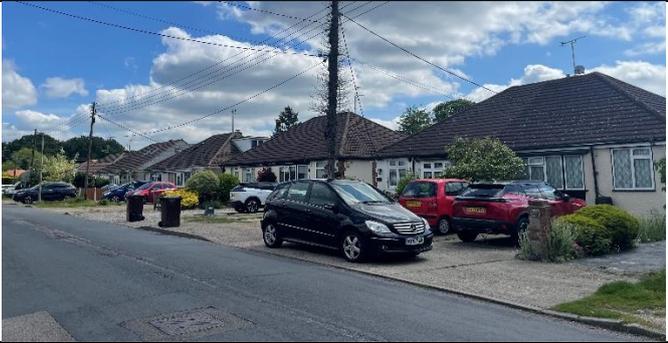
3. Address	339-353 Daws Heath Road		
4. Postcode			
5. Grid Ref	581327 188677		
6a. Conservation Area	No		
6b. If yes, which CA			
7. Description (Including Asset Type)			
<p>A group of bungalows, predominantly with hipped roofs covered in concrete tiles. The elevations are rendered, and some have brick quoining and bay windows.</p>

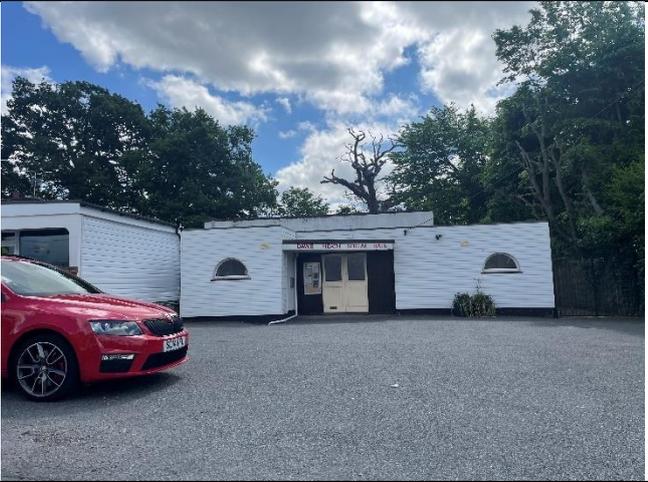
1. Name	Daws Heath Social Hall		
2. UID

3. Address	Daws Heath Social Hall, Daws Heath Road		
4. Postcode			
5. Grid Ref	581247 188549		
6a. Conservation Area	No		
6b. If yes, which CA			
7. Description (Including Asset Type)			
A single storey building with a flat roof. The elevations are clad in uPVC horizontal boarding.

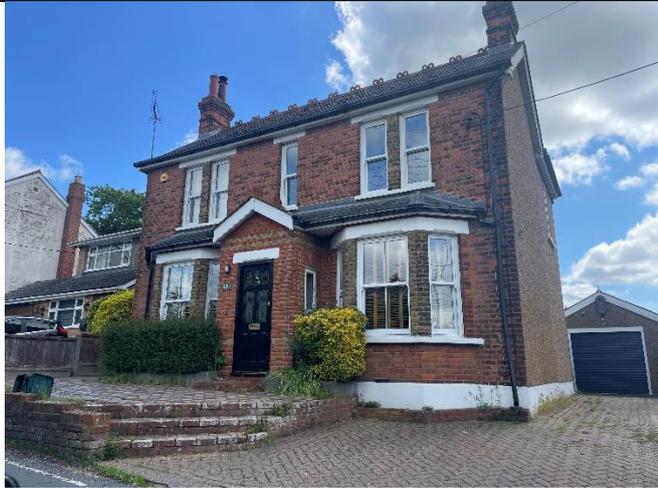
1. Name	389 Daws Heath Road	
2. UID

3. Address	389 Daws Heath Road	
4. Postcode		
5. Grid Ref	581222 188517	
6a. Conservation Area	No	
6b. If yes, which CA		
7. Description (Including Asset Type)		
<p>A detached, two-storey dwelling. The property is constructed from red brick with yellow brick banding. The roof form is gabled and is covered in concrete tiles. The ground floor has two bay windows, all windows have uPVC sashes.</p>

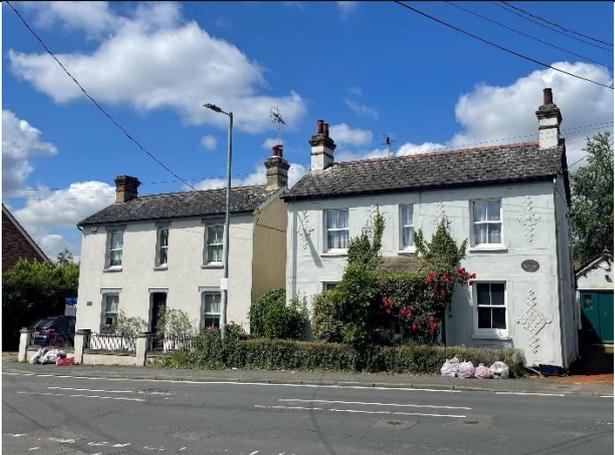
1. Name	412 & 414 Daws Heath Road	
2. UID

3. Address	412 & 414 Daws Heath Road	
4. Postcode		
5. Grid Ref	581161 188423	
6a. Conservation Area	No	
6b. If yes, which CA		
7. Description (Including Asset Type)		
<p>A pair of detached cottages that are two storeys high with simple gabled roof forms, flanked by chimneys. They have a central entrance flanked by two sash windows, the first floor is three lights wide with the central light of a narrower proportion. The elevations are rendered and the roof is covered in tiles.</p>

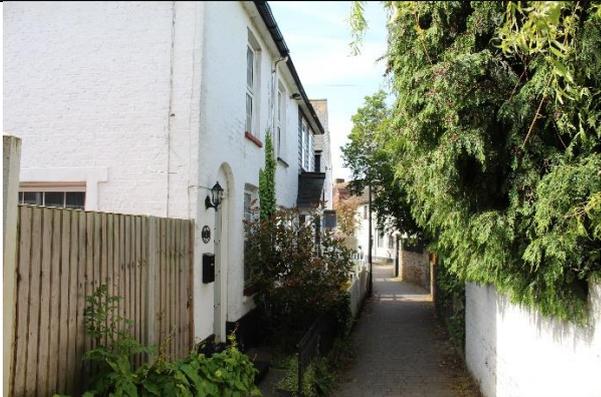
1. Name	The Close	
2. UID

3. Address	The Close, Off South Benfleet High Street	
4. Postcode		
5. Grid Ref	577779 186025	
6a. Conservation Area	Yes	
6b. If yes, which CA	South Benfleet	
7. Description (Including Asset Type)		
<p>The Close is a pedestrian passageway lined by detached, semi-detached and terrace dwellings. The properties along The Close are two-storeys in height, predominantly rendered, with some weatherboarded and are largely in residential use apart from the Benfleet Conservative Club.</p>

15. Overall Condition	Fair	
Notes:		
16. Recommended for inclusion	No	
17. Date of assessment	03/06/24

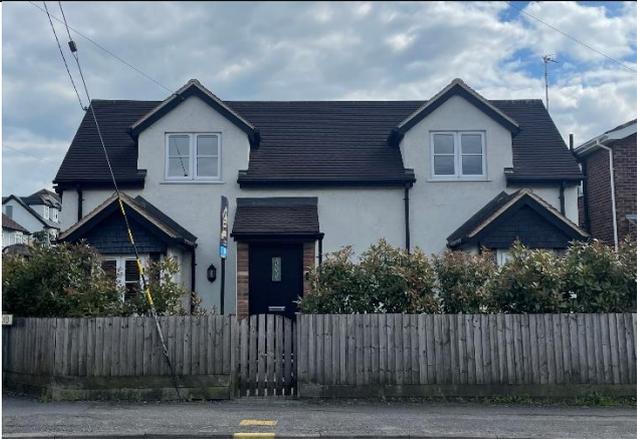
1. Name	74 Essex Way	
2. UID

3. Address	74 Essex Way	
4. Postcode	SS7 1	
5. Grid Ref	578117 186053	
6a. Conservation Area	No	
6b. If yes, which CA		
7. Description (Including Asset Type)		
A one and half storey, detached dwelling with a gabled roof form and dormers set into the eaves. The elevations are rendered and the roof is covered in concrete tiles.

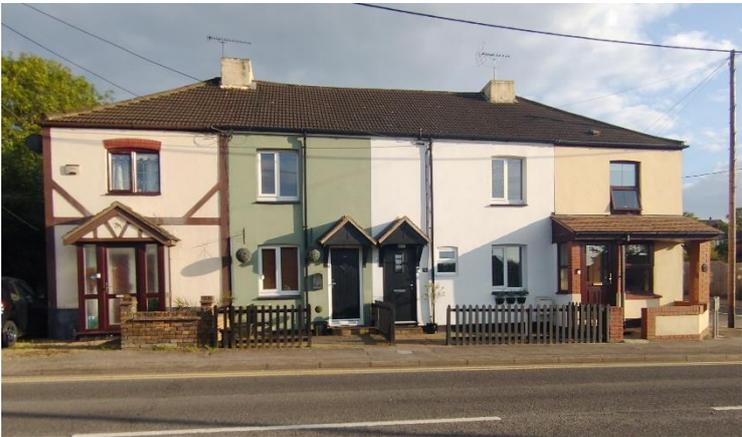
1. Name	76-82 Essex Way	
2. UID		
3. Address	76-82 Essex Way

4. Postcode	SS7 1	
5. Grid Ref	578166 186056	
6a. Conservation Area	No	
6b. If yes, which CA		
7. Description (Including Asset Type)	A row of four terraced residential dwellings. The properties are two-storeys high, with a hipped roof that is covered in concrete tiles.

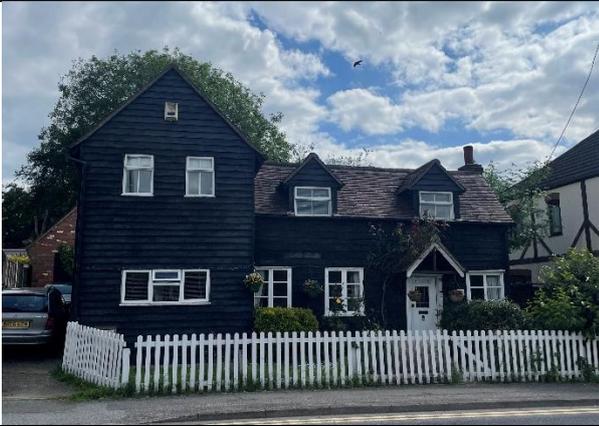
1. Name	84 Essex Way, Benfleet	
2. UID

3. Address	84 Essex Way, Benfleet	
4. Postcode	SS7 1	
5. Grid Ref	578178 186057	
6a. Conservation Area	No	
6b. If yes, which CA		
7. Description (Including Asset Type)		
A detached residential with weatherboarded elevations and a tiled roof. Original cottage was one and half storeys with dormer at eaves level. There is a modern, two-storey extension to the east, with the gable end fronting the road.

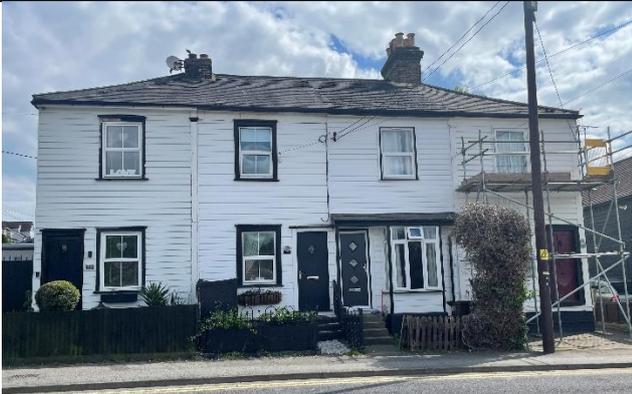
1. Name	86-92 Essex Way	
2. UID

3. Address	86-92 Essex Way, Benfleet	
4. Postcode	SS7 1	
5. Grid Ref	578186 186057	
6a. Conservation Area	No	
6b. If yes, which CA		
7. Description (Including Asset Type)		
<p>A row of four terraced residential dwellings. The properties are two-storeys high with a hipped roof covered in tiles. The elevations are a mix of timber weatherboarding and uPVC cladding.</p>

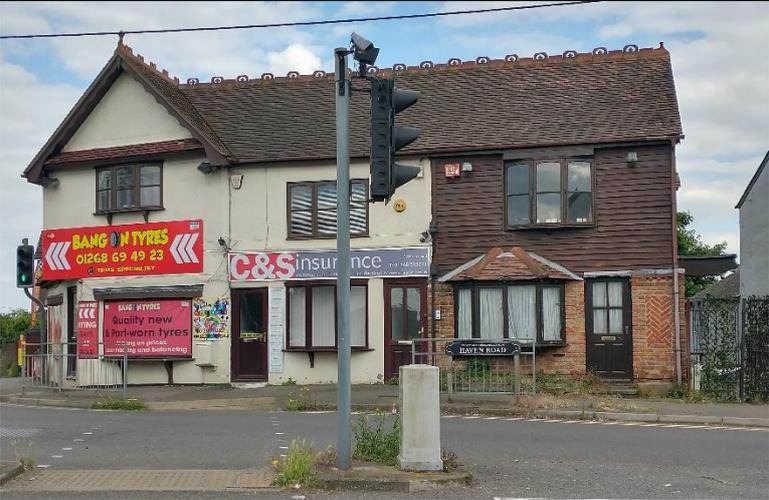
1. Name	1, 3, 5, 7 Haven Road	
2. UID

3. Address	1, 3, 5, 7 Haven Road	
4. Postcode		
5. Grid Ref	578015 183198	
6a. Conservation Area	No	
6b. If yes, which CA		
7. Description (Including Asset Type)		
A row of residential dwellings on the corner of Haven Road and Long Road. They are two-storeys high, and their elevations are a mix of render, brick and timber cladding.

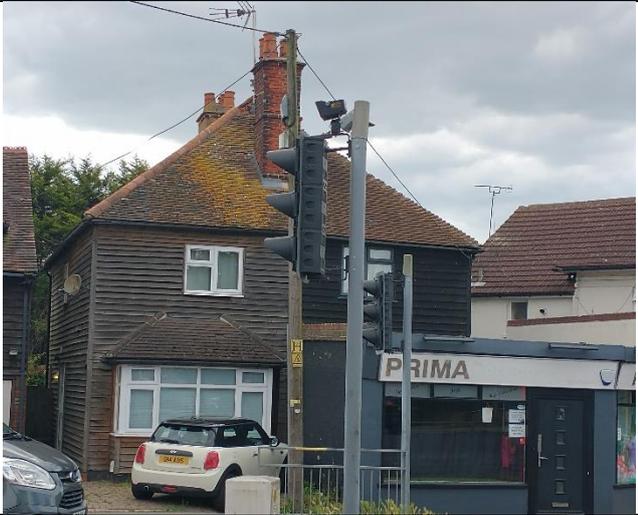
1. Name	2 Haven Road and 1 Canvey Road	
2. UID

3. Address	2 Haven Road and 1 Canvey Road	
4. Postcode	SS8 0	
5. Grid Ref	577985 183200	
6a. Conservation Area	No	
6b. If yes, which CA		
7. Description (Including Asset Type)		
<p>A semi-detached pair of residential buildings with shop to Number 1. The pair are two-storeys in height with a hipped roof and central chimney. The elevations are weatherboarded, and the windows are uPVC.</p>

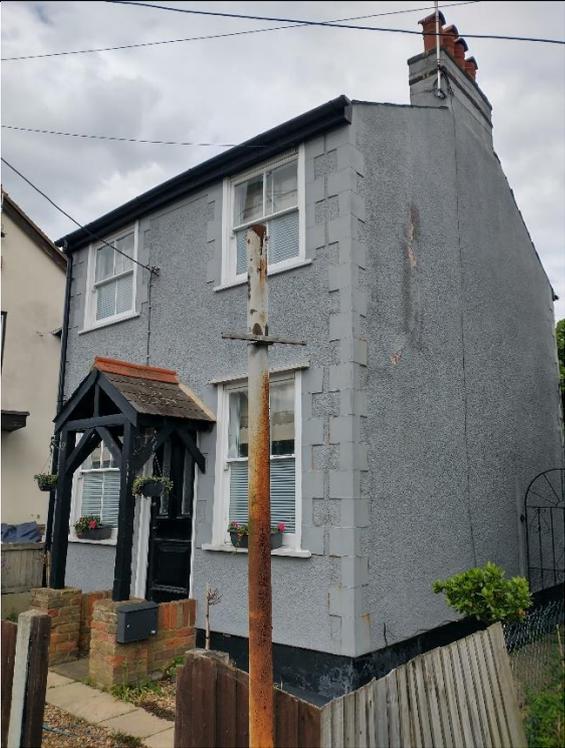
1. Name	9 Haven Road, Canvey Island	
2. UID

3. Address	9 Haven Road, Canvey Island	
4. Postcode	SS8 0LU	
5. Grid Ref	578009 183184	
6a. Conservation Area	No	
6b. If yes, which CA		
7. Description (Including Asset Type)		
A detached residential building that is two-storey high with slate tiles and rendered elevations. The property has a central entrance and sash windows to the ground and first floor.

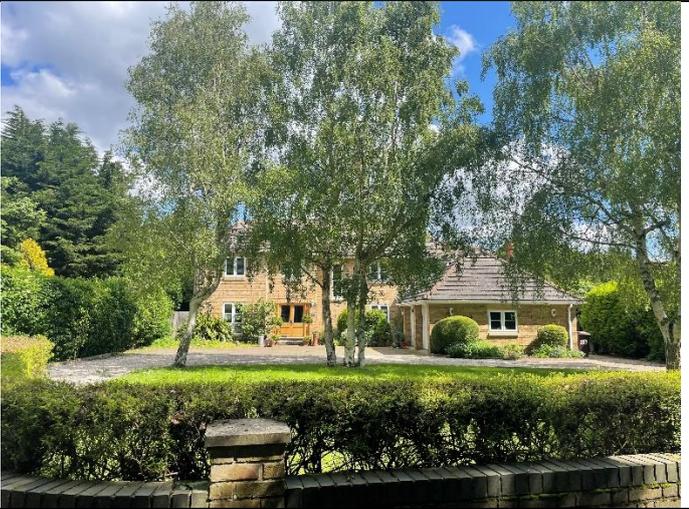
1. Name	209 Bramble Road		
2. UID

3. Address	209 Bramble Road, Daws Heath		
4. Postcode			
5. Grid Ref	582085 188398		
6a. Conservation Area	No		
6b. If yes, which CA			
7. Description (Including Asset Type)			
A large, detached residential dwelling constructed of light brick with a hipped roof.

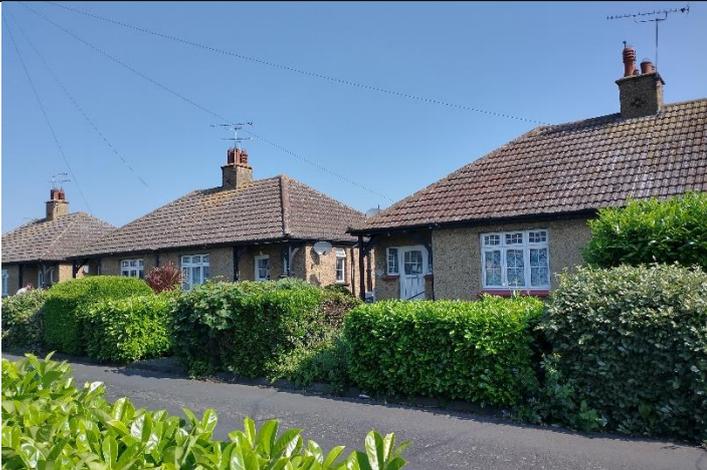
1. Name	1-24 Florence Gardens	
2. UID

3. Address	1-24 Florence Gardens	
4. Postcode	SS7 2	
5. Grid Ref	580575 187088	
6a. Conservation Area	Yes	
6b. If yes, which CA	Florence Gardens	
7. Description (Including Asset Type)		
A group of twenty-five bungalows constructed in the early-mid twentieth century. The bungalows are all of a consistent scale, form and appearance.

15. Overall Condition	Good	
Notes:		
16. Recommended for inclusion	No	
17. Date of assessment	03/06/24

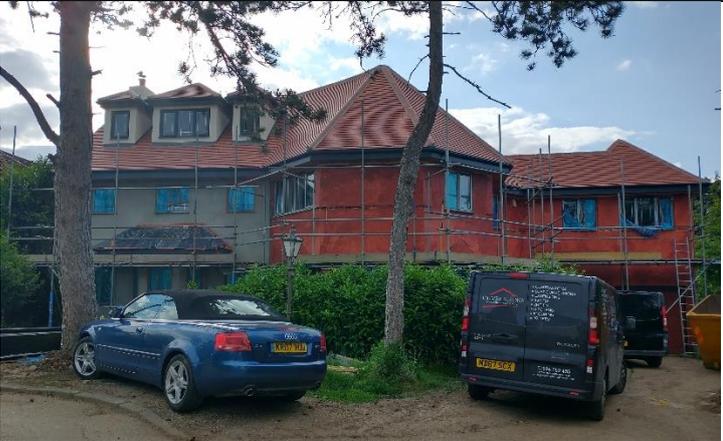
1. Name	7 Ferndale Crescent	
2. UID

3. Address	7 Ferndale Crescent, Canvey Island	
4. Postcode	SS8 0AR	
5. Grid Ref		
6a. Conservation Area	No	
6b. If yes, which CA		
7. Description (Including Asset Type)		
The property was constructed between 1932 and 1939, originally in a 'Dutch cottage' style. The property is two-storeys in height with large side and rear extensions.
